Memorandum

DATE: June 30, 2023

RE: Yarmouth Stormwater Retrofit Assessment – Final Report

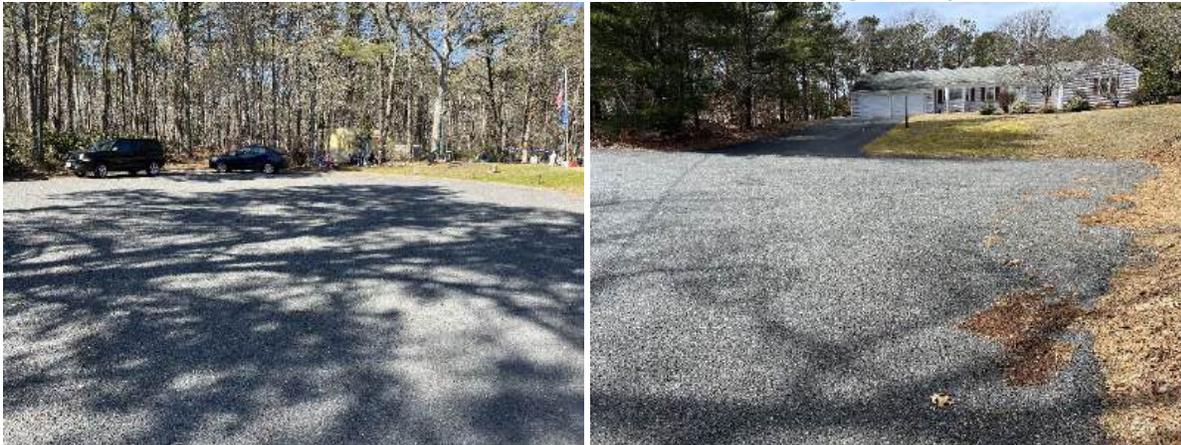
Photo 5. Excess pavement at the end of Hawes Run Road (left) and Curve Hill Road (right) examples.

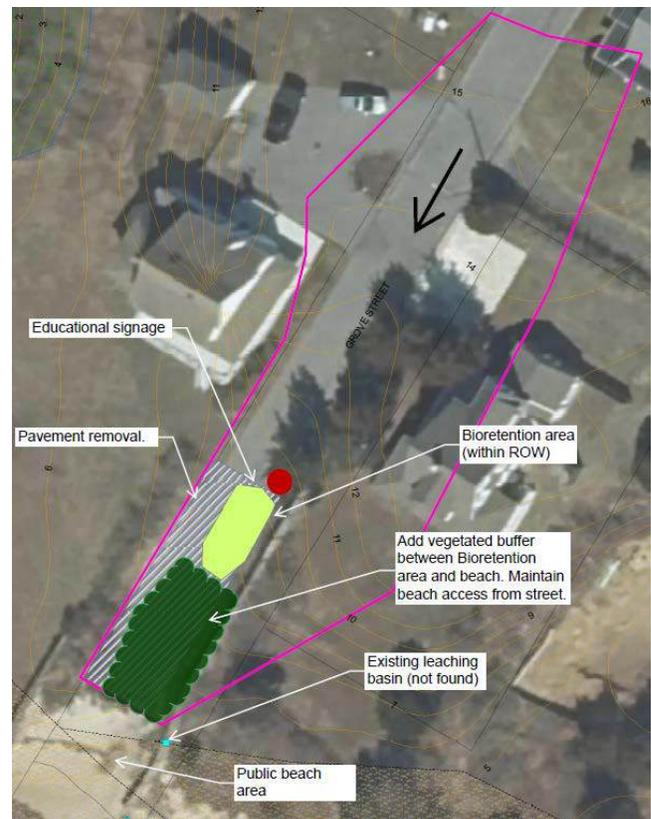
Photo Caption: Grove Street looking north.

<p>Concept Description: The concept for this site is to shorten the road to a length where two cars are still able to park at the end of the street without blocking driveways. This pavement removal area would then be replaced with a bioretention and vegetated buffer between the beach and the road. A path would be incorporated into the design for continued access to the beach.</p>		
GENERAL SITE INFORMATION	RETROFIT DETAILS	
<p>Site Contact: Amanda Lima (Town Engineer) Ownership: Town Existing Site Condition: Poor Land Use: Residential, beach access</p>	<p>Existing or New?: New Proposed BMP/Pretreatment: Bioretention / Sediment Forebay Non-Structural Controls: Pavement Removal, Buffer Planting, Public Education BMP Maintenance Burden: Low</p>

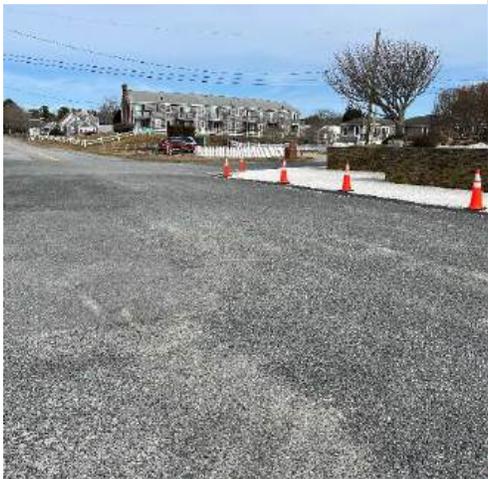
Photo Caption: End of Standish Way. Porous pavement parking lot to the right. Infiltration trench under the white shell area.

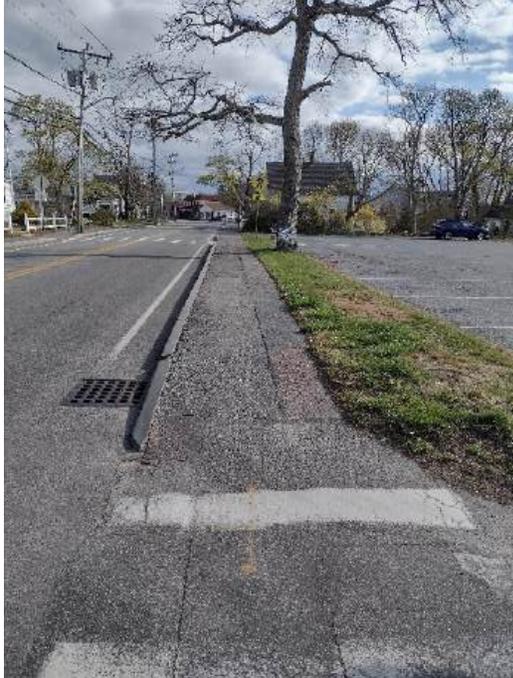
Photo Caption: Catch Basin at 311 Old Main Street (Location 2- Infiltration Trench location).

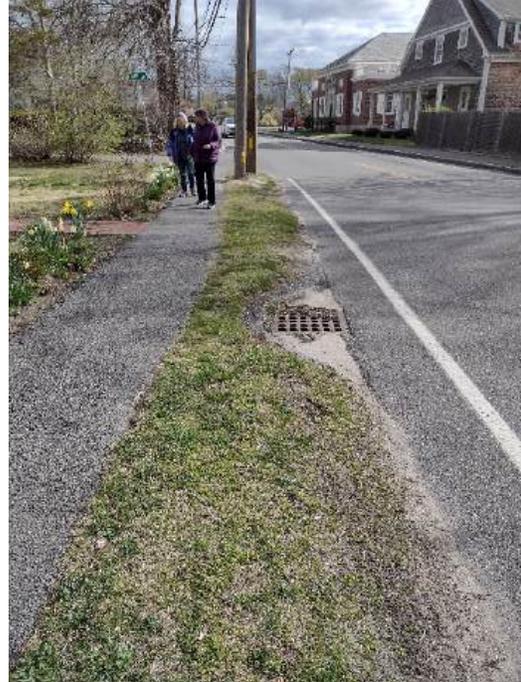
Photo Caption: Catch Basin at 296 Old Main Street (Location 3- Infiltration Trench (with tree) location).

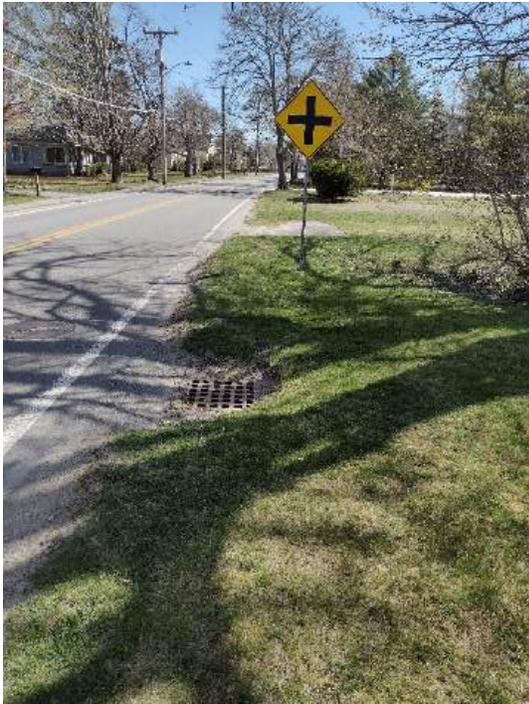
Photo Caption: Catch Basin at 221 Old Main Street (Location 9- Bioretention location).

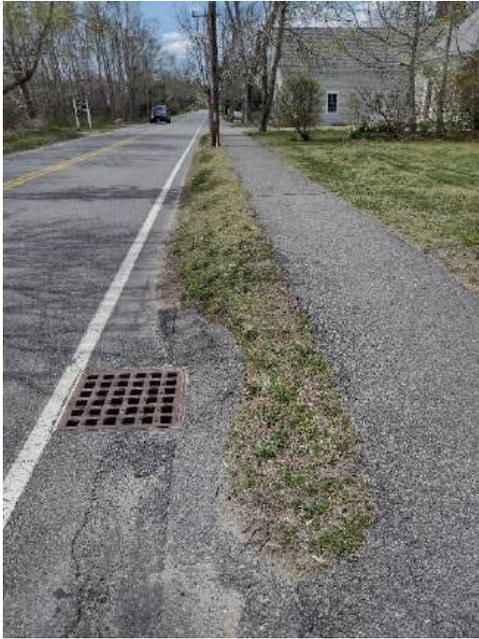
Photo Caption: Catch Basin at 154 Old Main Street (Location 4- Infiltration Trench (with tree) location).

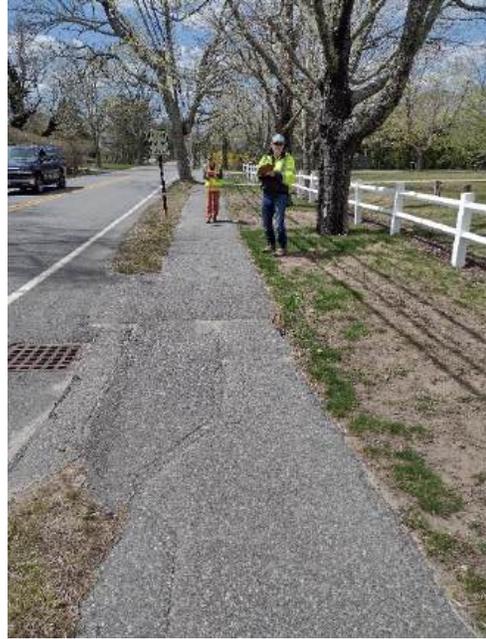
Photo Caption: Catch Basin at 134 Old Main Street (Location 6- Infiltration Trench location).

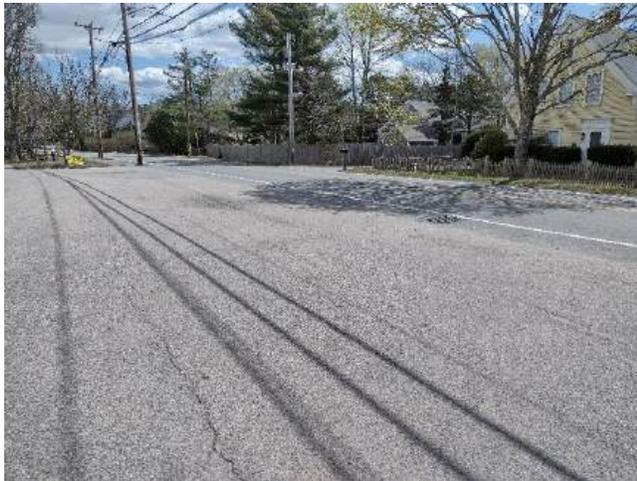
Photo Caption: Catch Basin at 96 Old Main Street (Yarmouth Fire Department) (Location 10- Underground chambers location).

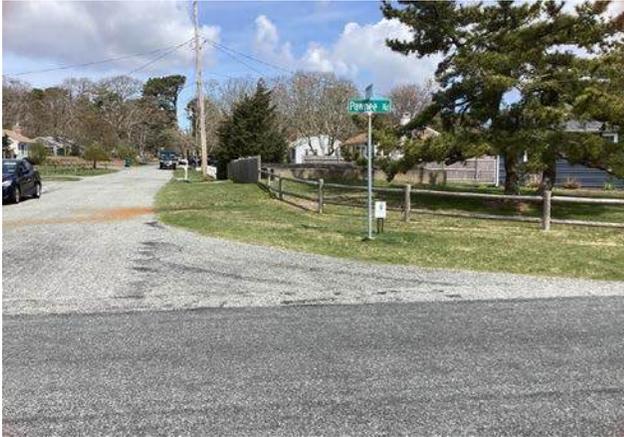
Photo Caption: Looking north on Iroquois Blvd (note rust-colored staining).

<p>Concept Description: The concept is to eliminate the existing catch basins and construct a paved flume and wet swale in the ROW. If porous pavement is considered here, should do a larger stretch of road rather than just the intersection which will clog faster from run-on.</p>

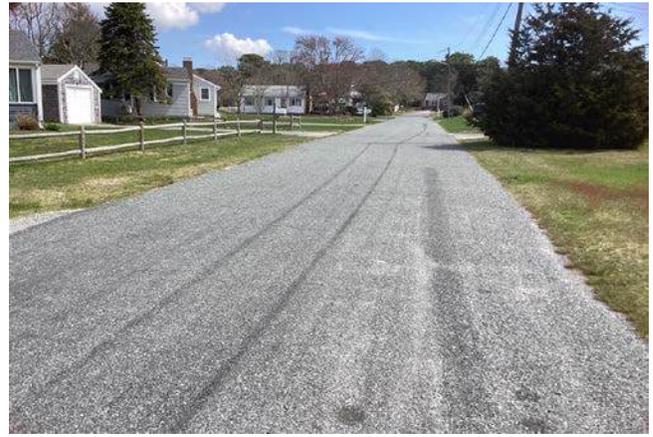
Photo Caption: Looking east on Pawnee Road.
