# Cleaning Up The Bays

## Managing Stormwater in the Three Bays

# Project Overview

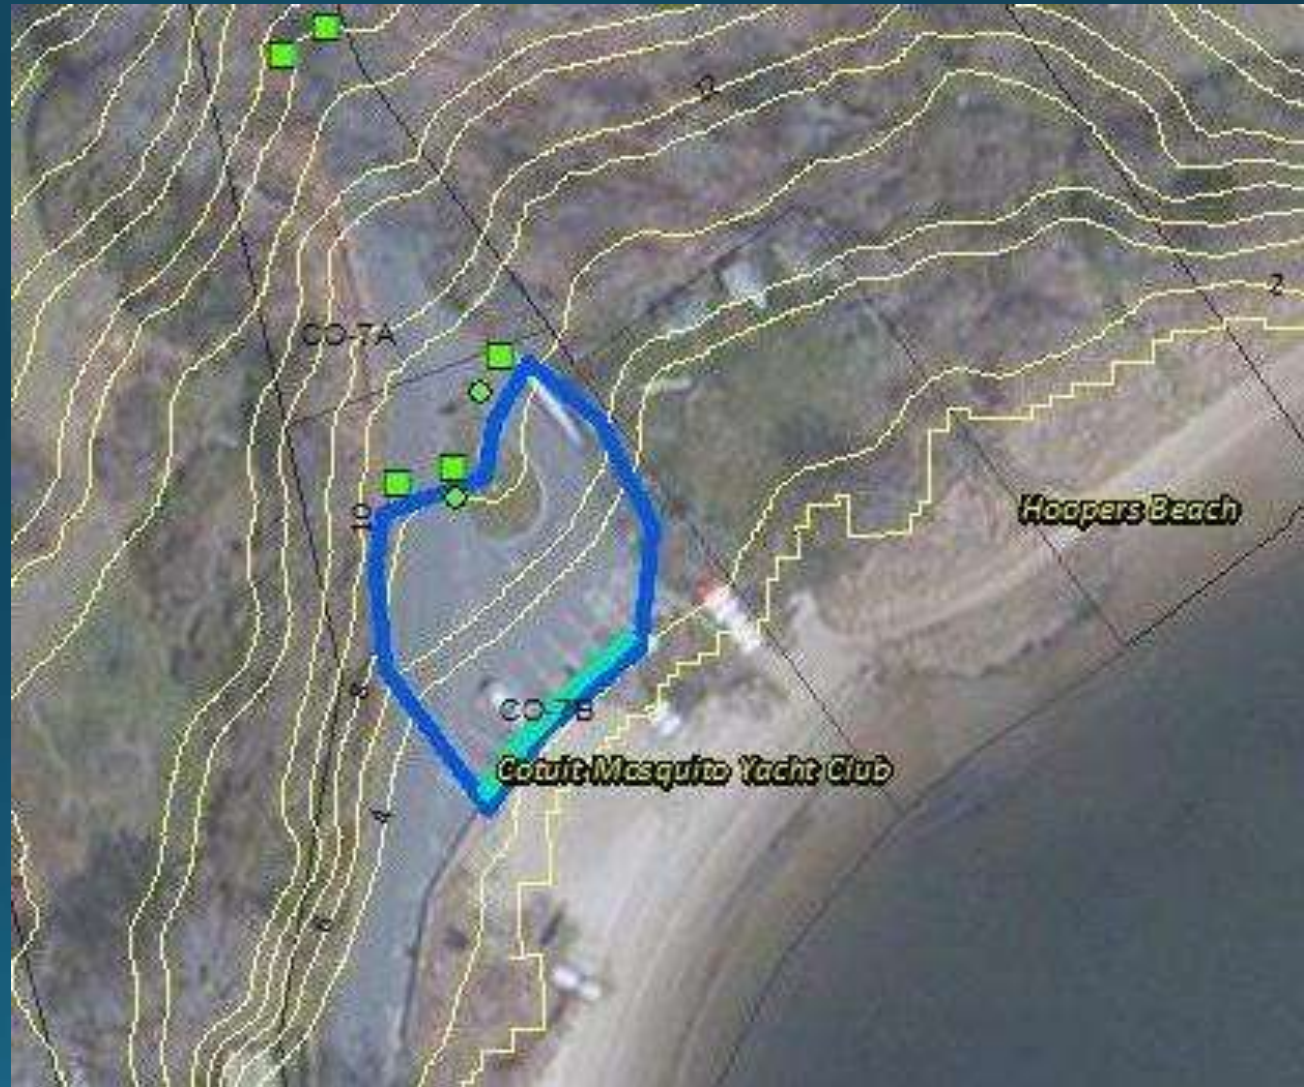
# CO-7B: Ropes Beach

- Gravel Wetland
- Pavement Reduction
- Keep Parking but Move Back
- Public Education:  
Incorporate Site into Cotuit Stormwater Walking Tour

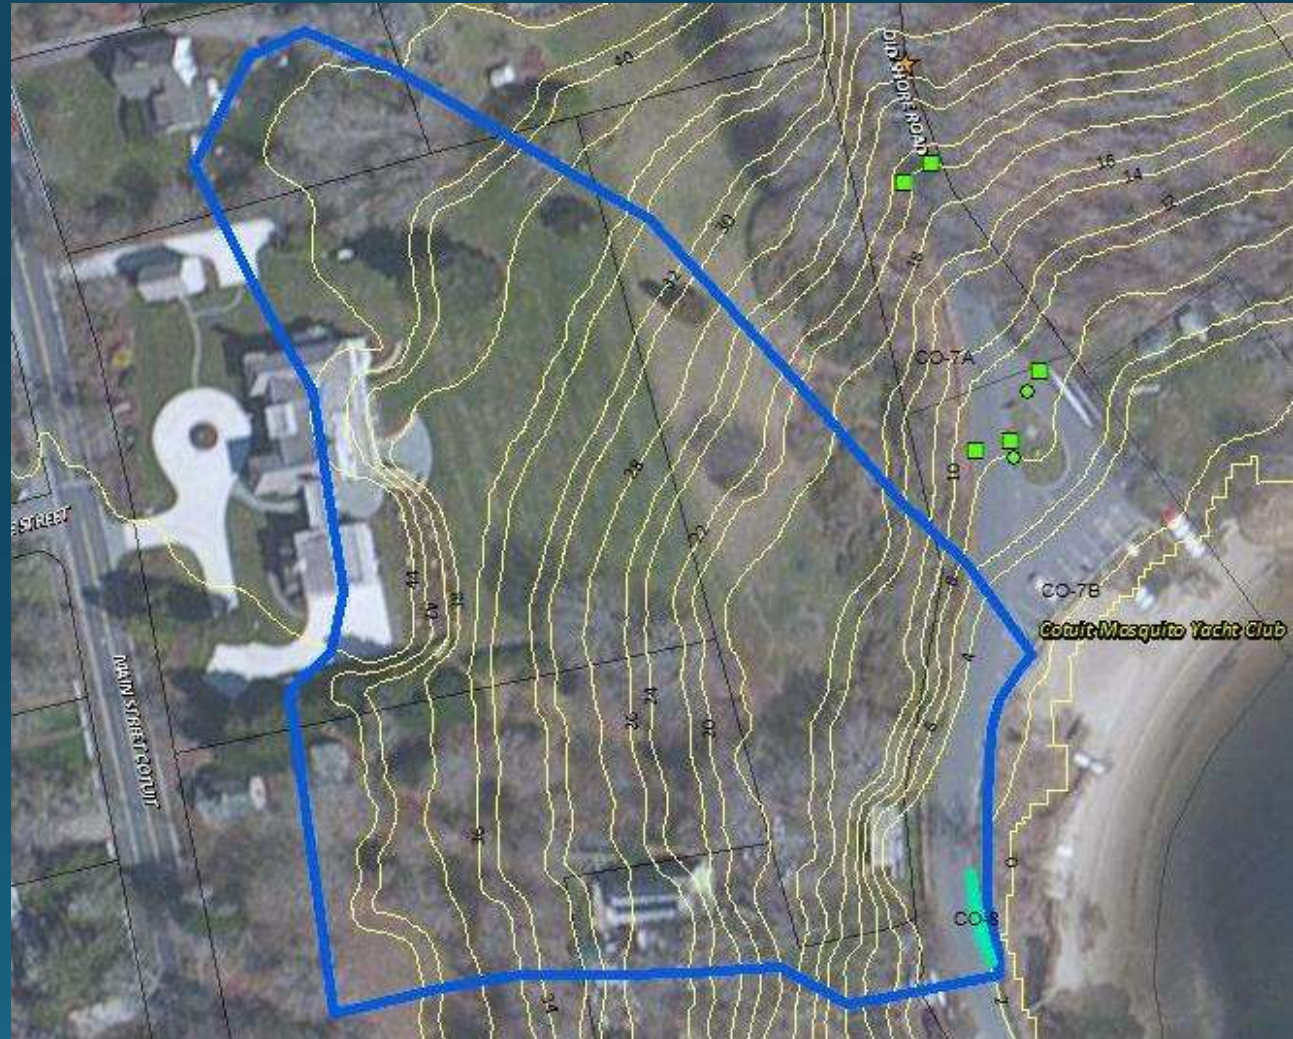
# CO-8: Ropes Beach

- **Wet Swale**
- Salt Marsh Restoration
- Public Education: Incorporate Site into Cotuit Stormwater Walking Tour

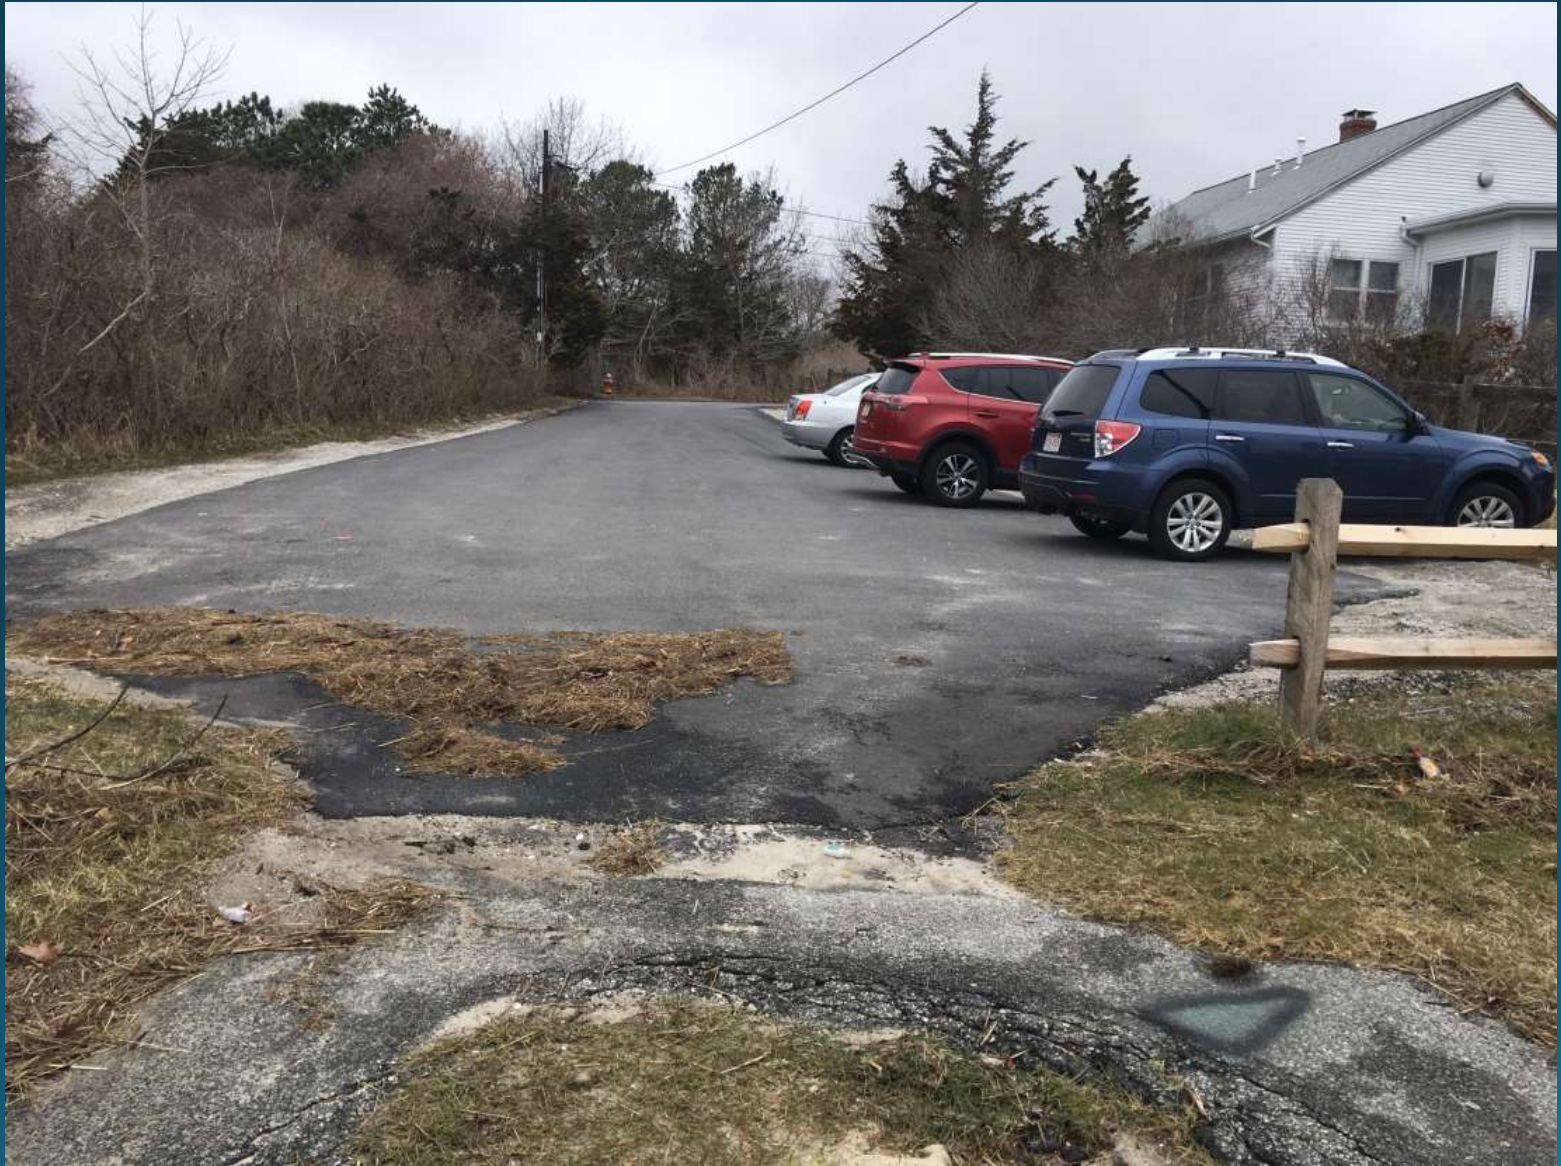
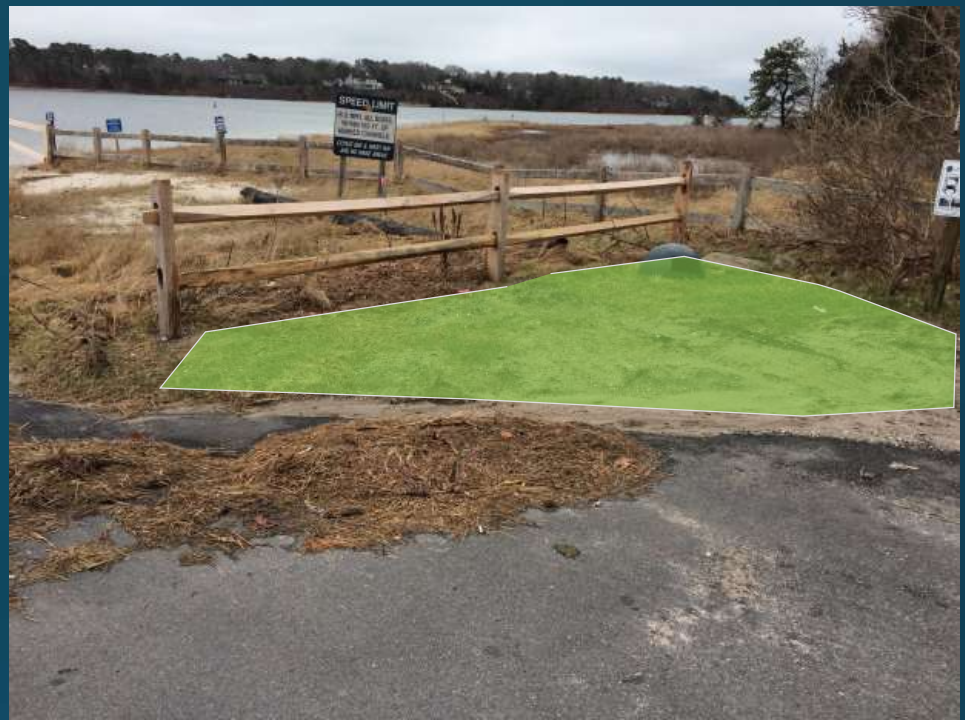
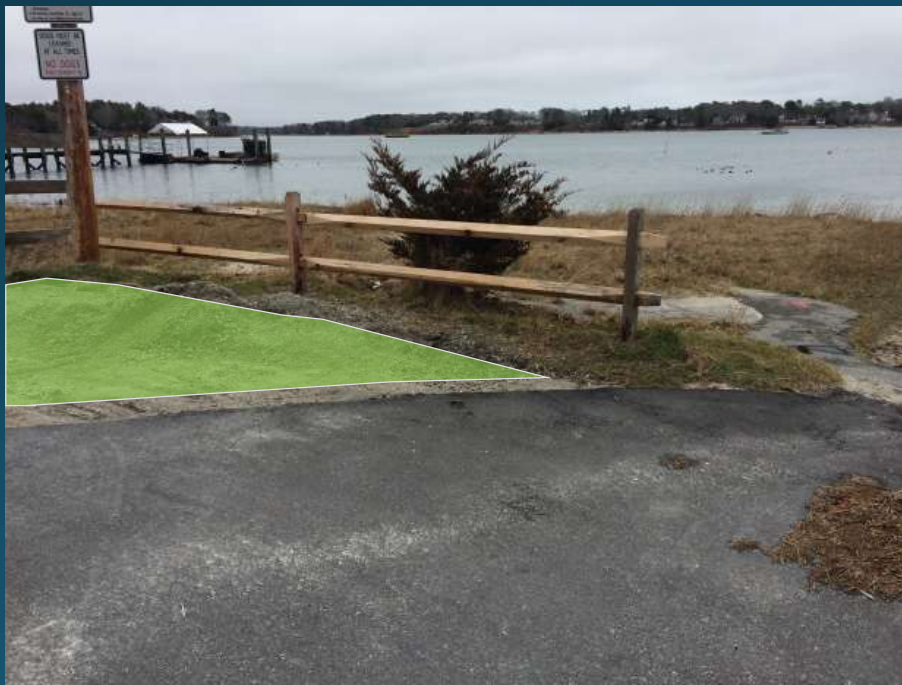
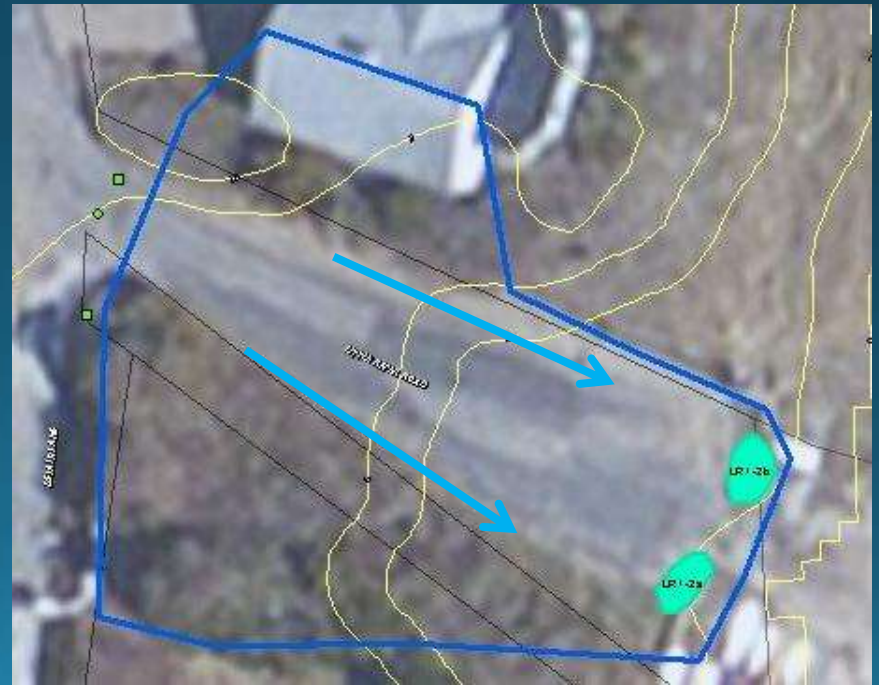
# LR1-2: Little River Landing

- **Wet Bioswales**
- Pavement Reduction
- Salt Marsh Restoration
- Stabilized/Improved Water Access
- Public Education

Remove Old  
Pavement and  
Restore Marsh

Stormwater  
Treatment

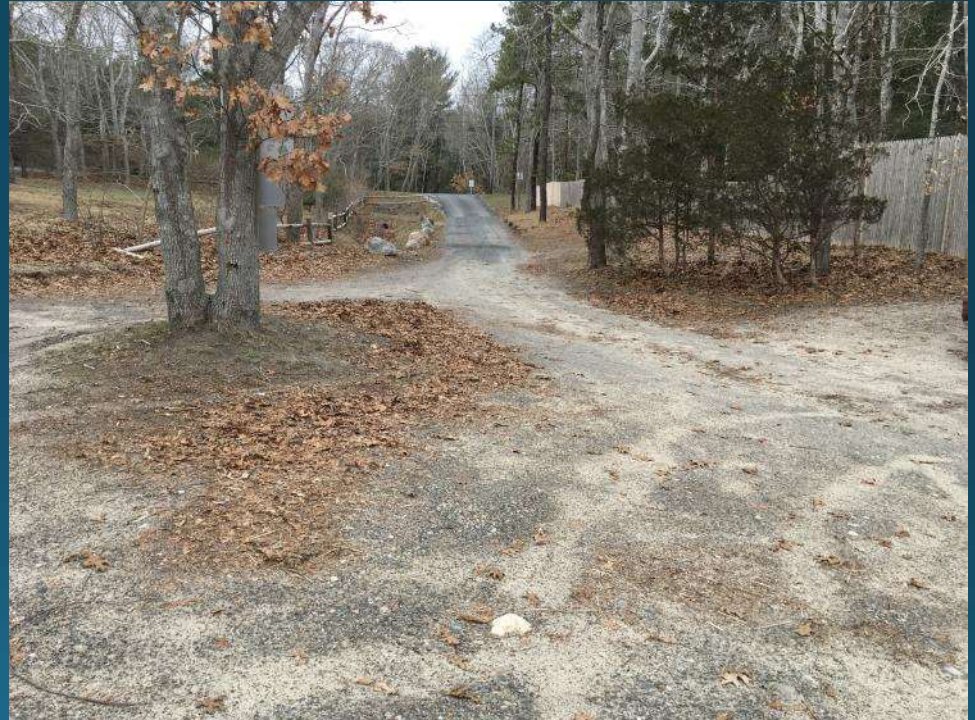
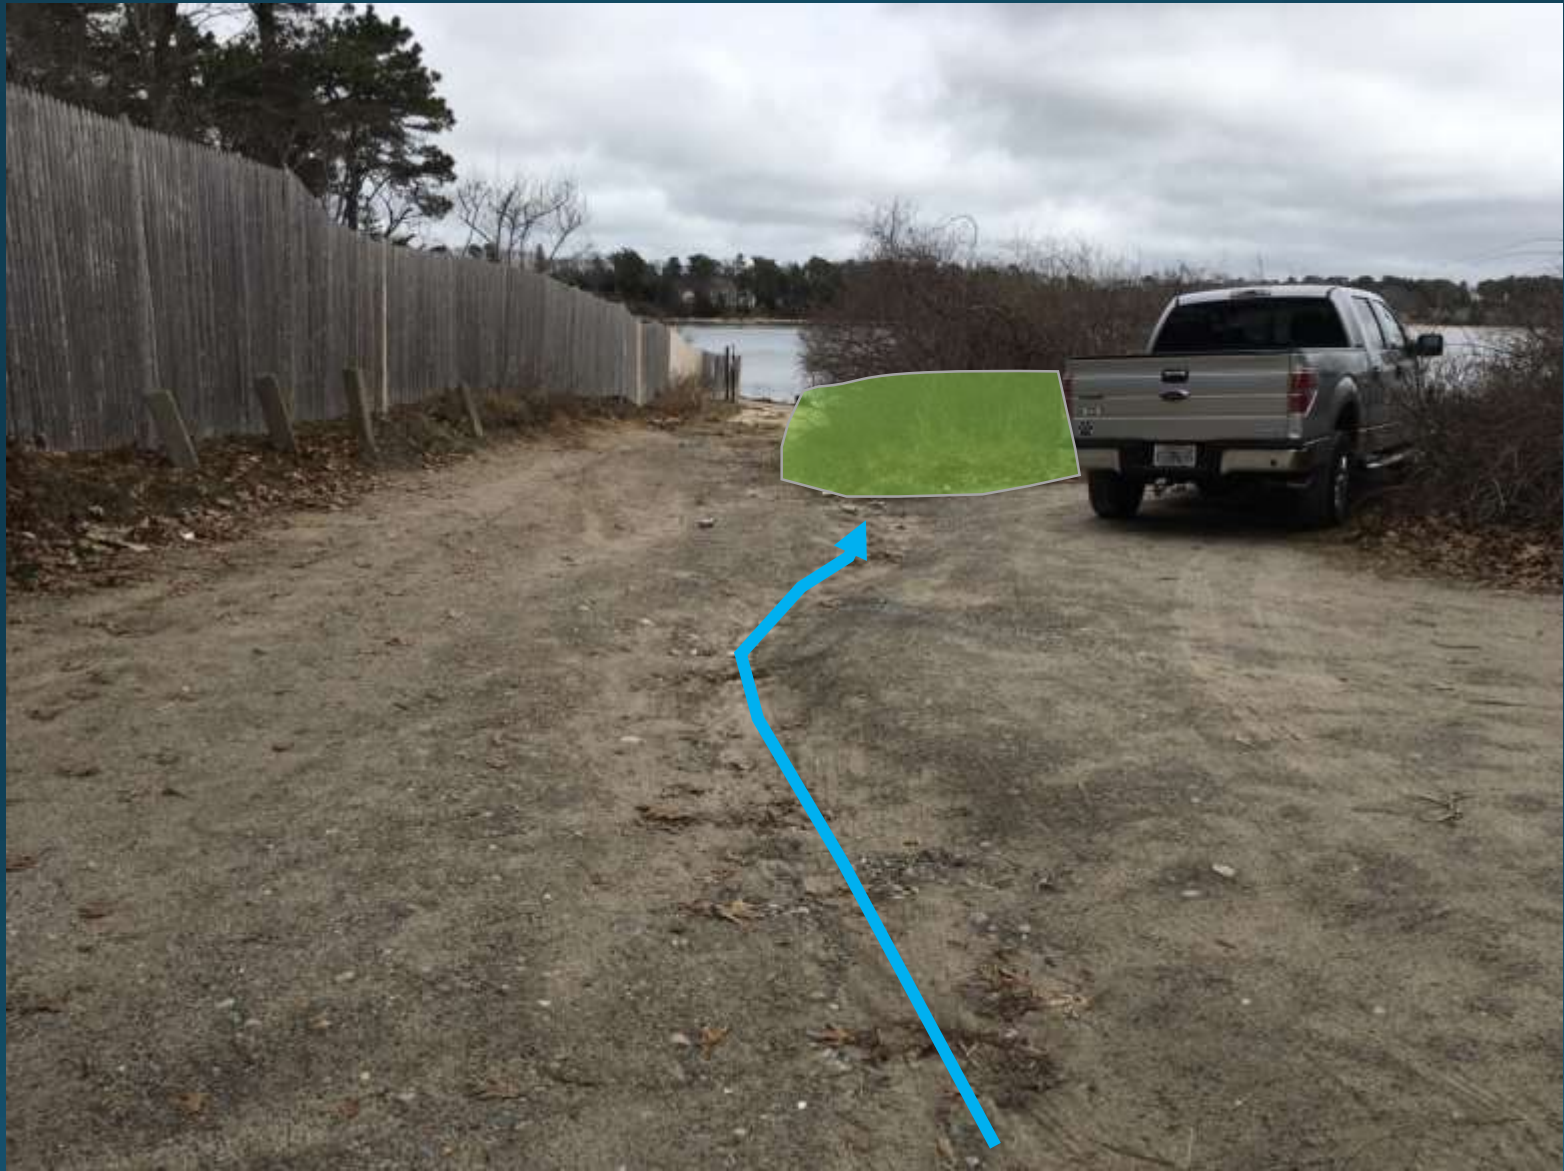
# CW-2: Cordwood Landing

- **Bioretention**
- Invasive Species Removal/  
Buffer Restoration
- Stabilized/  
Improved  
Water Access
- Improve  
Parking Lot
- Public  
Education

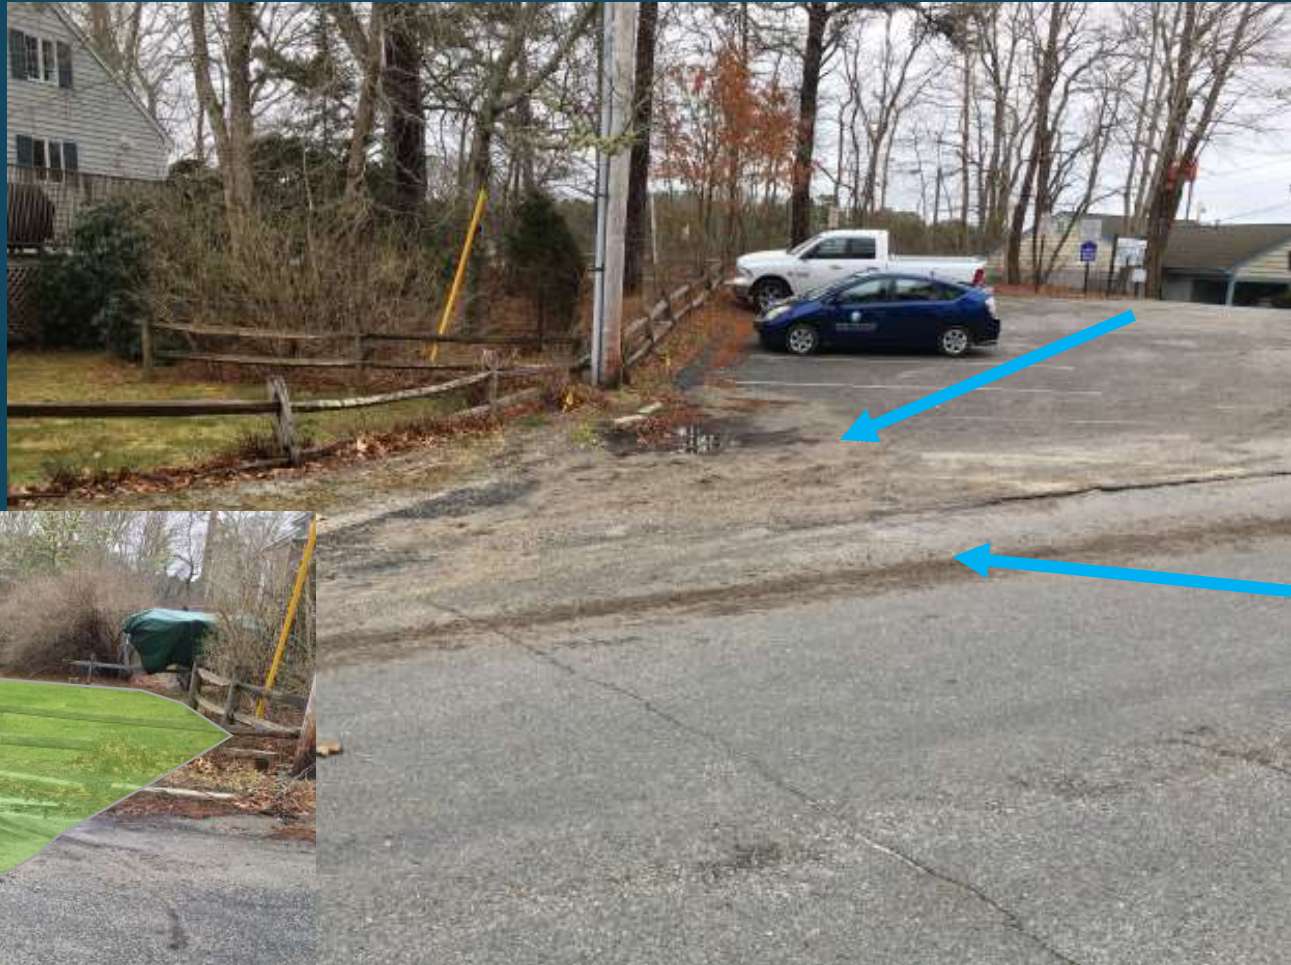
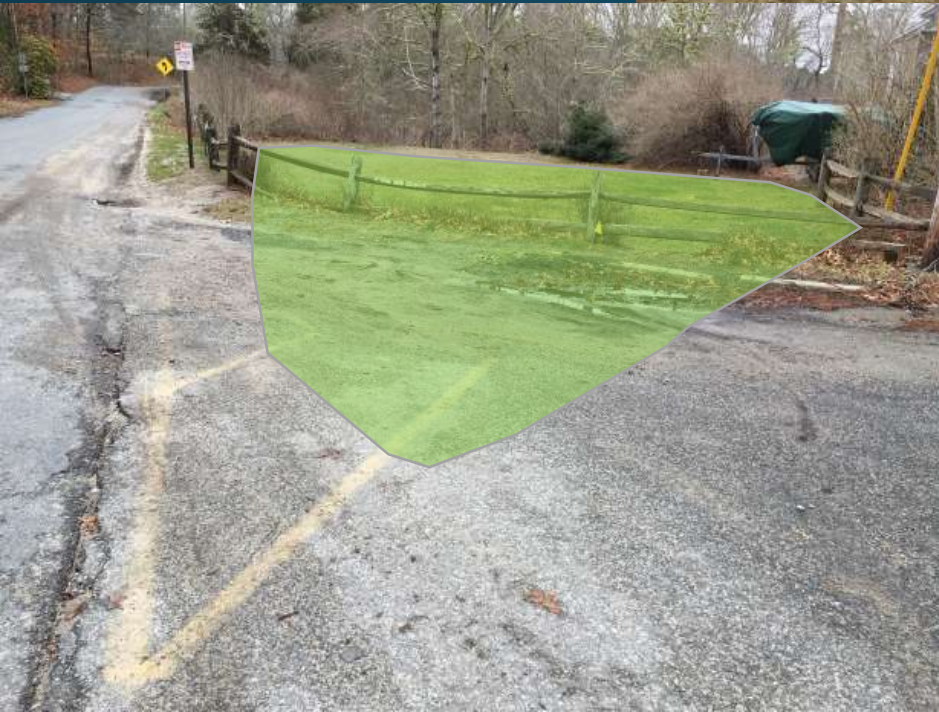
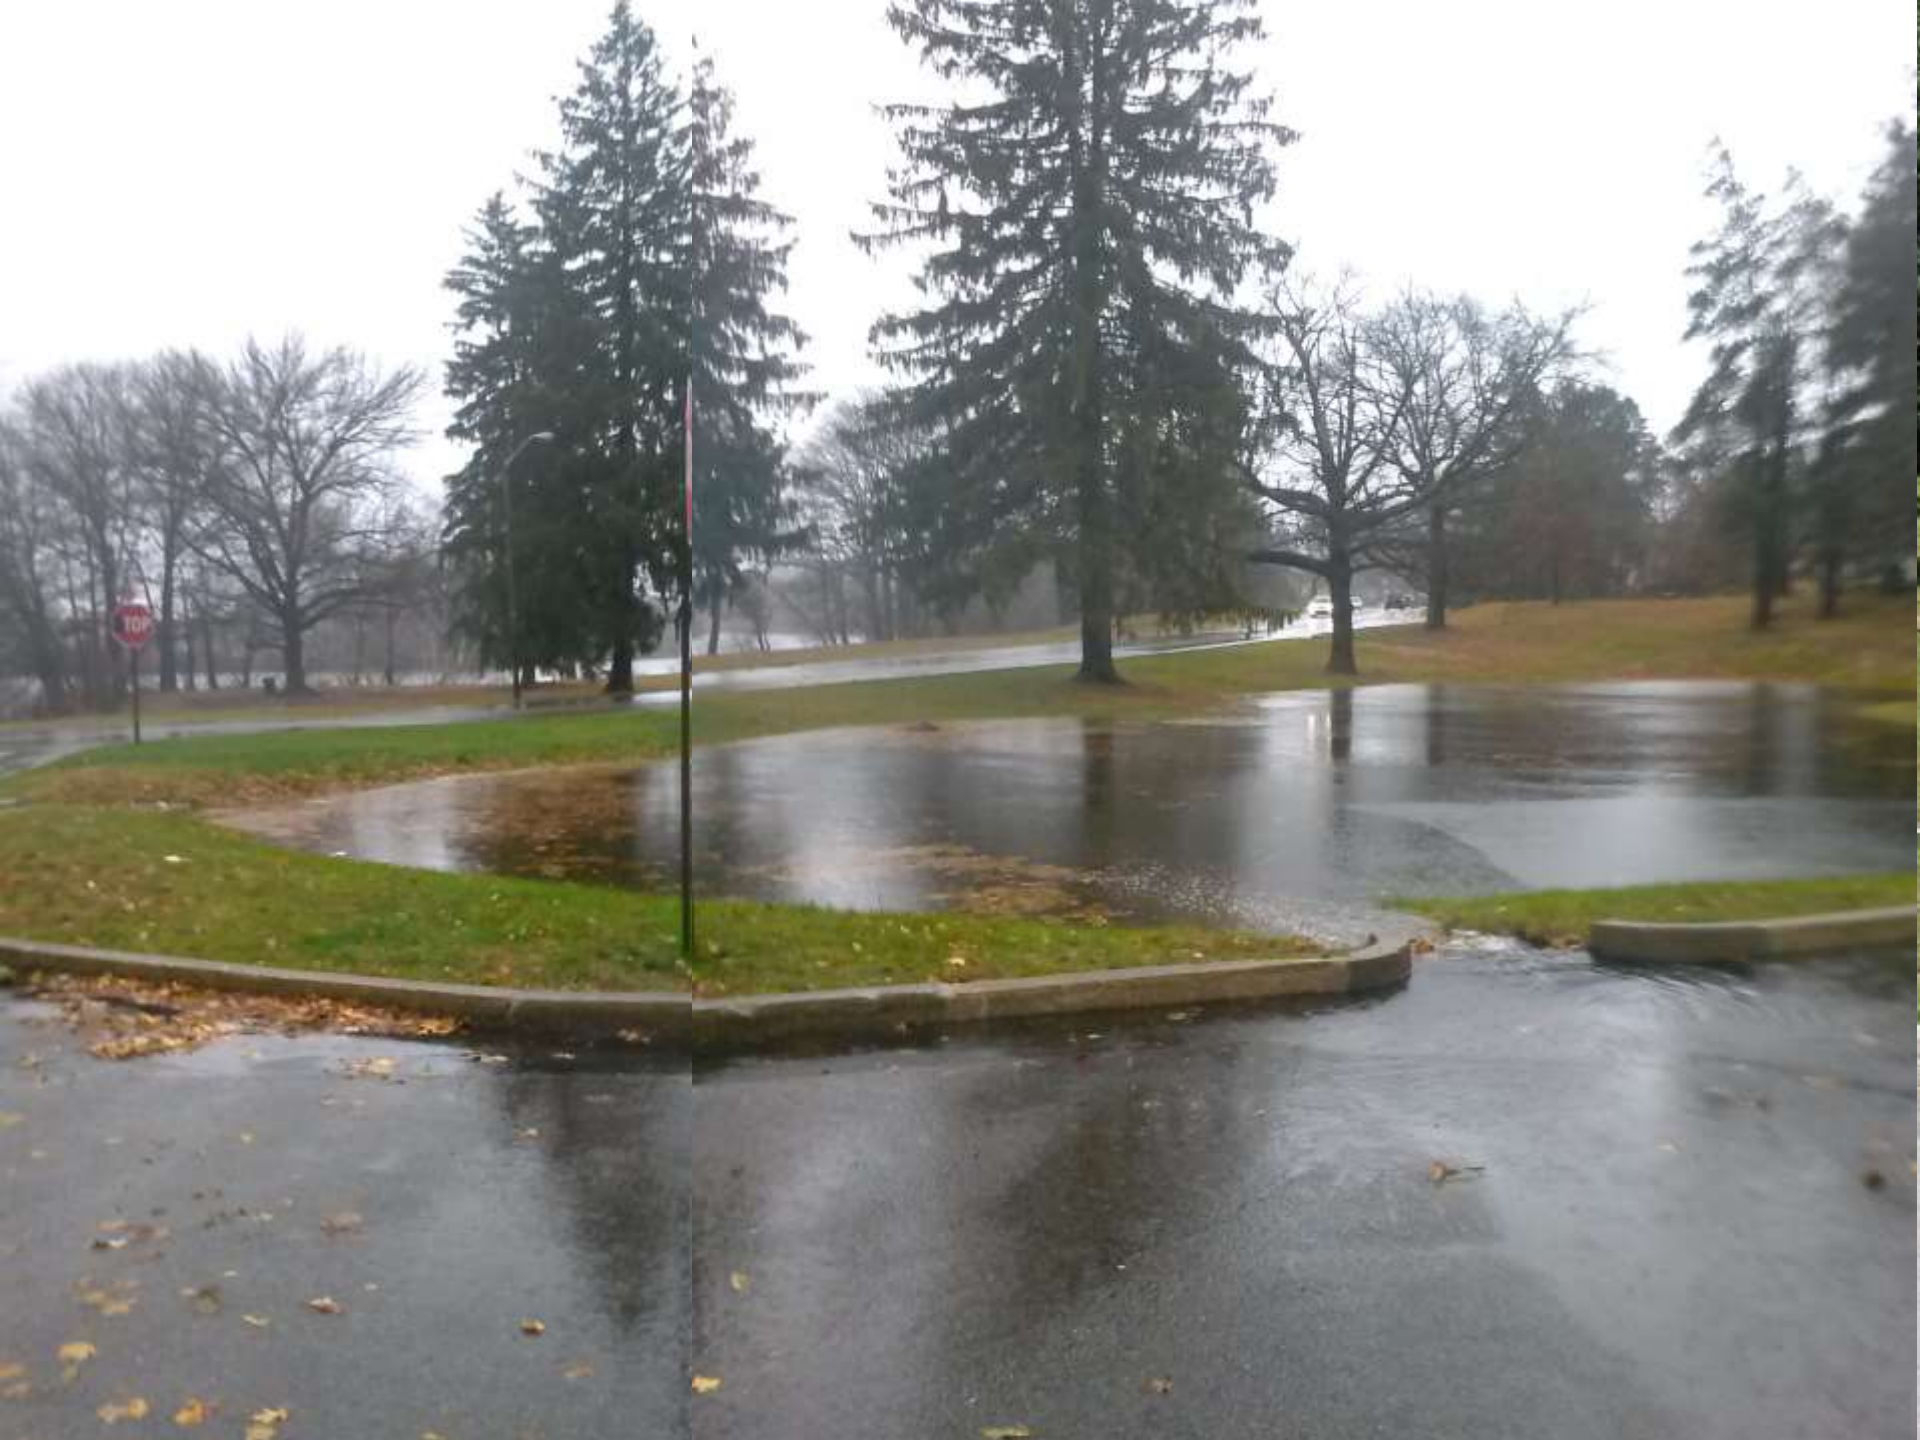
# PC-1: Prince Cove Marina

- Sand Filter
- Pavement Reduction
- Coordination with Barnstable Land Trust
- Buffer Restoration
- Public Education

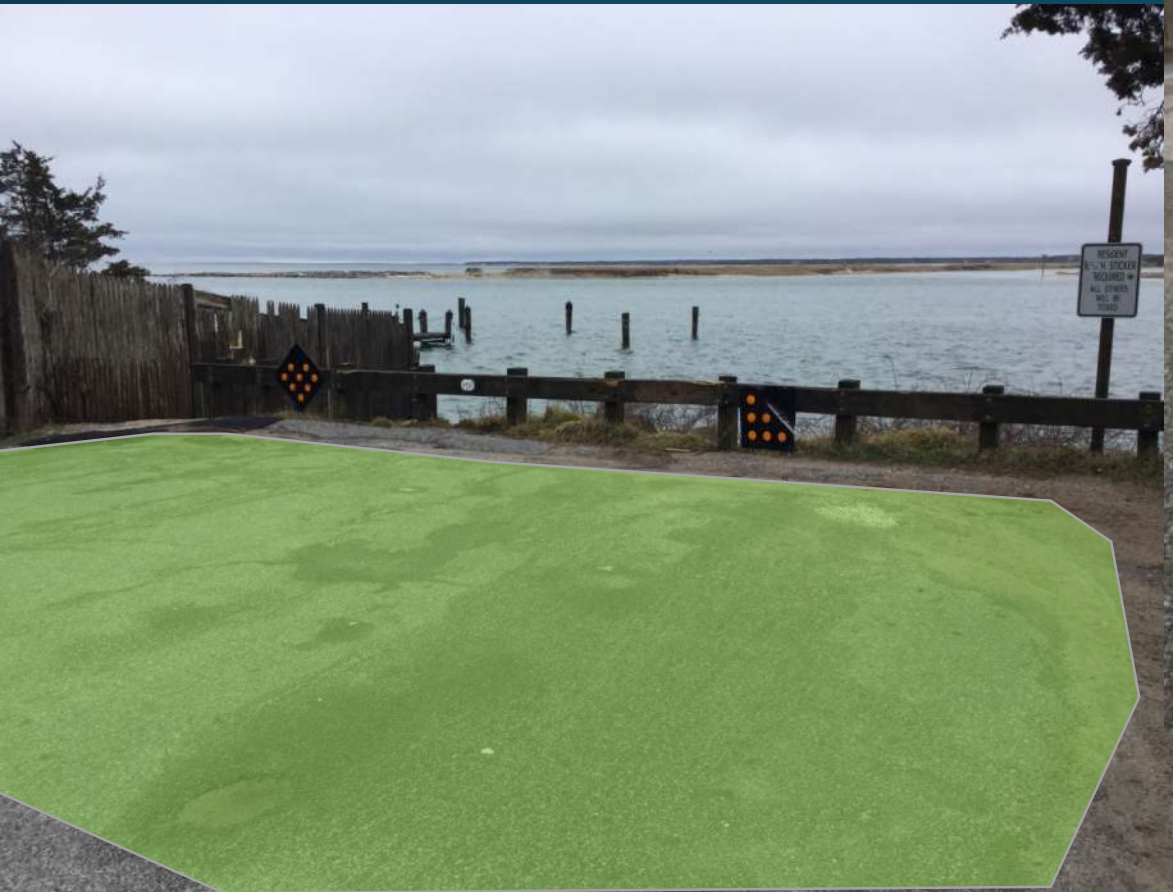
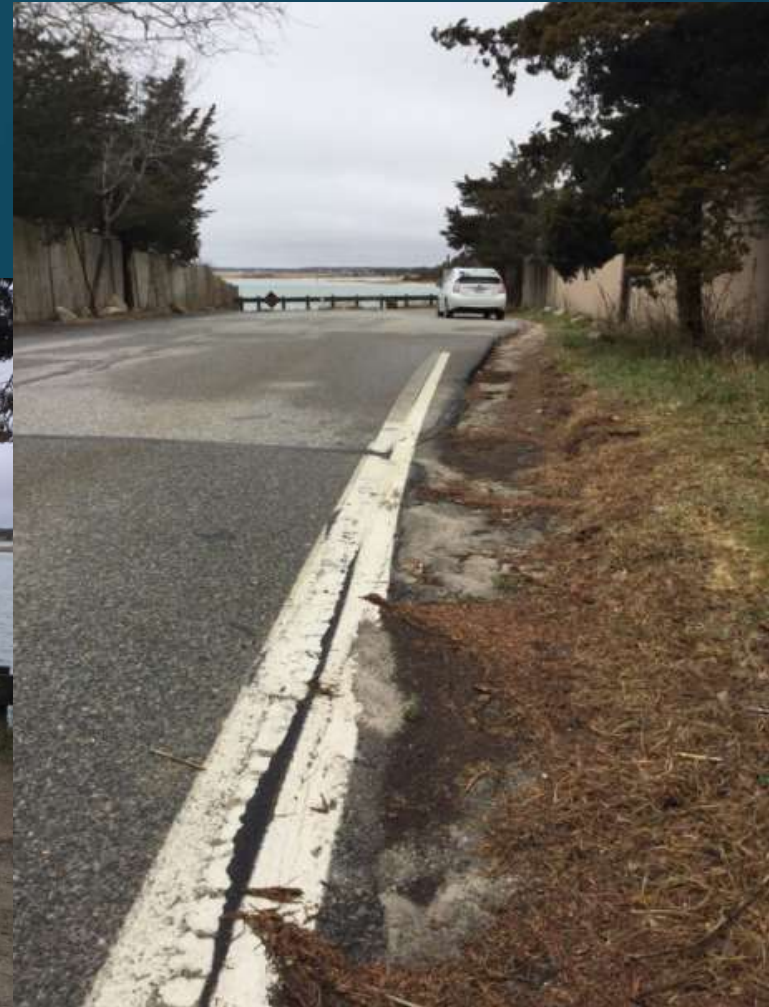
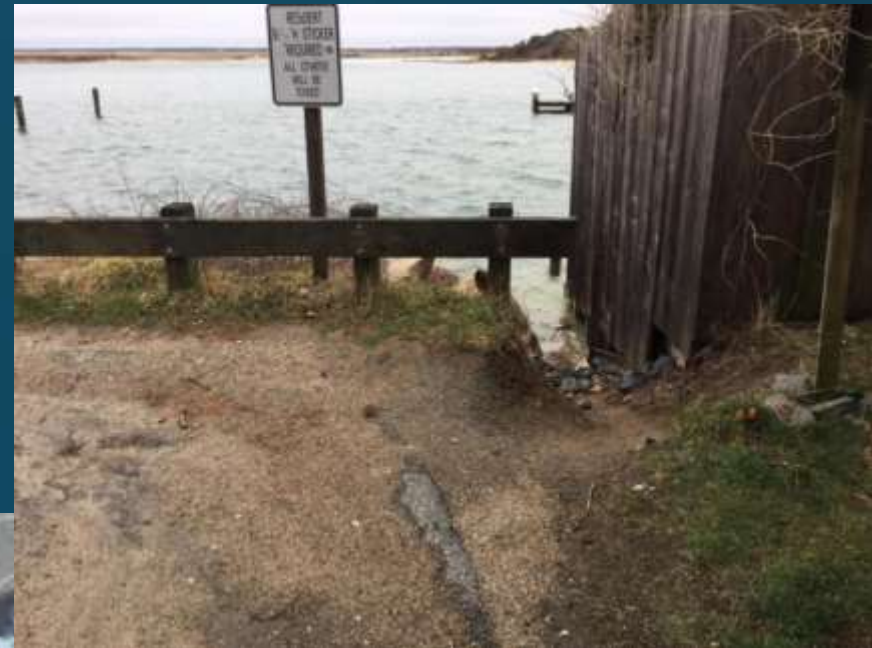
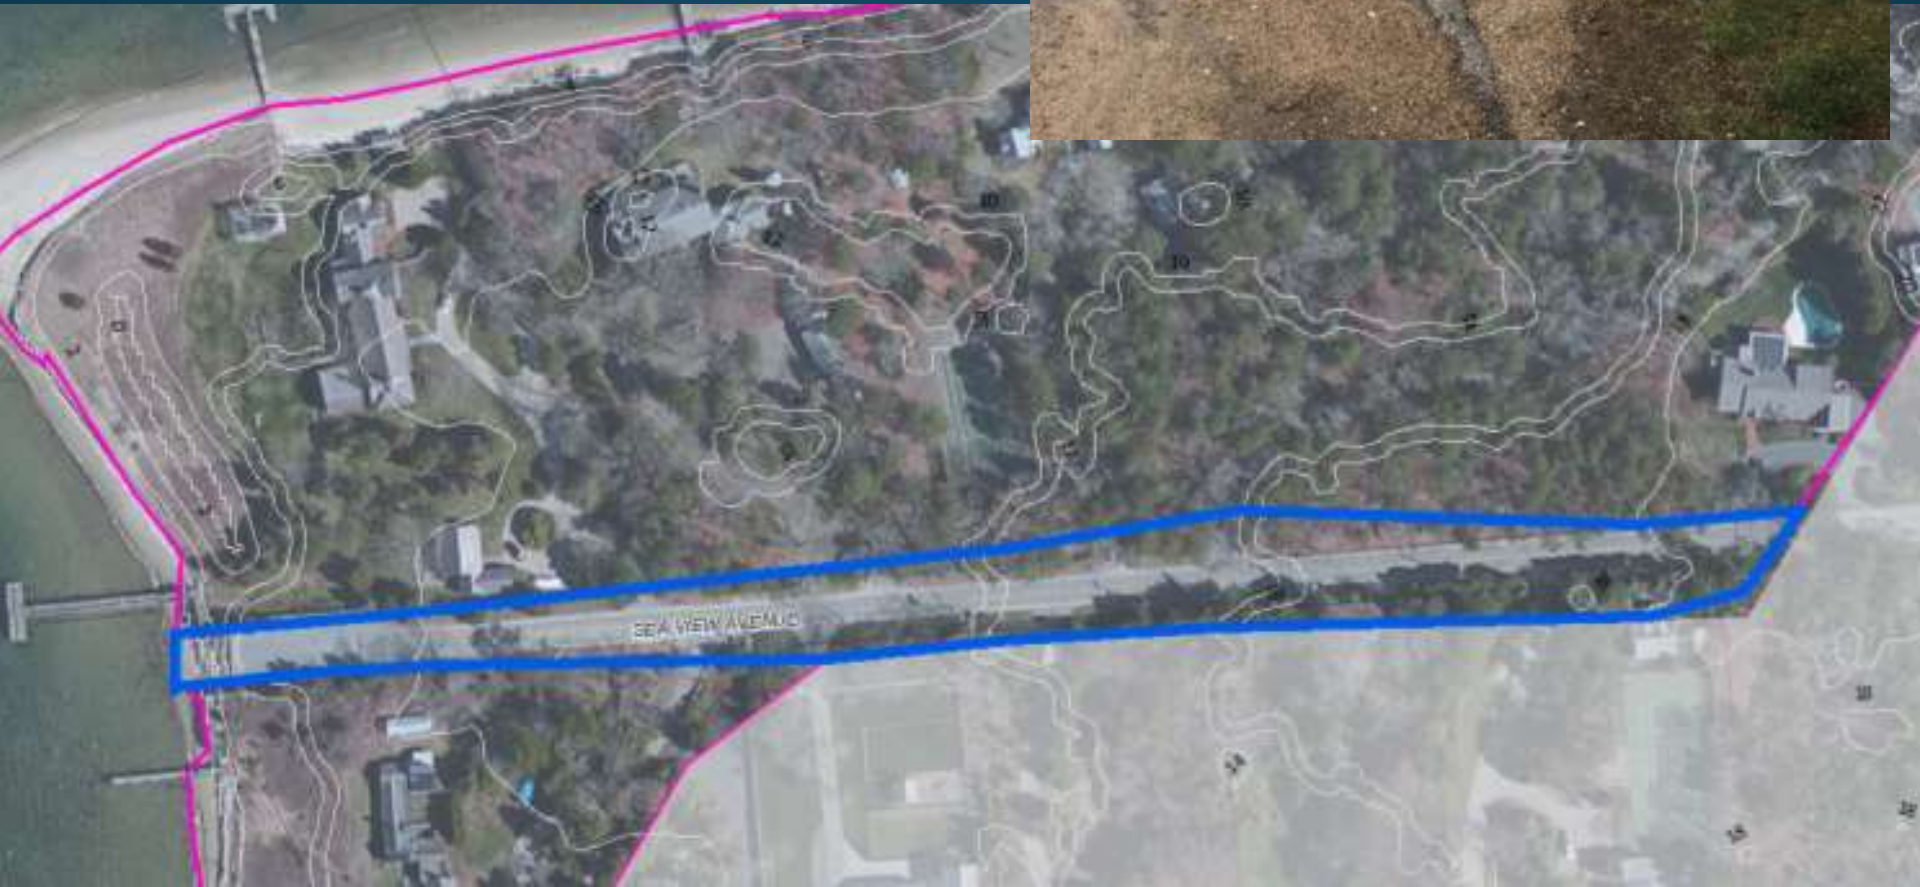
# ER-1: End of Seaview Ave

- **Bioretention**
- Pavement Reduction
- Stabilized/Improved Access
- Public Education

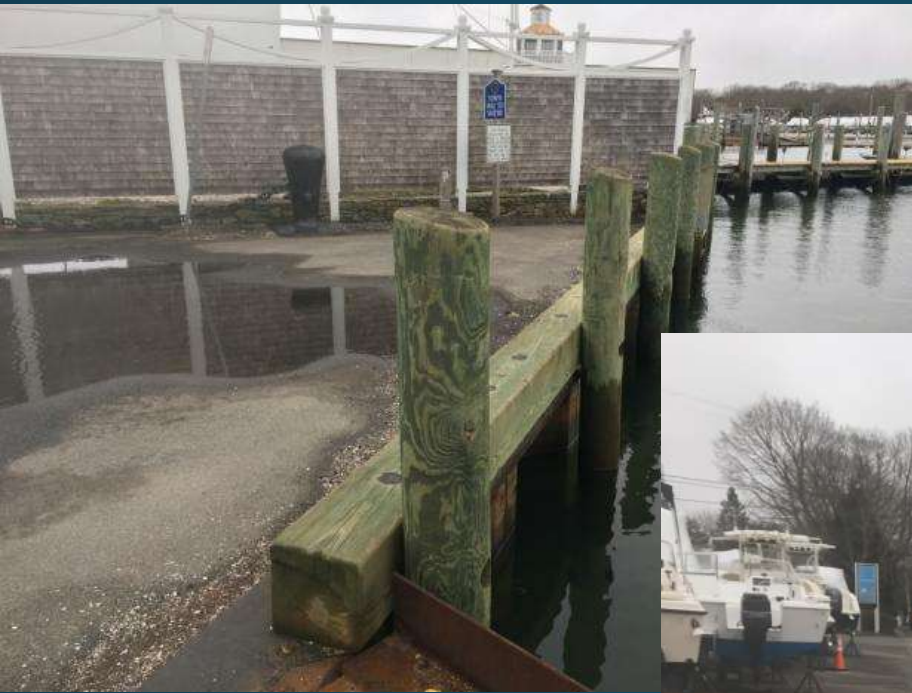
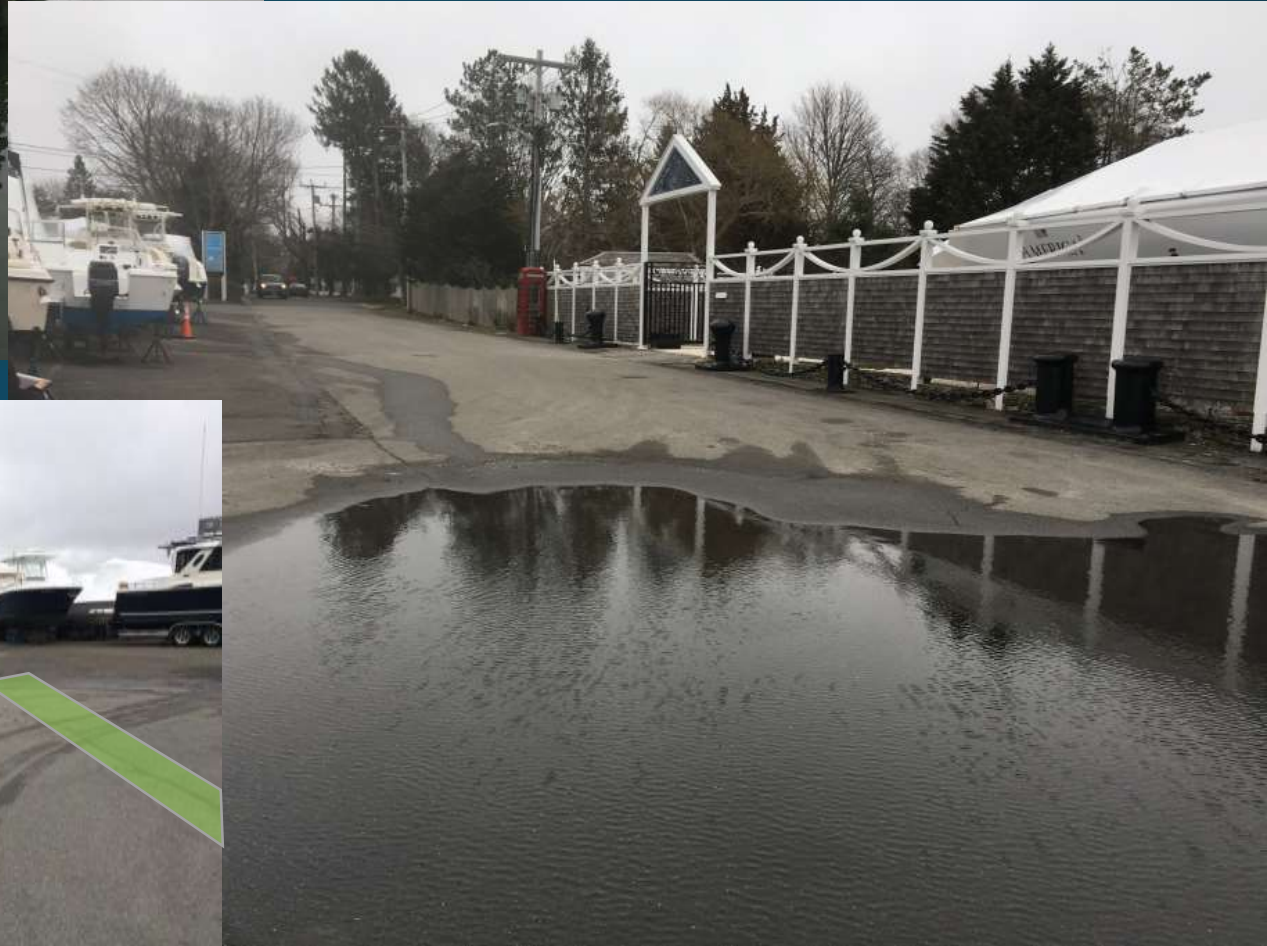
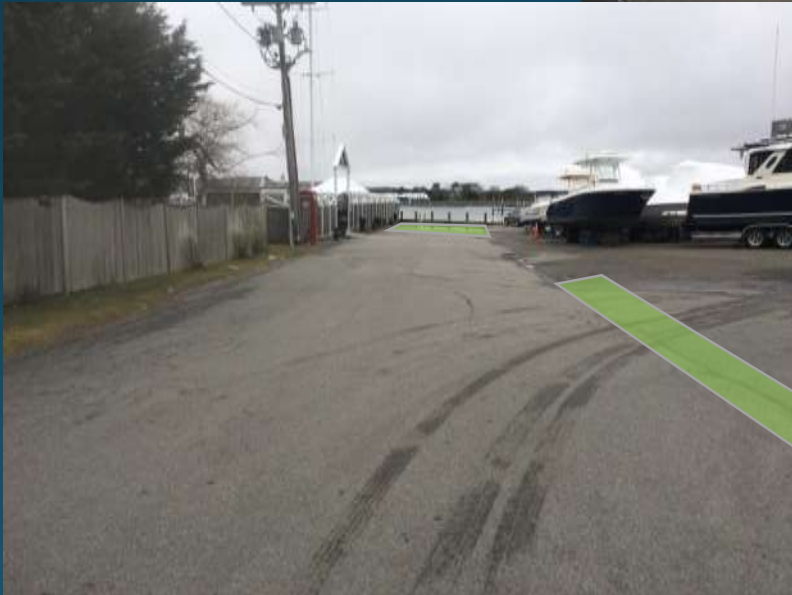
# OS2-6: End of W. Bay Rd

- Underground Sand Filters
- Pavement Reduction
- Public Education
- Public/Private Partnership Opportunity
