Cleaning Up The Bays

Managing Stormwater in the Three Bays

Project Overview

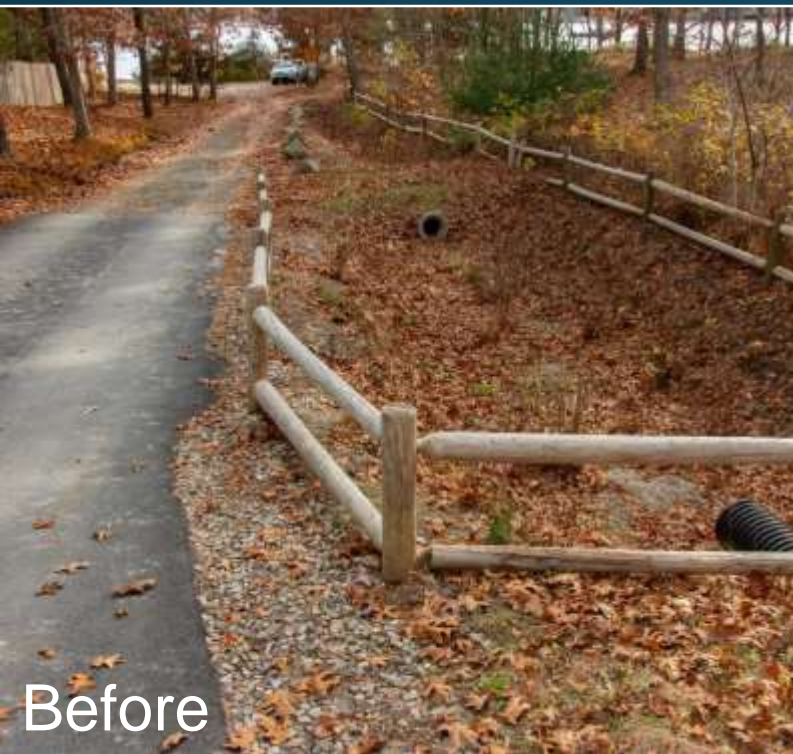
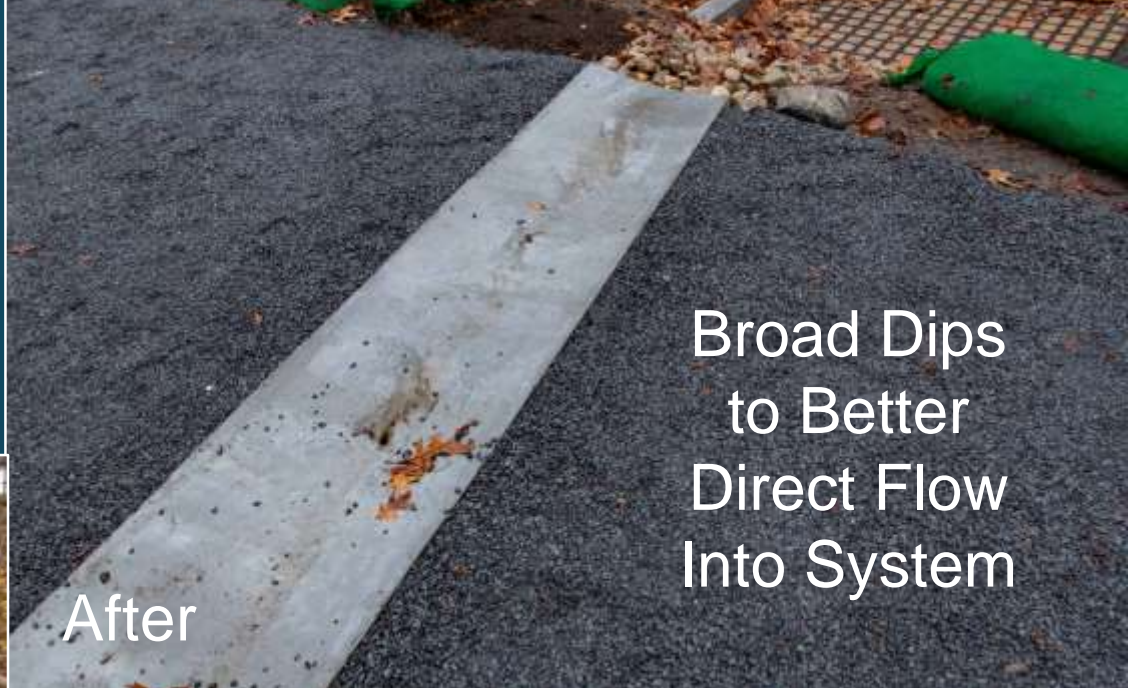
Site 1: Cordwood Landing Existing System Improvements

Broad Dips
to Better
Direct Flow
Into System

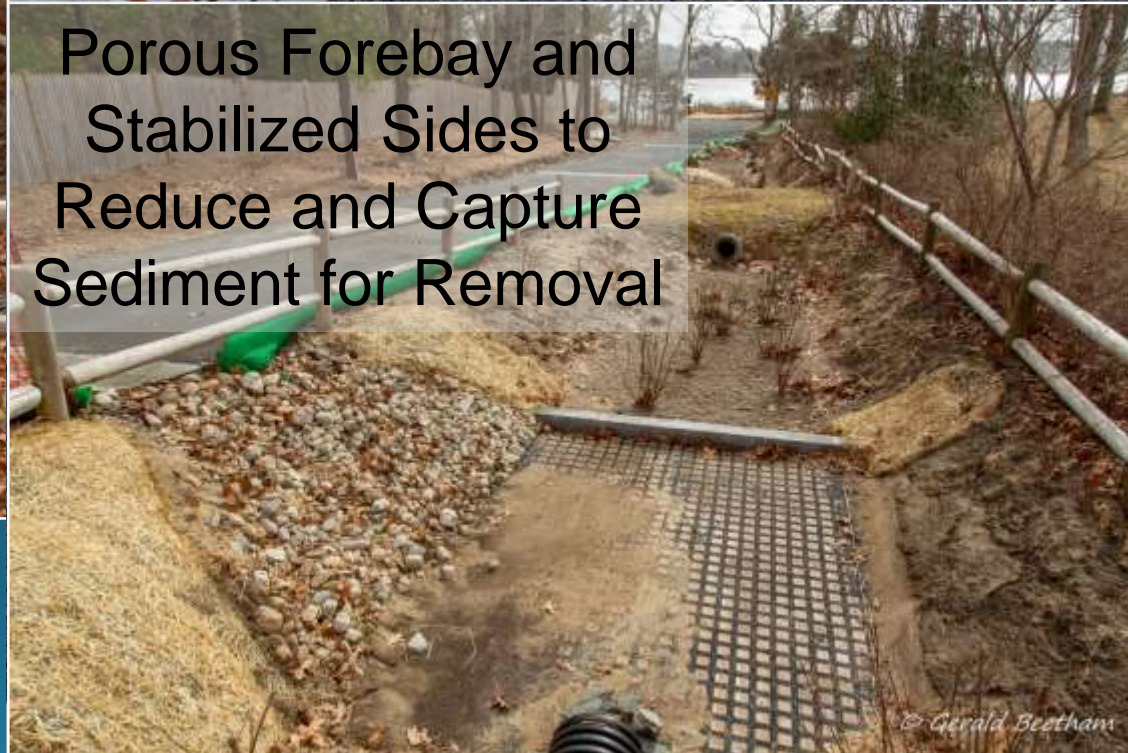
Porous Forebay and
Stabilized Sides to
Reduce and Capture
Sediment for Removal

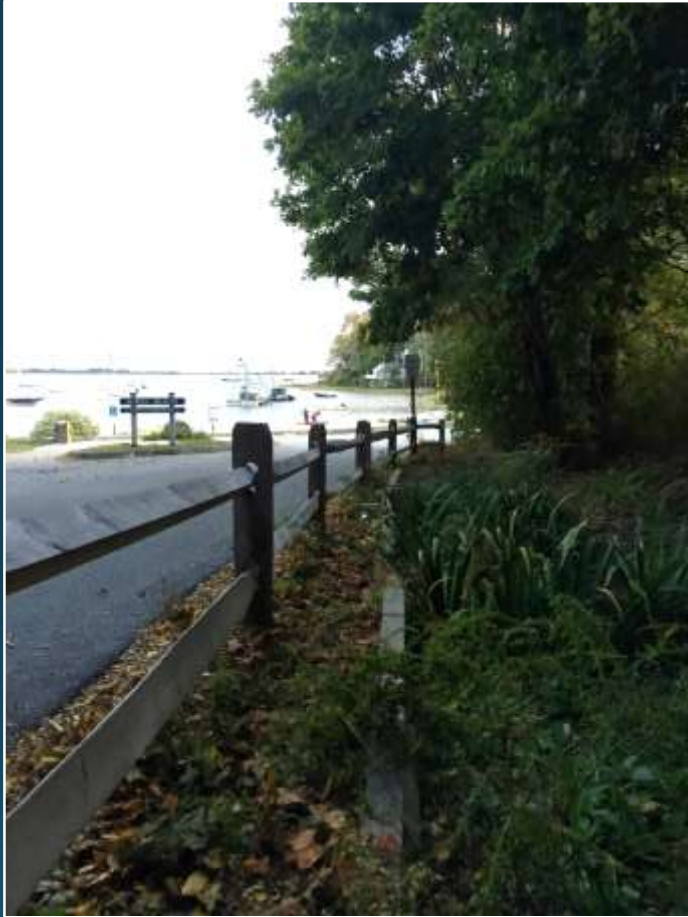
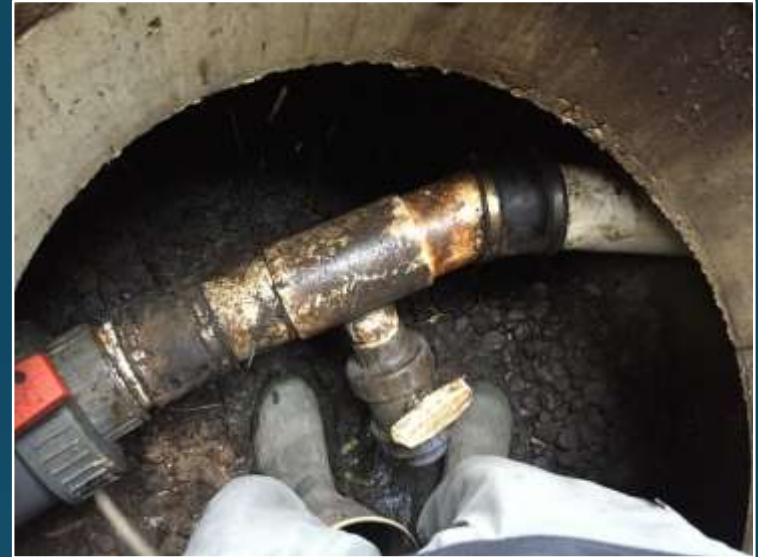
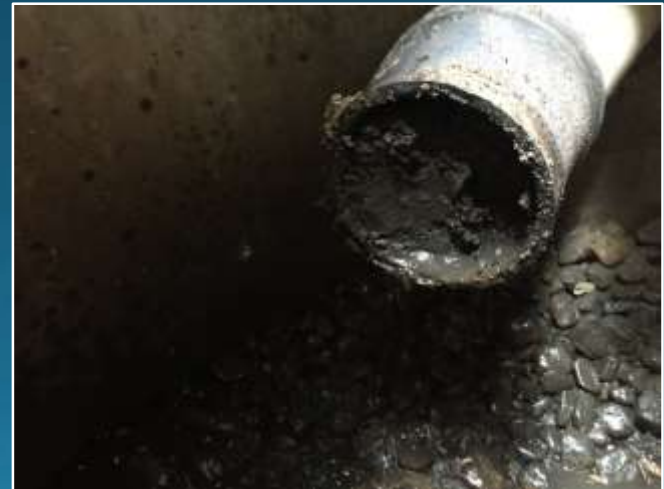
Site 3: Ropes Beach, Maintenance of Existing Systems

Fixed pipes and flushing
underdrains of existing system

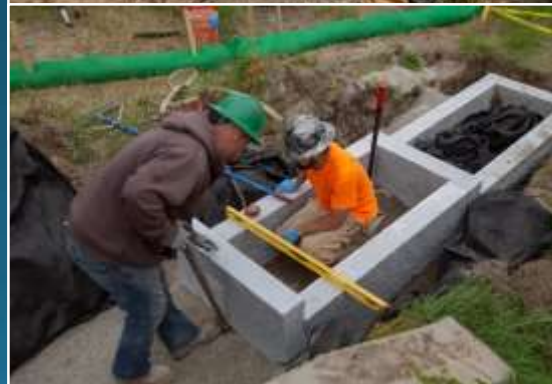
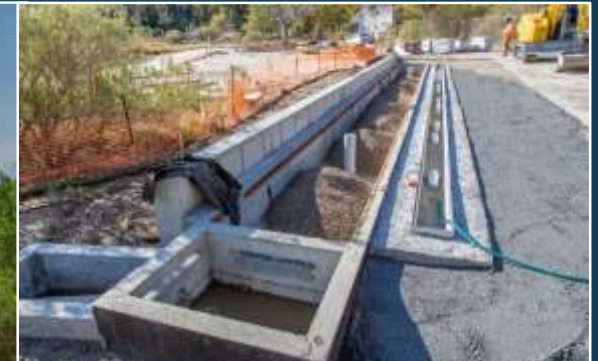
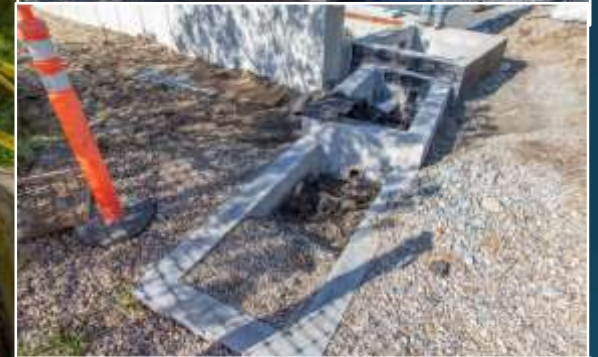
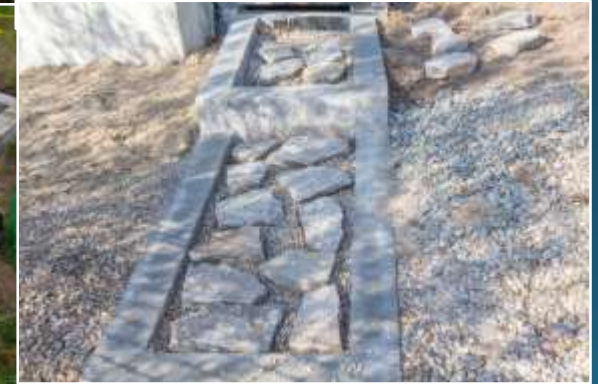
Site 3: Ropes Beach Linear Gravel Wetland

System flush to parking lot with plantings below grate to allow view, parking and beach access

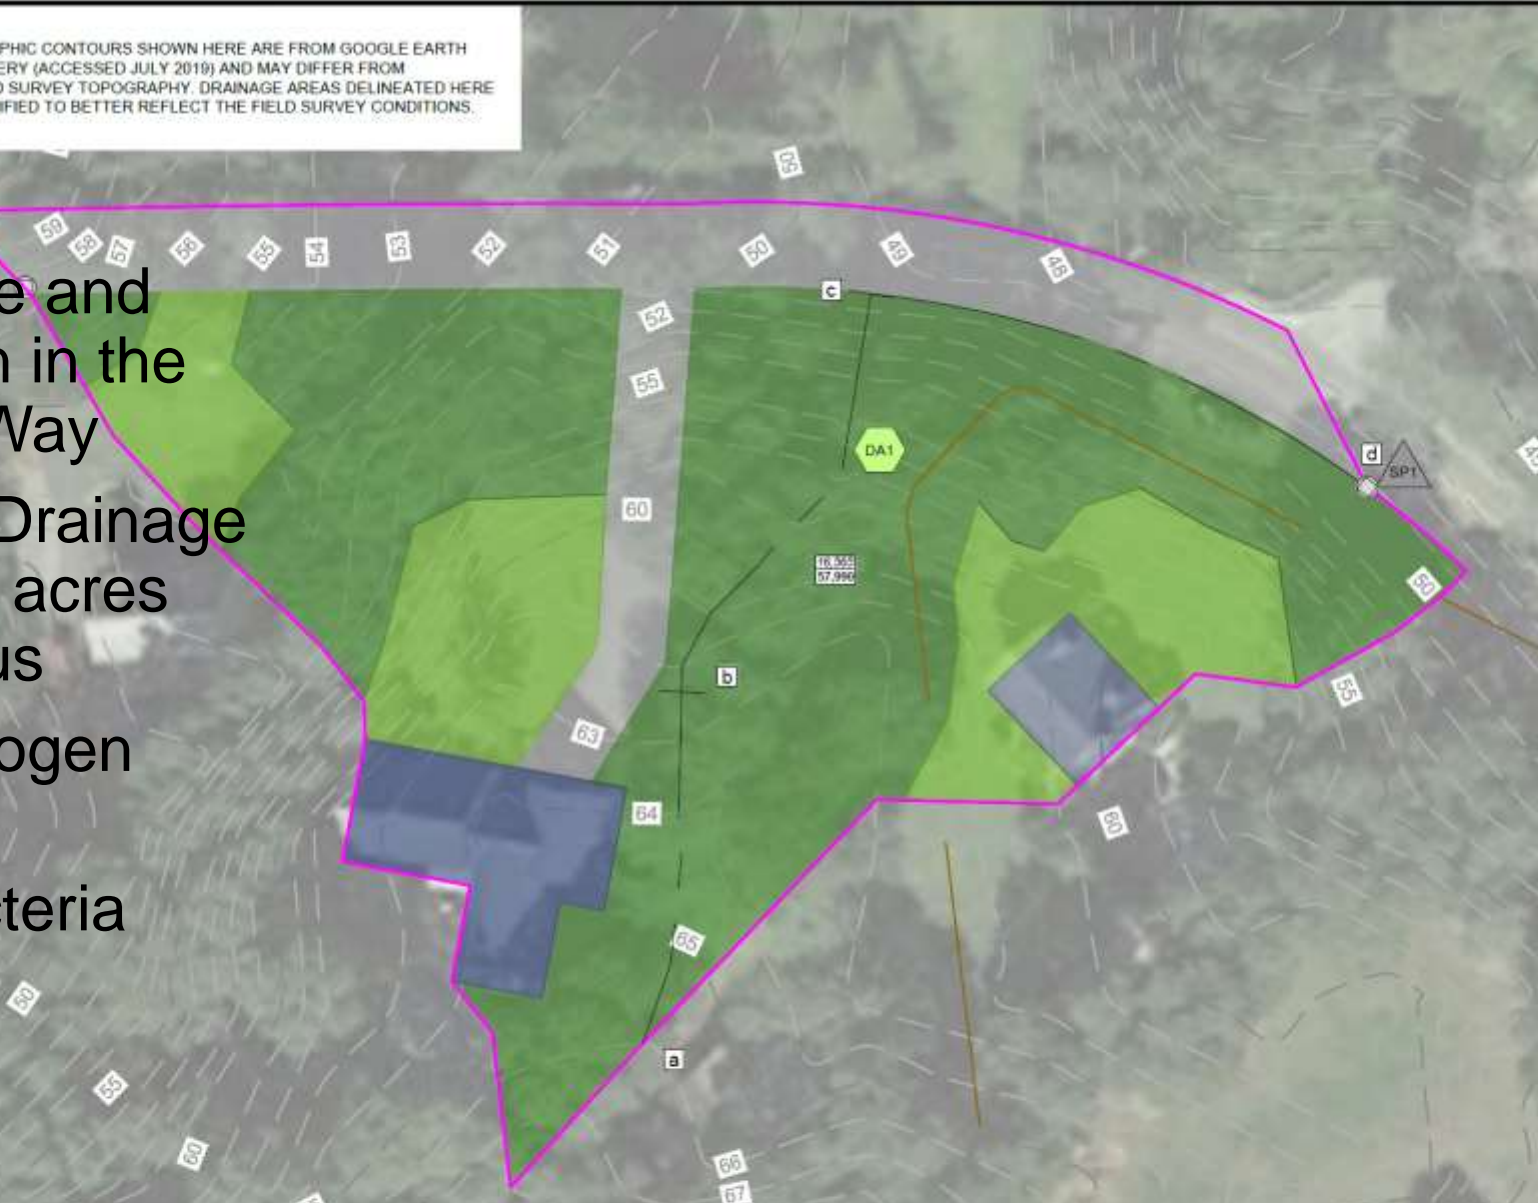
Site 10: River Road Dry Swale

- Dry Swale and Infiltration in the Right of Way
- 1.3-acre Drainage Area, 0.4 acres impervious
- 55% Nitrogen Removal
- 70% Bacteria Removal
