Cordwood Landing Bioretention

CORDWOOD LANDING BIORETENTION IMPACT REPORT

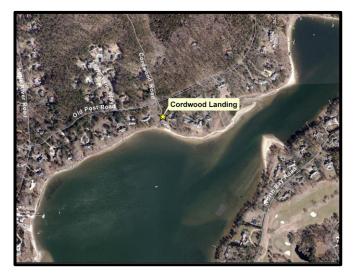
Construction was completed in spring of 2019. Invasives were removed, the parking space shifted over, and the bioretention garden planted out with native vegetation.

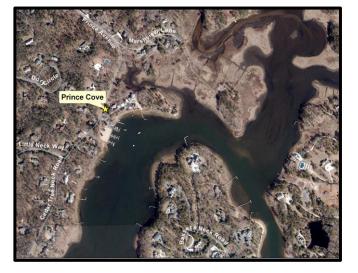
A sand filter with underdrain was constructed in early 2019 as part of the first round of construction projects completed.

A large forebay lined with porous pavers was installed to capture sediment for easy removal with the sand filter constructed behind the fence for treatment of stormwater.

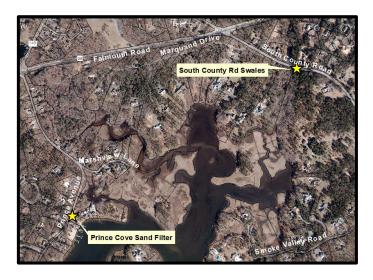
Final planting was completed in May of 2021 with grass and other native plantings for low maintenance.
