# Cape Cod Boat Ramps – Stormwater Retrofit Field Forms

# CC Boat Ramp Retrofit Field Summary Sheet

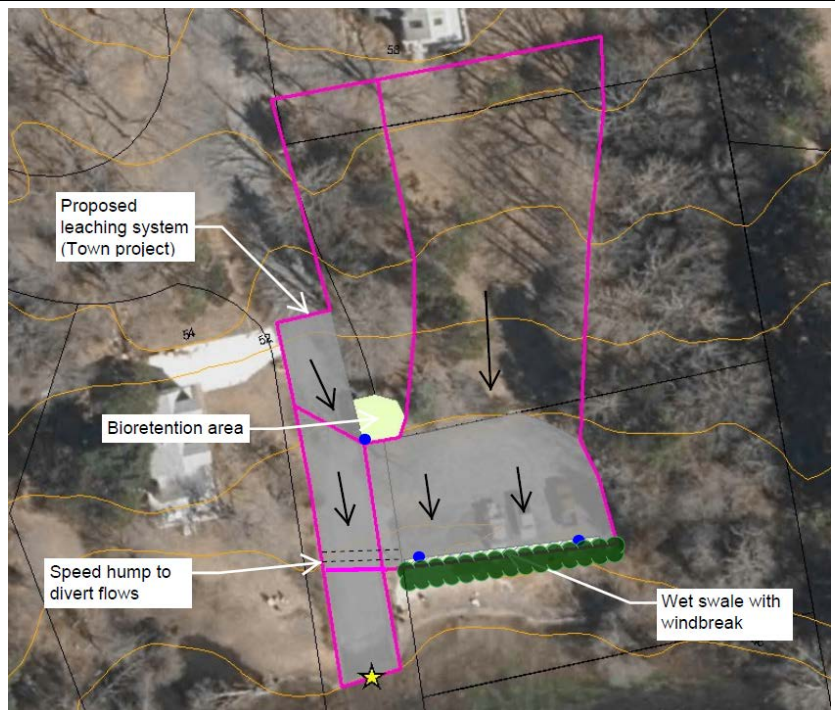
**Site Sketch:** Drainage area in pink, impervious cover in gray, BMPs in light green, revegetation in dark green, and proposed paved flumes in dark blue. Star represents the GIS location of the boat ramp.

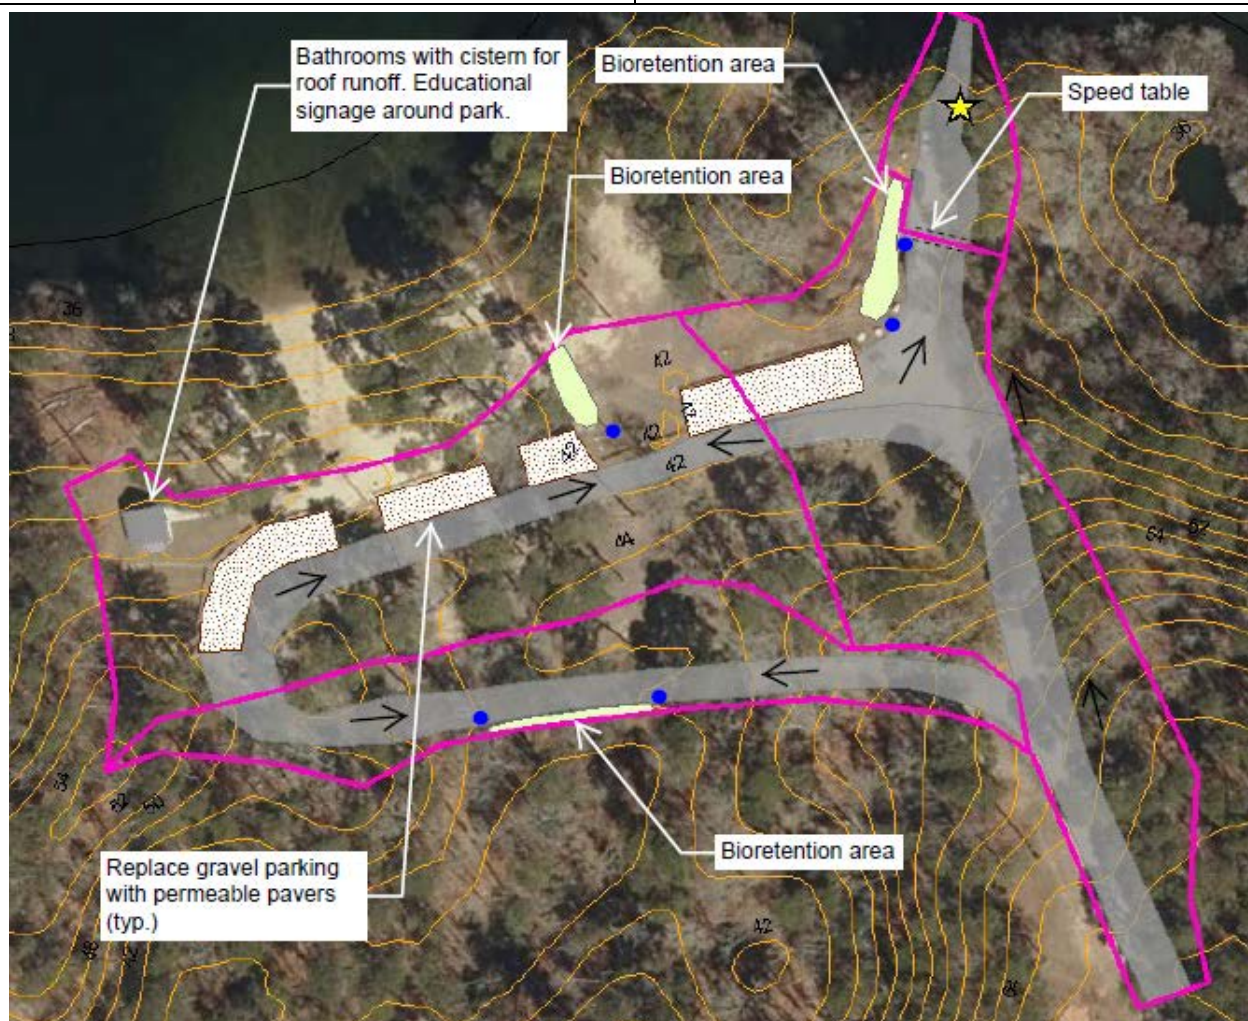
**Site Sketch:** Drainage area (pink), impervious cover (gray), BMPs (light green and speckled brown), paved flumes (dark blue), and drainage flow paths (arrows). Star represents the GIS location of the boat ramp.

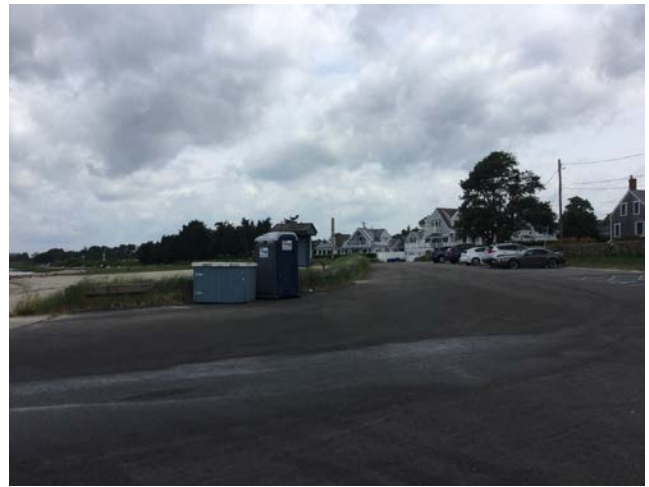
**Photo Caption:** Looking up the driveway at parking spaces (right) and beach (left), with portable toilet and trash/recycling. Note existing flow path down center of pavement.

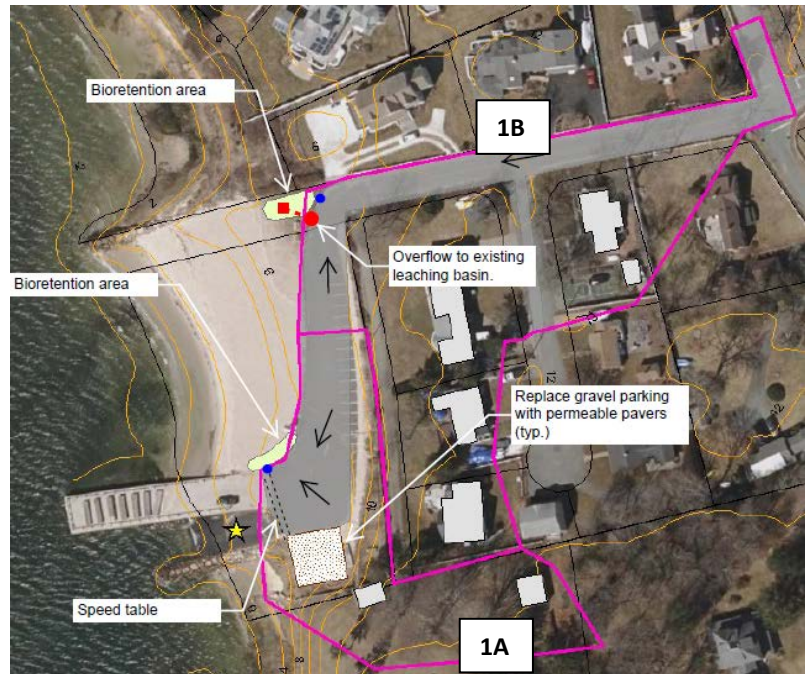
**Site Sketch:** Drainage area (pink), impervious cover (gray), BMPs (light green and speckled brown), paved flumes (dark blue), existing infrastructure (red), and drainage flow paths (arrows). Star represents the GIS location of the boat ramp.

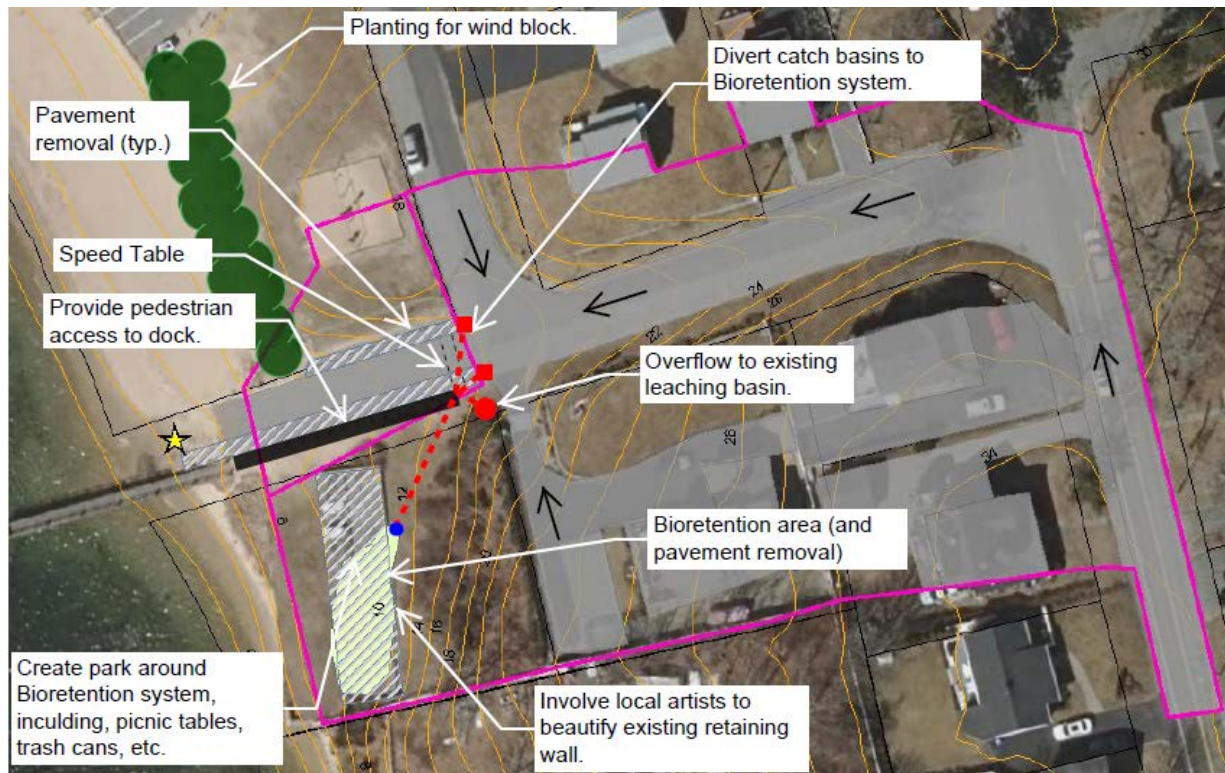
**Site Sketch:** Drainage area (pink), impervious cover (gray), impervious cover reduction (striped gray), BMPs (light green), paved flumes (dark blue), proposed infrastructure (red), revegetation (dark green), and drainage flow paths (arrows). Star represents the GIS location of the boat ramp.

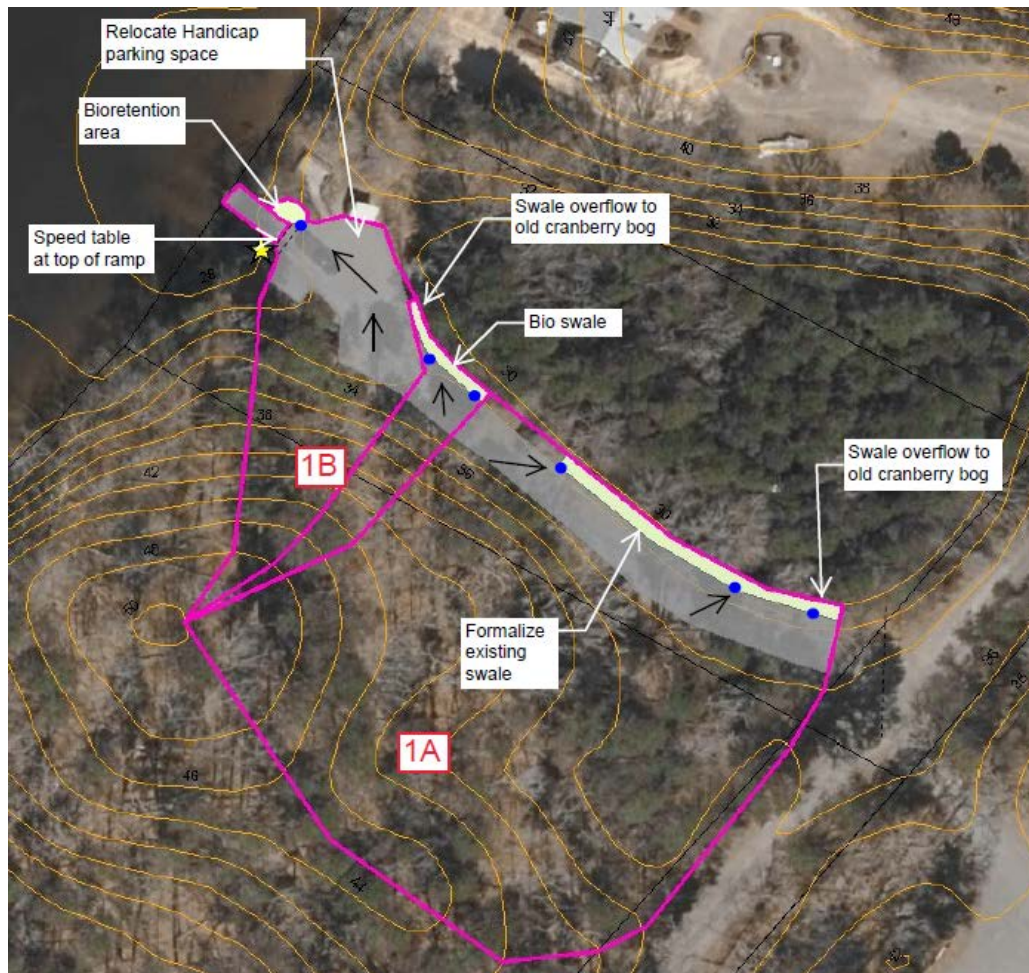
**Site Sketch:** Drainage area in pink, impervious cover in gray, BMPs in light green, paved flumes in dark blue, and drainage flow paths shown with arrows. Star represents the GIS location of the boat ramp.

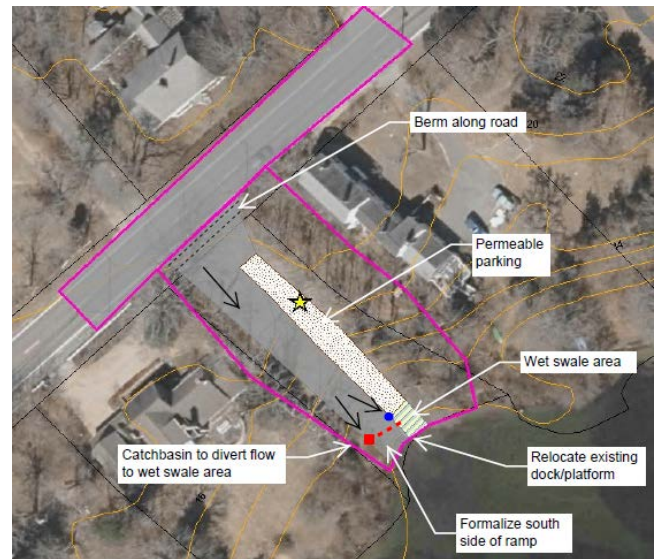
**Site Sketch:** Drainage area (pink), impervious cover (gray), impervious cover reduction (striped gray), BMPs (light green and speckled brown), paved flumes (dark blue), and proposed infrastructure (red). Star represents the GIS location of the boat ramp.

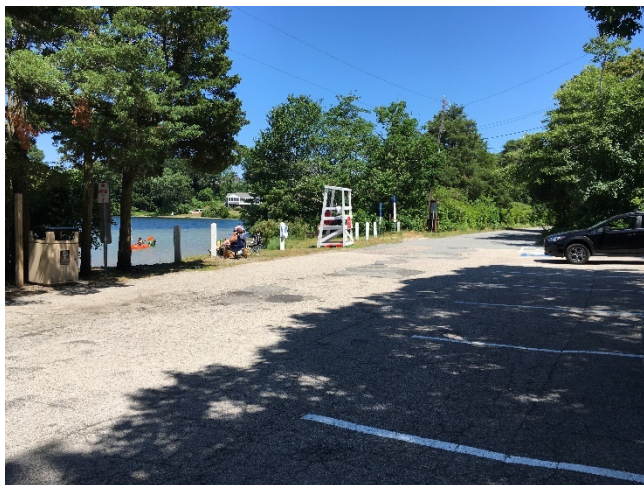
**Photo Caption:** Parking lot, boat ramp, and Town beach. Note proximity of parking lot to lake.

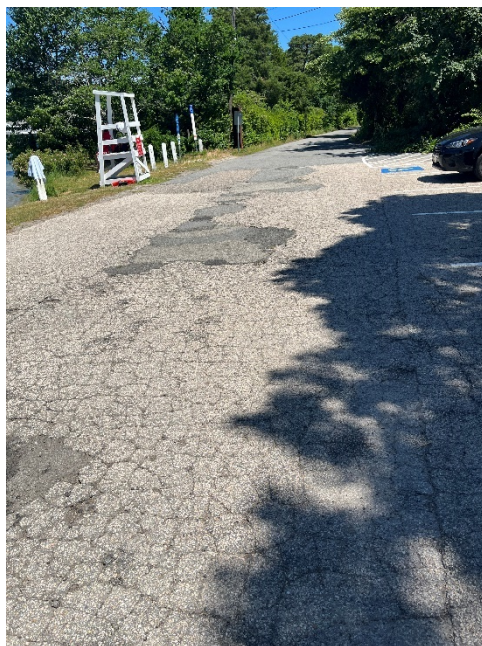
**Photo Caption:** Parking lot in need of improvement

<b>Name: Dr Lords Common Landing – Bioretention/Permeable Pavers</b>		<b>ID#: DE-BR2</b>
<b>Site Description:</b> This site is commonly used as a public beach and boat ramp. Parking lot is paved but in need of repair – Town has the repaving in their CIP for parking lot (rec dept) and access road (Eng). There are two residential driveways on either side of the parking lot to maintain access to throughout the year. The parking lot is very close to the shoreline. There are multiple access points to the lake from the parking lot that the Town would like to limit to preserve habitat. There is no formalized boat ramp needed here, site is for small car-top watercraft only (e.g., kayak, canoe, paddleboards). Overhead wires and Town water utilities on site. Creek runs alongside road that provides anadromous fish access to lake.		<b>Site Location:</b> 41 Dr Lords Rd, Dennis, MA 02638

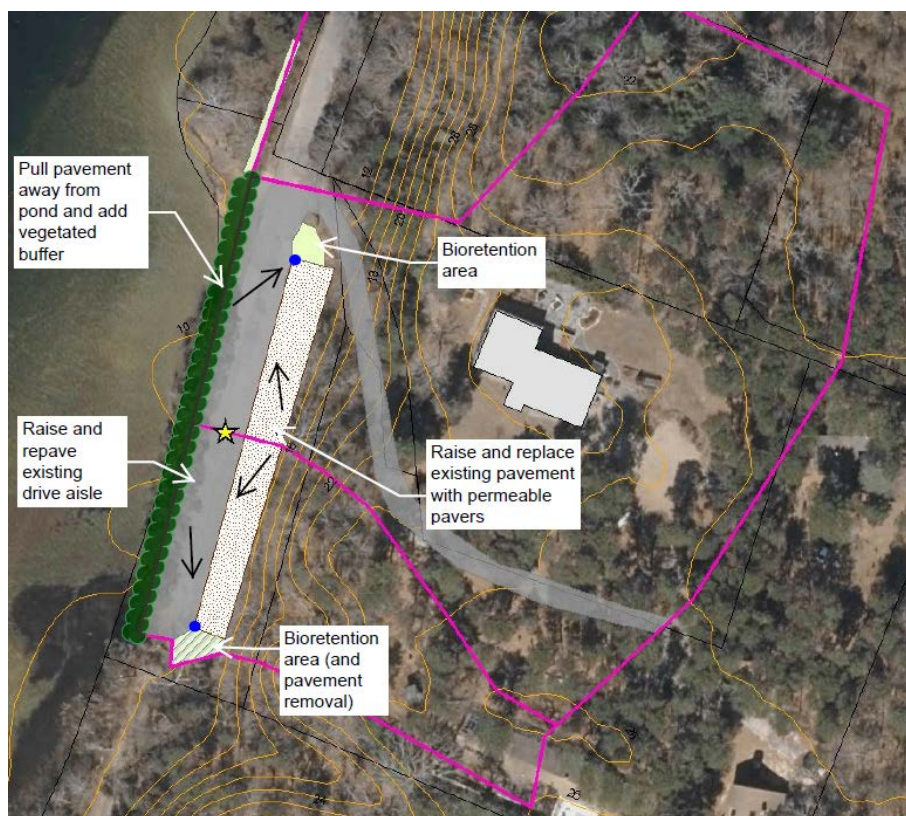
**Site Sketch:** Drainage area (pink), impervious cover (gray), impervious cover reduction (striped gray), BMPs (light green and speckled brown), revegetation (dark green), paved flumes (dark blue), and drainage flow paths (arrows). Star represents the GIS location of the boat ramp.

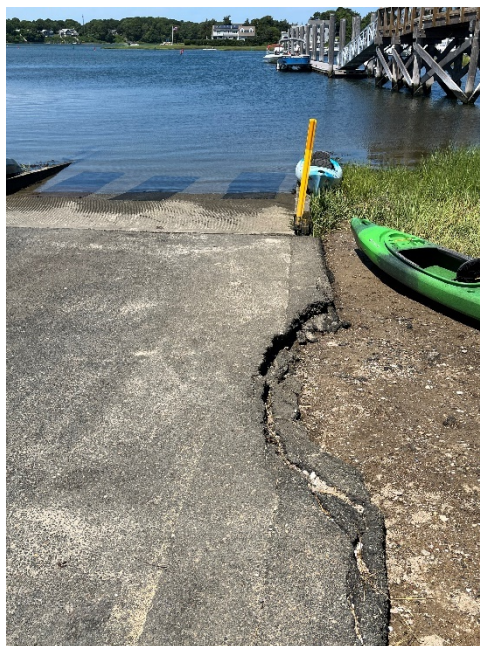
**Photo Caption:** Erosion and damage to boat ramp

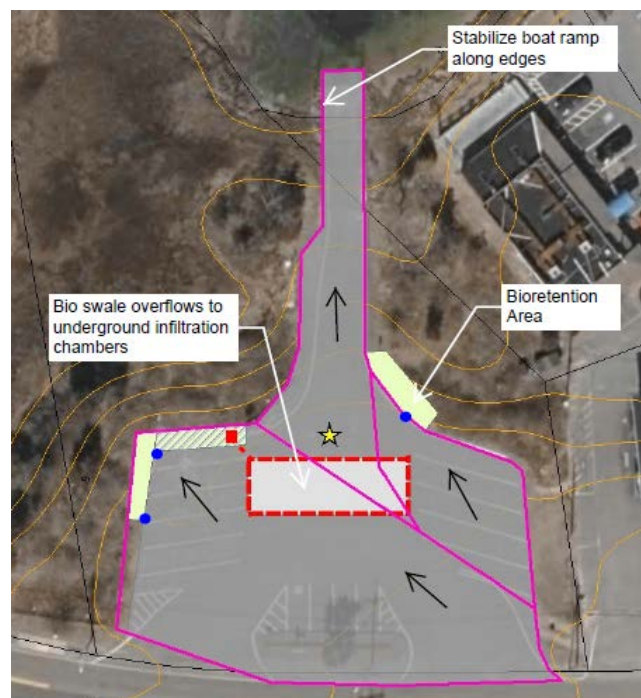
**Site Sketch:** Drainage area (pink), impervious cover (gray), impervious cover reduction (striped gray), BMPs (light green and speckled brown), paved flumes (dark blue), proposed infrastructure in red, and drainage flow paths (arrows). Star represents the GIS location of the boat ramp.

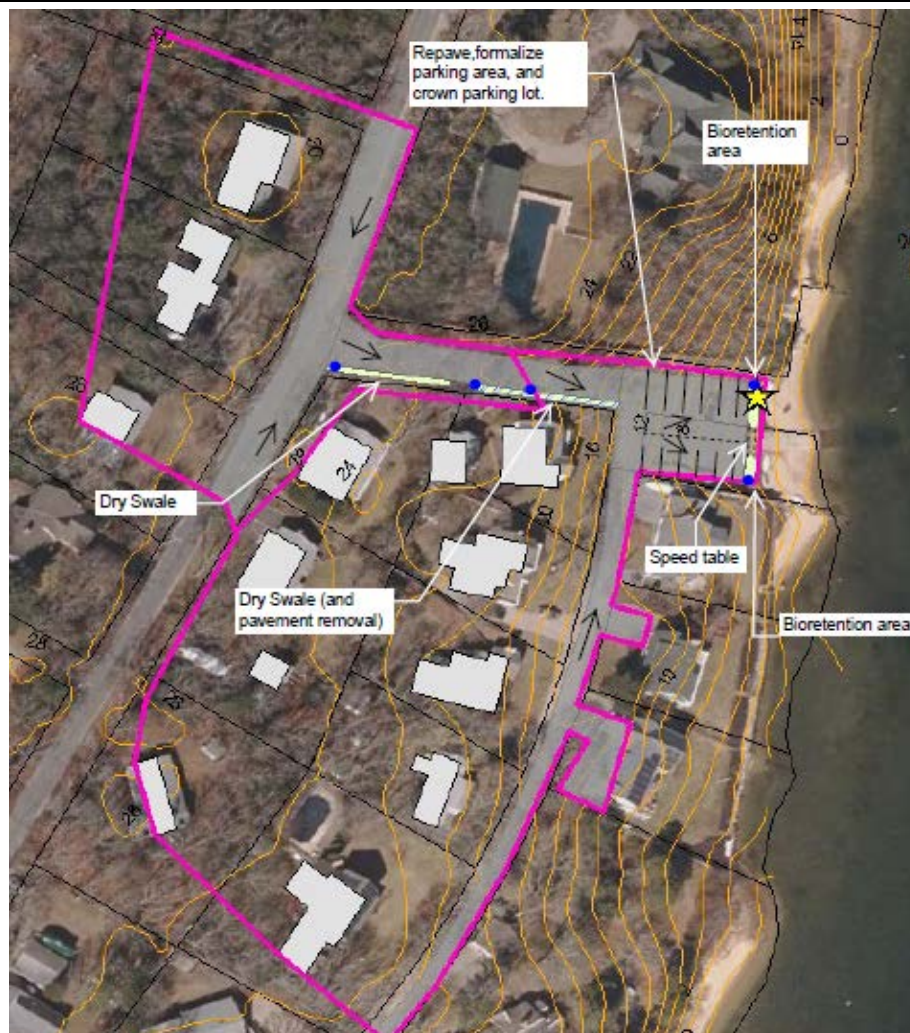
**Site Sketch:** Drainage area (pink), impervious cover (gray), BMPs (light green), paved flumes (dark blue), and drainage flow paths (arrows). Star represents the GIS location of the boat ramp.

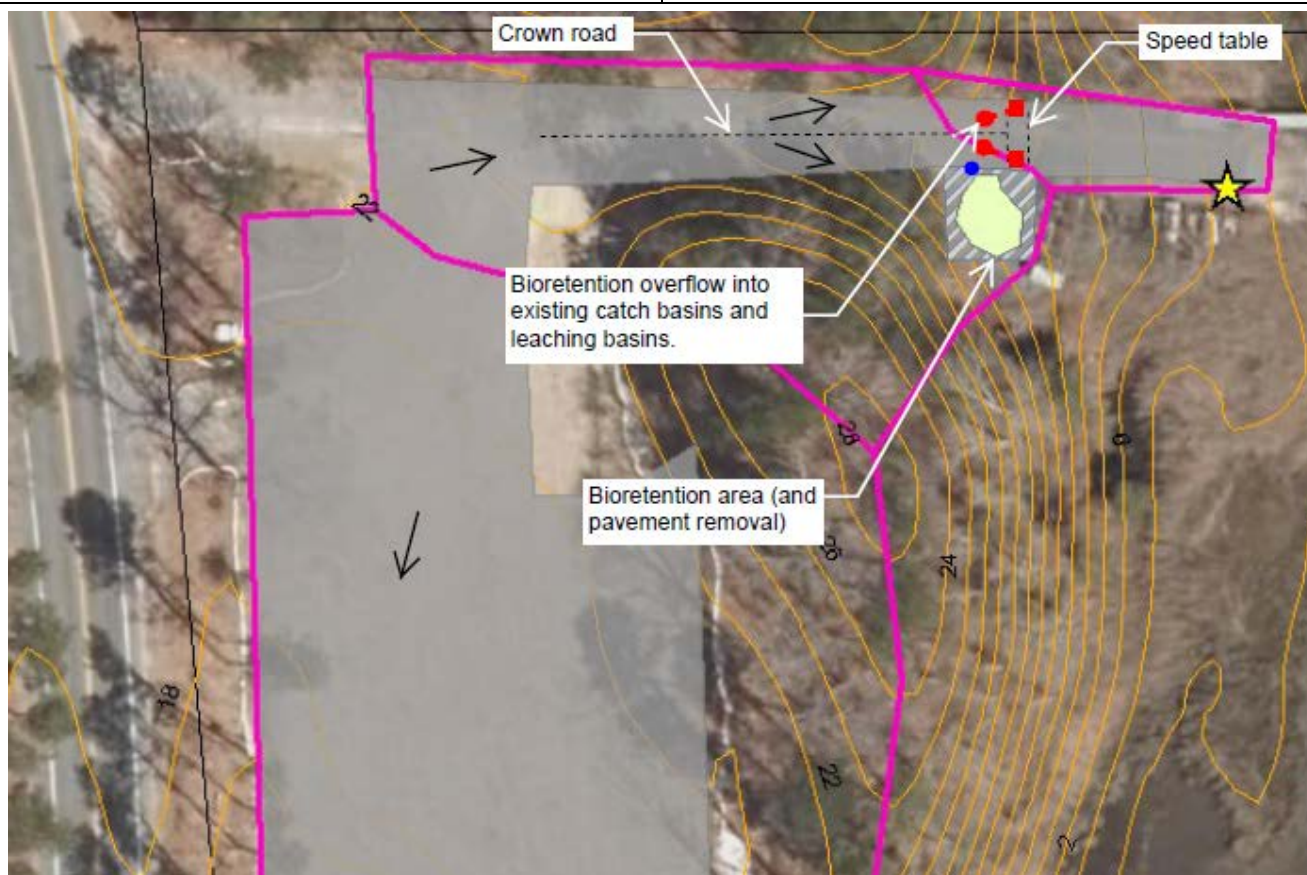
**Site Sketch:** Drainage area (pink), impervious cover (gray), impervious cover reduction (striped gray), BMPs (light green), paved flumes (dark blue), existing infrastructure (red), and drainage flow paths (arrows). Star represents the GIS location of the boat ramp.

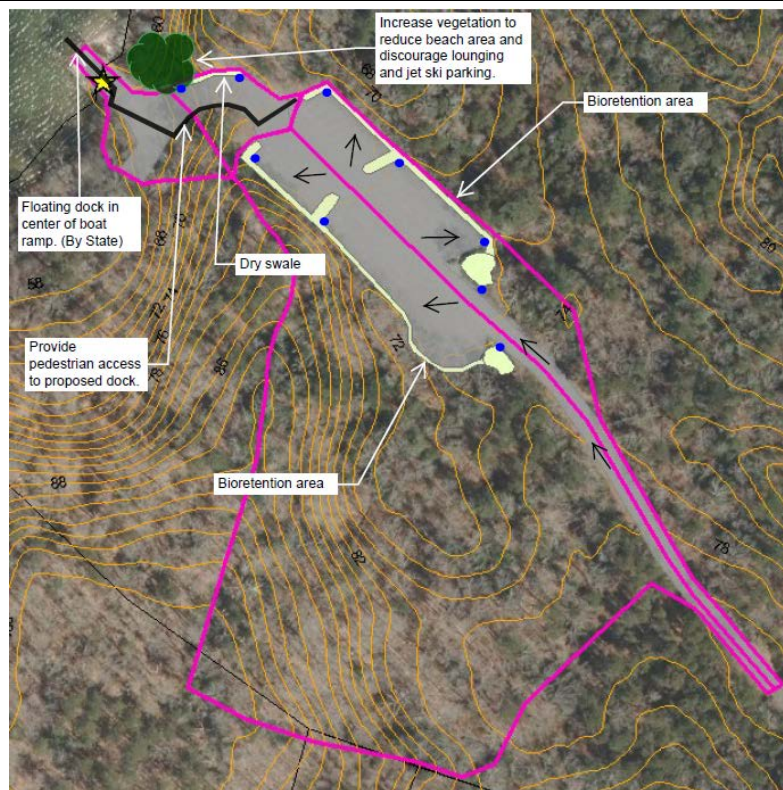
**Site Sketch:** Drainage area (pink), impervious cover (gray), BMPs (light green), revegetation (dark green), paved flumes (dark blue), and drainage flow paths (arrows). Star represents the GIS location of the boat ramp.

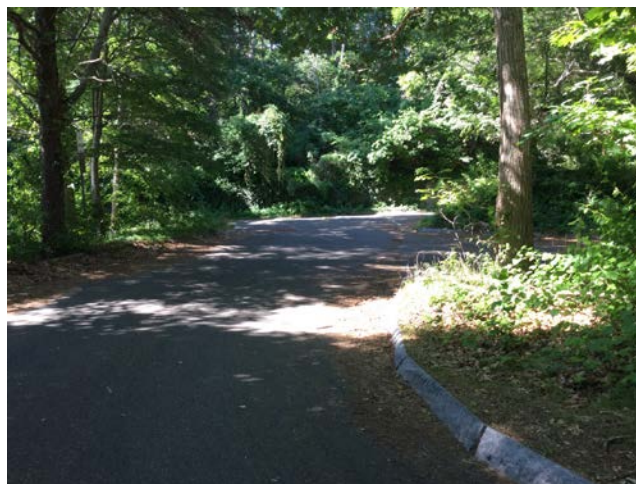
**Photo Caption:** Looking uphill at portion of Upper Parking Lot where underground infiltration is proposed.

<p><b>Proposed BMP Description:</b> The upper portion of the parking lot does not need space for trailers as they cannot maneuver the geometry, so pavement removal is proposed. In addition, runoff will be directed to a dry swale as pretreatment to underground infiltration, as well as to a shallow bioretention near the ramp itself.</p>

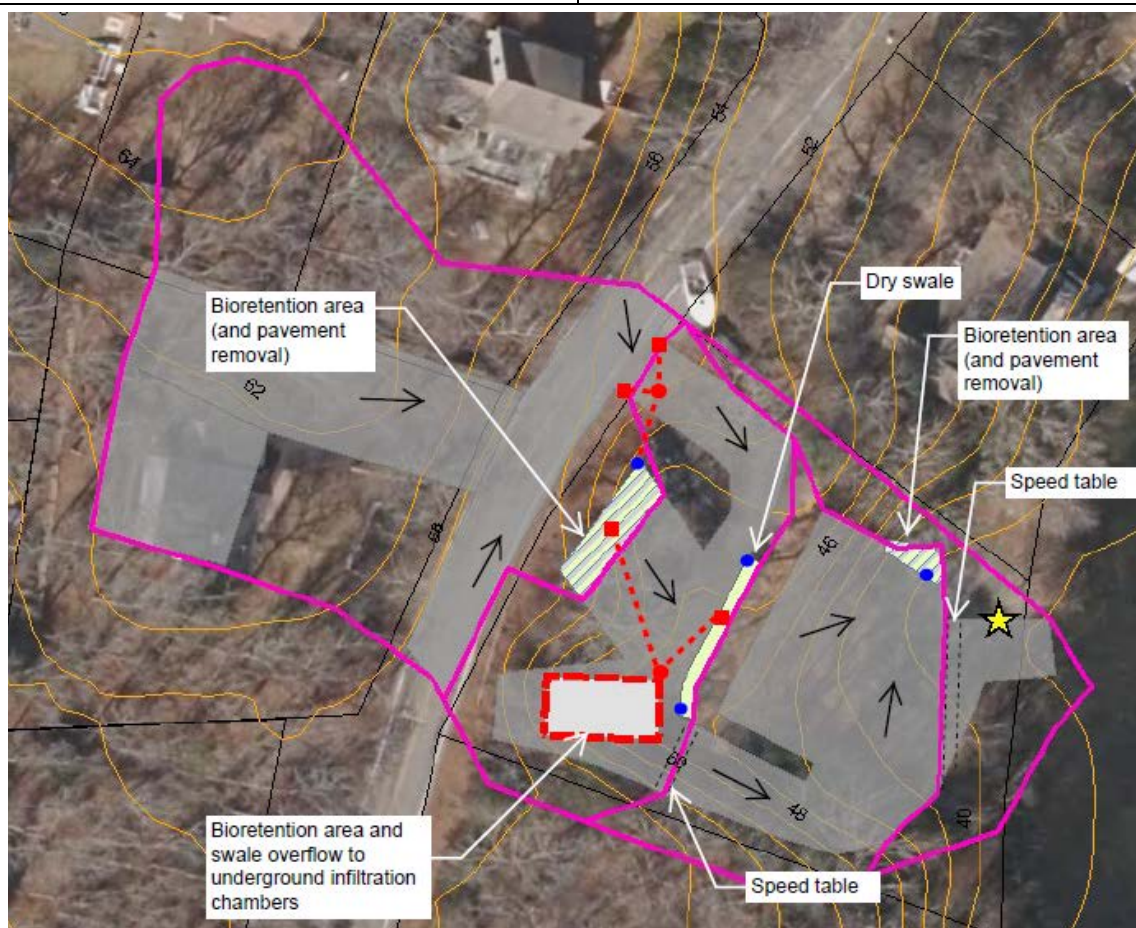
**Site Sketch:** Drainage area (pink), impervious cover (gray), impervious cover reduction (striped gray), BMPs (light green), paved flumes (dark blue), proposed infrastructure (red), and drainage flow paths (arrows). Star represents the GIS location of the boat ramp.

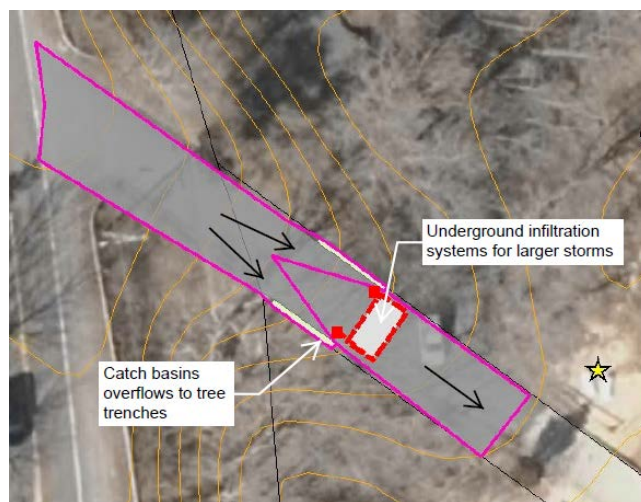
**Site Sketch:** Drainage area (pink), impervious cover (gray), BMPs (light green), proposed infrastructure (red), and drainage flow paths (arrows). Star represents the GIS location of the boat ramp.

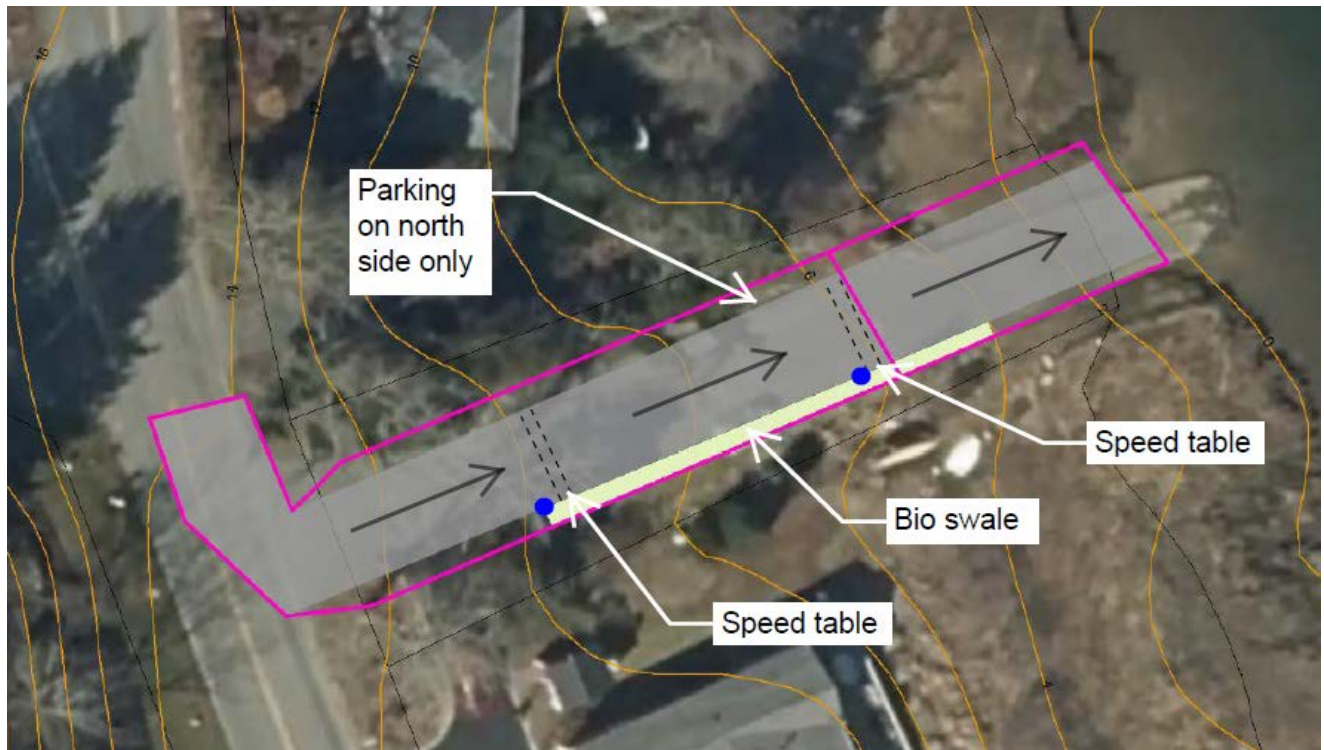
**Site Sketch:** Drainage area (pink), impervious cover (gray), BMPs (light green), paved flumes (dark blue), and drainage flow paths (arrows).

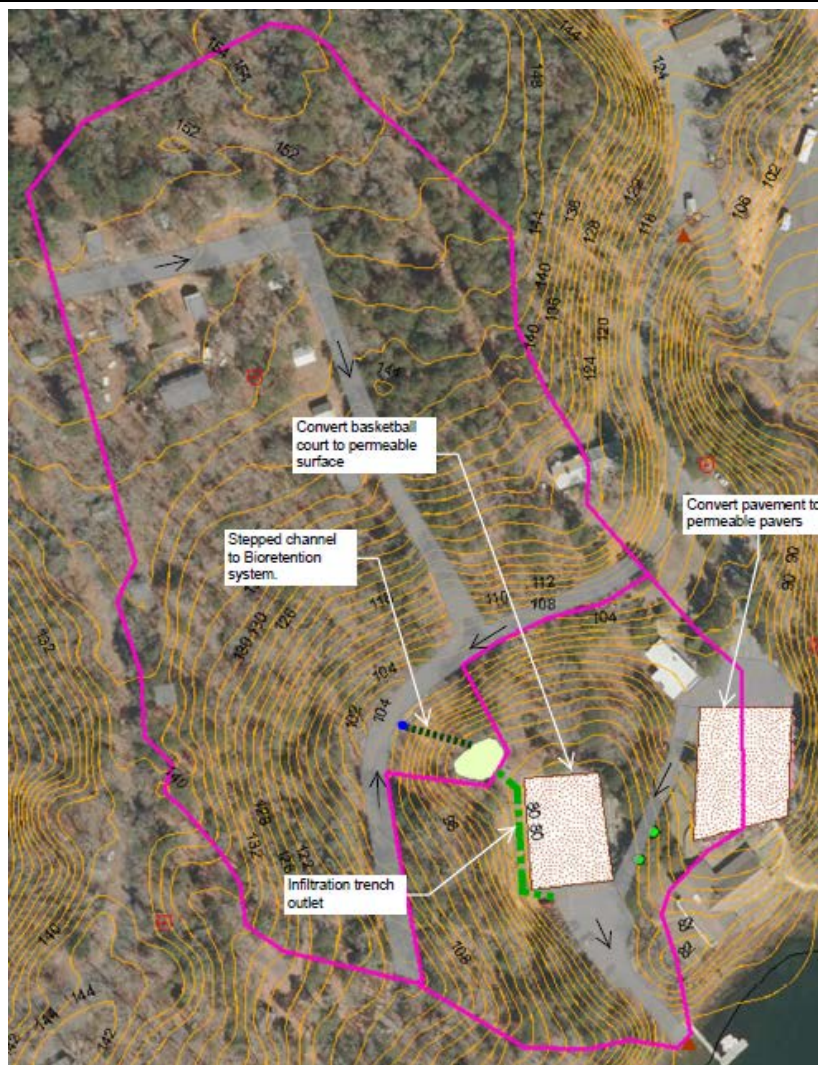
**Site Sketch:** Drainage area (pink), impervious cover (gray), BMPs (light/dark green and speckled brown), paved flumes (dark blue), existing outfalls (green circles), and drainage flow paths (arrows). Star represents the GIS location of the boat ramp.

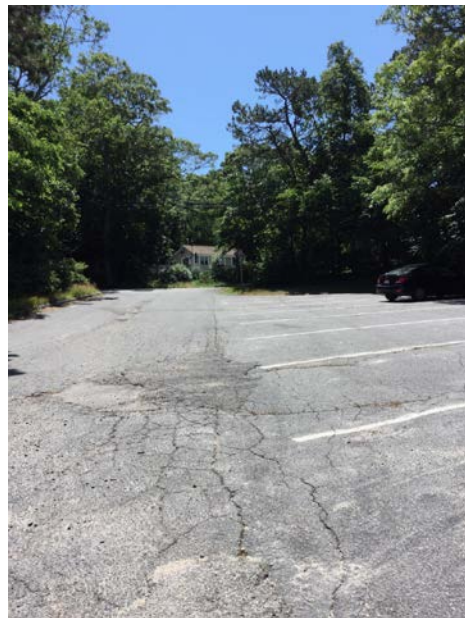
**Photo Caption:** Looking uphill at upper portion of parking lot – note the condition of the pavement.

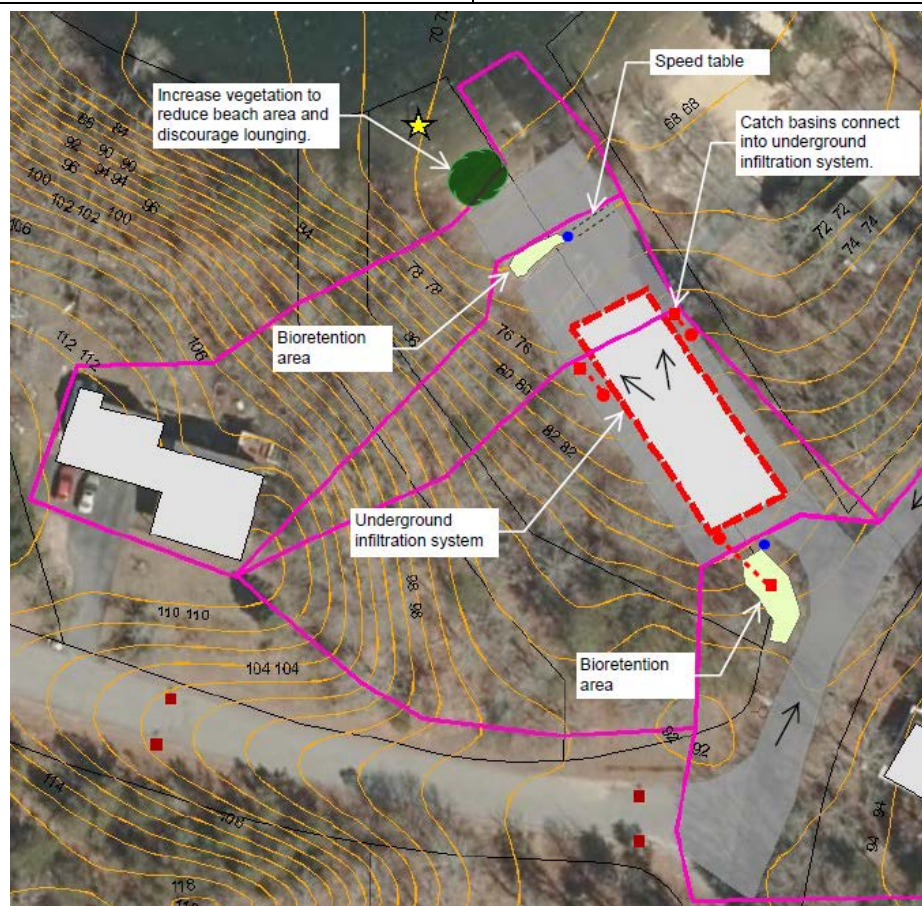
**Site Sketch:** Drainage area (pink – only portion near ramp shown here), impervious cover (gray), BMPs (light green), paved flumes (dark blue), proposed infrastructure (red), existing catchbasins (dark red squares), revegetation (dark green), and drainage flow paths (arrows). Star represents the GIS location of the boat ramp.

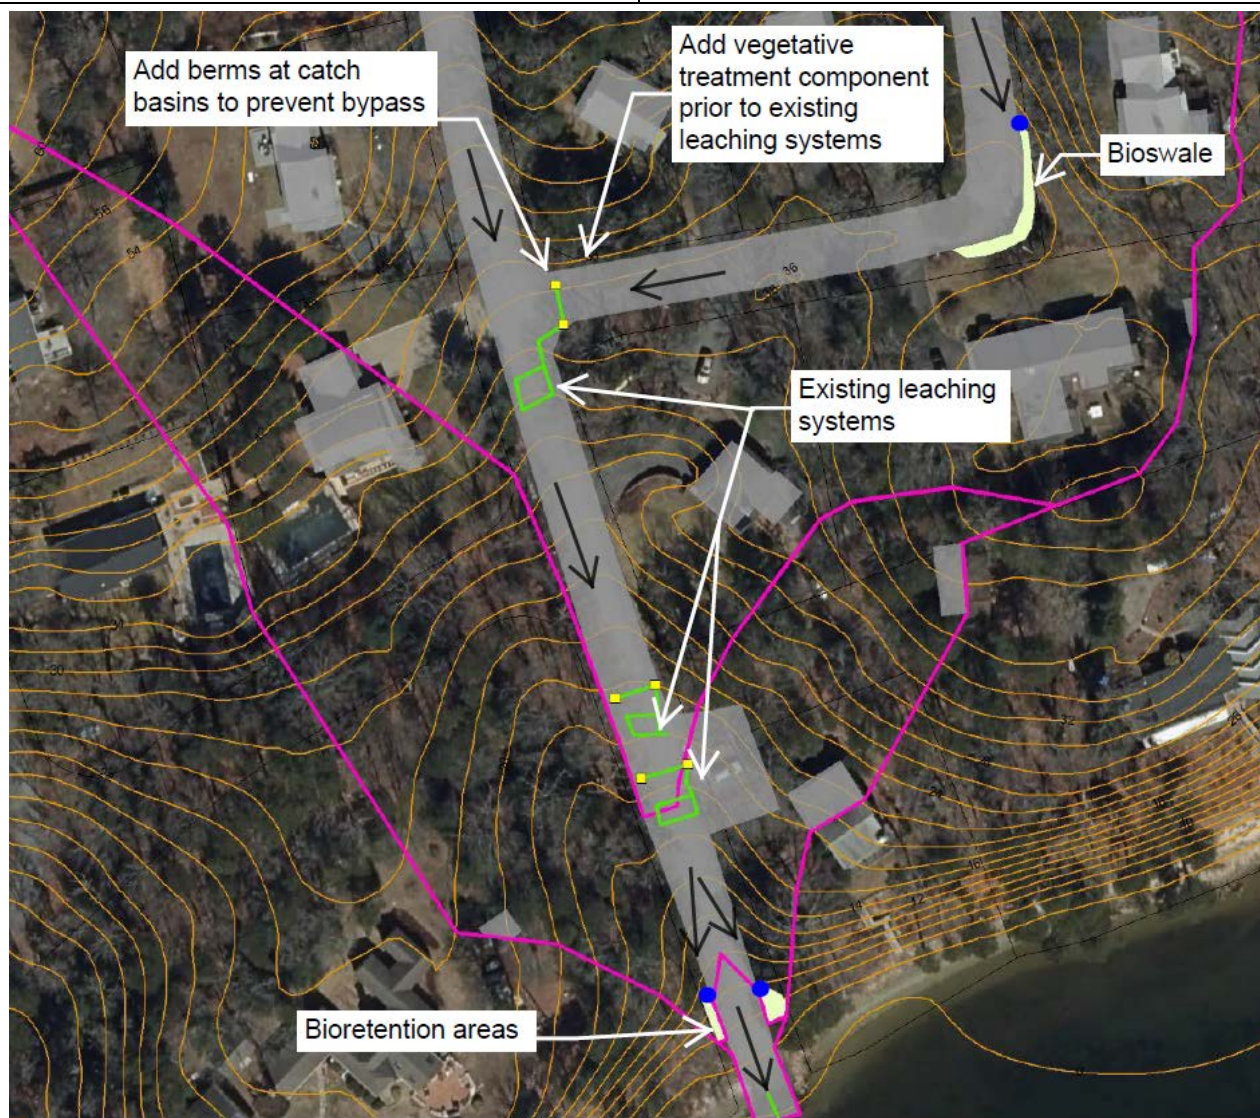
**Site Sketch:** Drainage area (pink), impervious cover (gray), BMPs (light green), paved flumes (dark blue), drainage flow paths (arrows), existing catch basins (yellow), and existing leaching basins (green).

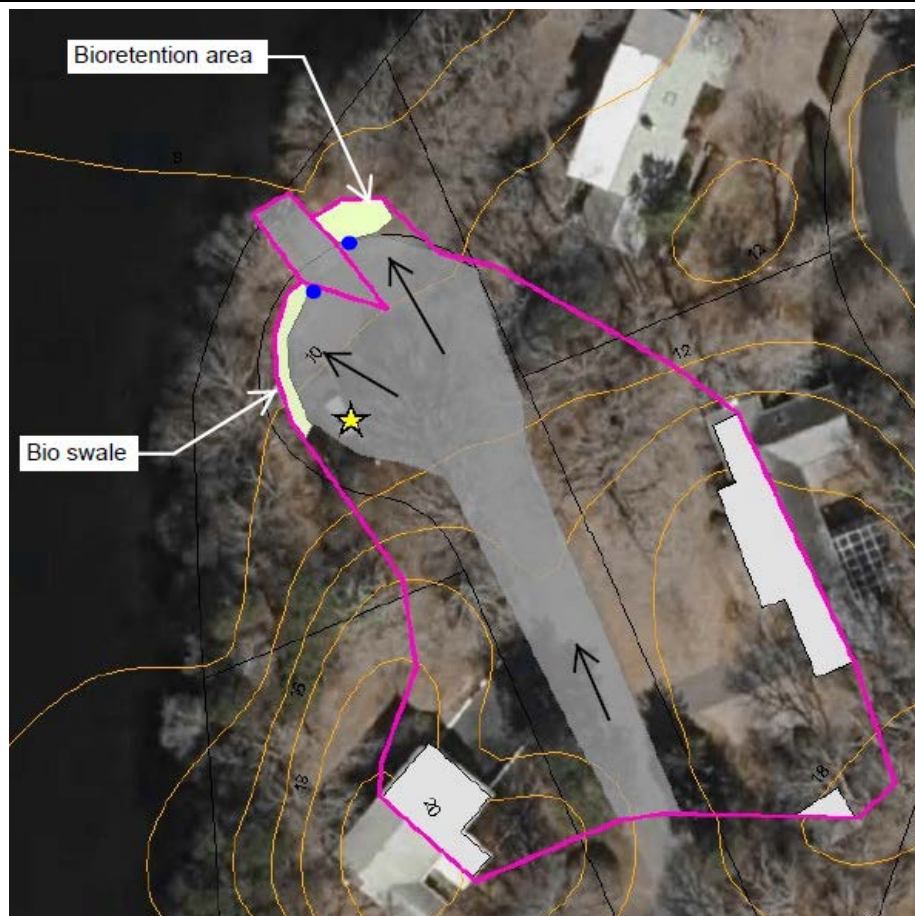
**Site Sketch:** Drainage area (pink), impervious cover (gray), BMPs (light green), paved flumes (dark blue), and drainage flow paths (arrows). Star represents the GIS location of the boat ramp.
