**UPPER CHILDS RIVER RESTORATION PROJECT**  
**One-Year Post-Construction Report**

**Falmouth Rod and Gun Club**  
**April 2023**

*Developed under contract by:*  
*Jordan Mora and April Wobst, Association to Preserve Cape Cod (APCC)*

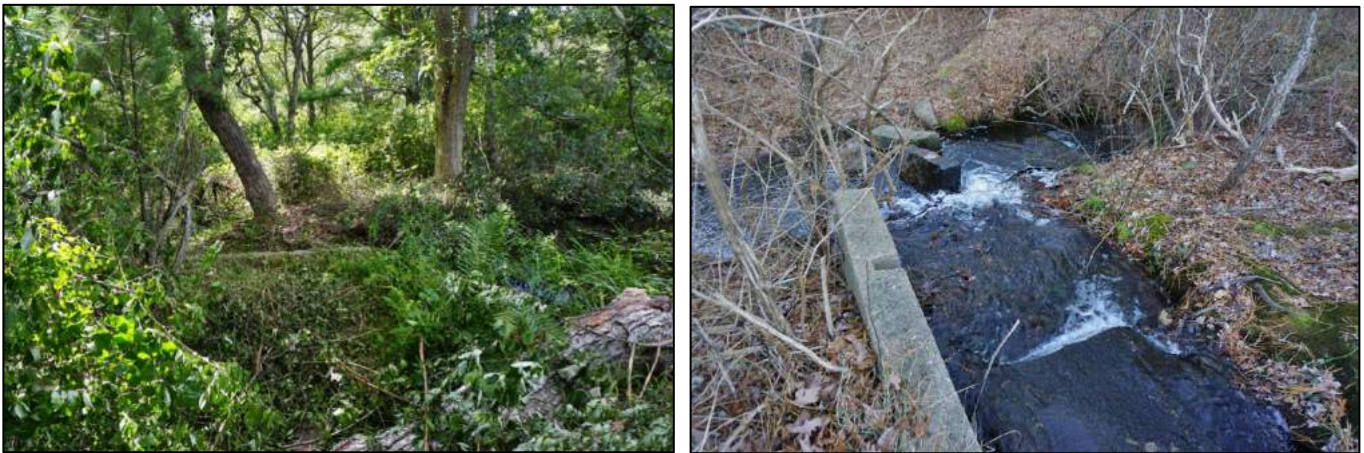
Figure 3: *Left:* Photo of the earthen berm or dam (credit: Falmouth Rod and Gun Club). *Right:* Photo of the spillway with concrete pieces broken away from the structure (credit: Falmouth Rod and Gun Club).

At the southern end of the project area south of Carriage Shop Road was the earthen berm or mill dam (Figure 3). The dam was constructed in the shape of the letter “L” with a 125-foot long and 10-foot high earthen embankment running east-west across the river and 180 feet long earth embankment (only a few feet high) running north to south. The earthen dam was heavily overgrown with trees, shrubs, vines and ground cover that severely limited visibility and provided limited habitat value to wildlife. The primary outlet to the dam was in poor condition having partially failed (Figure 3) resulting in more limited flow through the fish ladder. Likewise, the supplemental overflow spillway on the southwest corner of the dam was overgrown and covered with woody debris limiting its function.

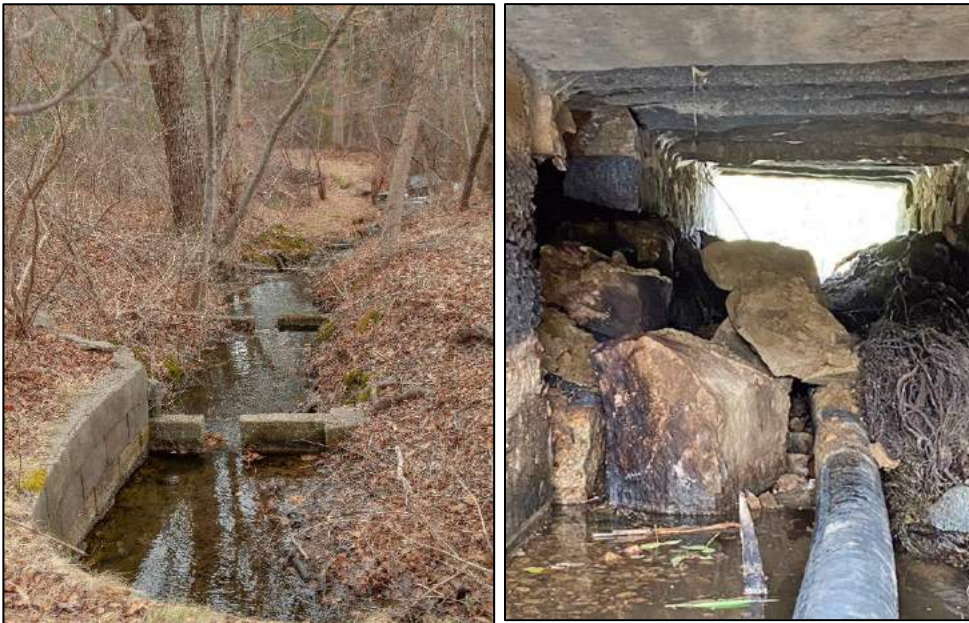
Figure 4: *Left*: Photo of fishway (credit: Gerald Beetham). *Right*: Photo of culvert under Carriage Shop Road captured during construction (credit: Falmouth Rod and Gun Club).

The fishway included a series of low concrete weirs that were in poor condition and the upstream weir where water entered the fish ladder from the pond was not built into the banks (Figure 4). This allowed water to bypass the weir in high water conditions, and when water was low, nothing flowed through the fishway. As a result, the fishway had been largely non-functional since 2012. The 3 ft x 5 ft wide box culvert under Carriage Shop Road was also in poor condition (Figure 4).

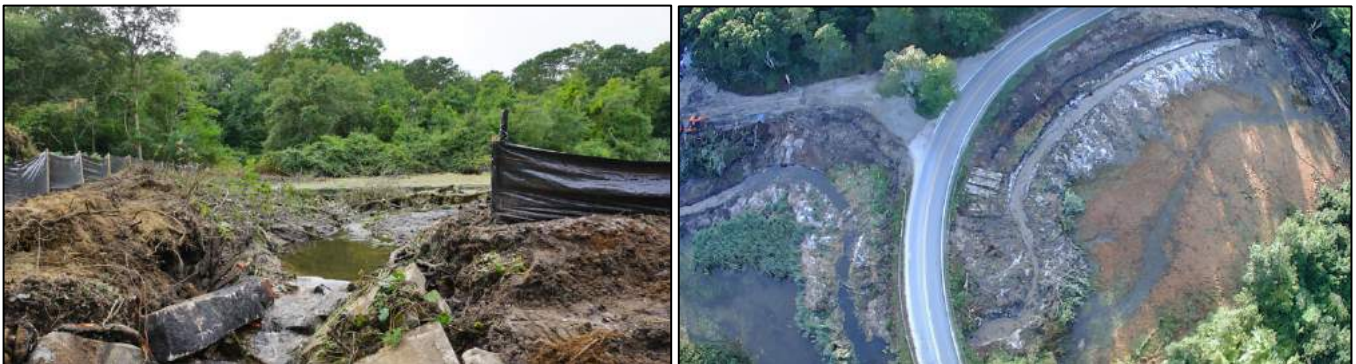
Figure 5: *Left*: Photo of dam spillway removal (credit: Falmouth Rod and Gun Club). *Right*: Aerial of diversion channels created north and south of Carriage Shop Road (credit: Falmouth Rod and Gun Club.).

The project was put out to bid and construction commenced on August 26, 2020, and was completed in September of 2021. Initial work focused on creation of diversion channels for the river throughout the project area and tree and brush removal along Carriage Shop Road, especially in the area of the failed fish ladder and along the earthen berm (Figure 5). Due to time of year restrictions for in-water work put in place by the Massachusetts Division of Marine Fisheries for protection of river herring and American eel, completion of initial in-stream work had to be completed by mid-September of 2020.

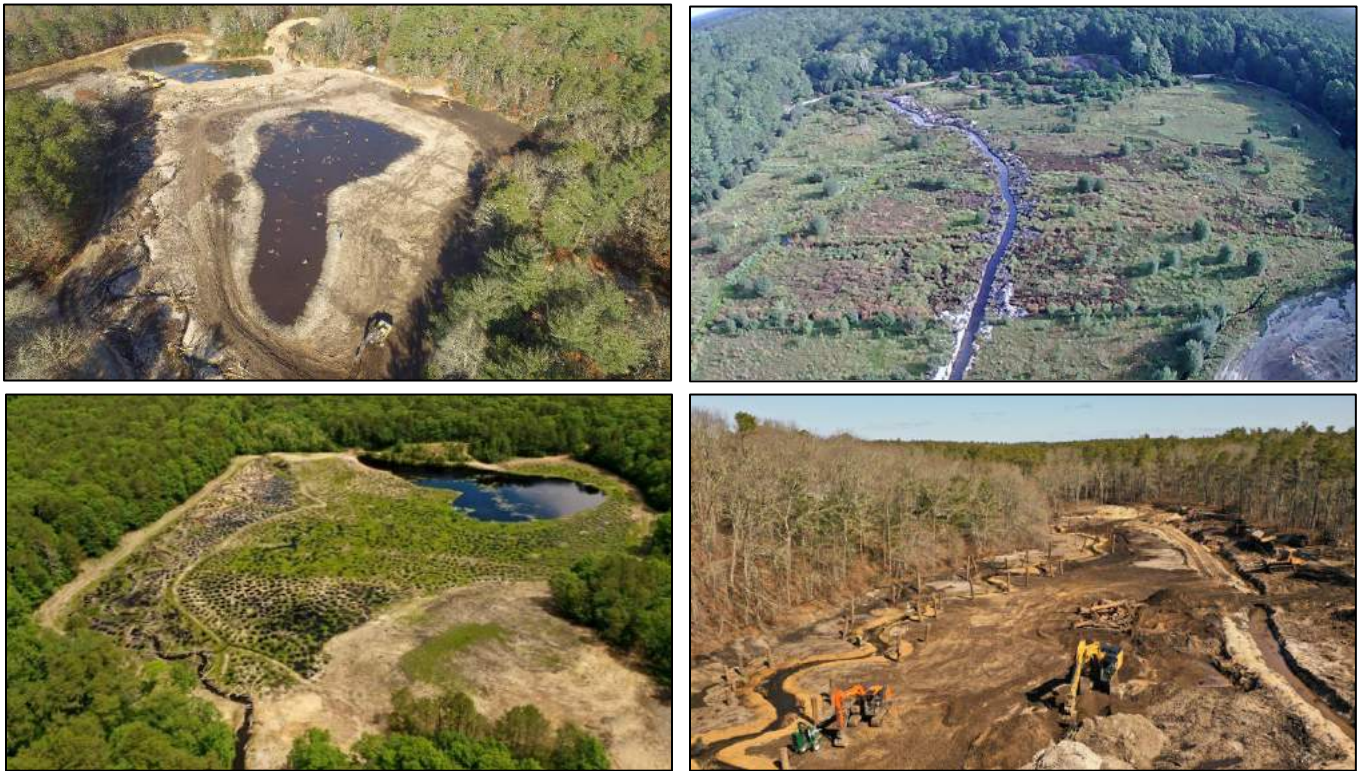
Figure 6: *Top left:* Creation of new stream channel and shallow ponds in the former Garner Pond, fall/winter 2020-2021 (credit: Inter-Fluve, Inc.). *Top right:* Diversion channel created in Farley Bog prior to regrading and new channel, October 2020 (credit: Falmouth Rod & Gun Club). *Lower left:* Completed construction and early revegetation of Farley Bog in spring 2021 (credit: Inter-Fluve, Inc.). *Bottom right:* Removal of impoundment north of Carriage Shop Road and creation of the new river channel (credit: Inter-Fluve, Inc.).

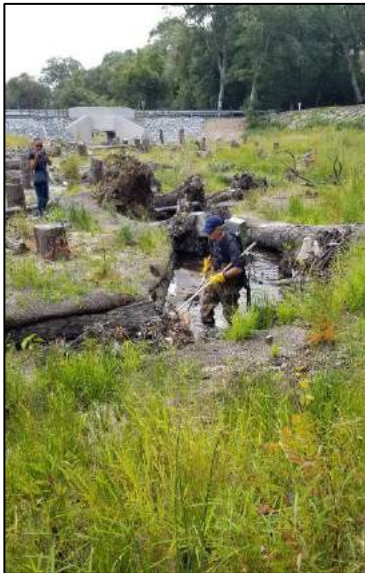
Figure 9: Electrofishing in the former pond area, September 23, 2021 (credit: Patty Waltner).

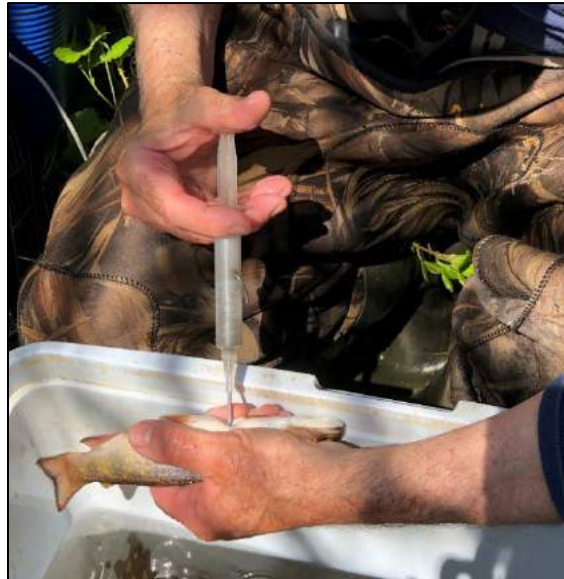
Figure 10: PIT tagging of Childs River brook trout. Tags are injected into the abdominal cavity. (credit: A.D. Colburn).

MassWildlife conducted fish surveys along the Childs River at four main locations (above Barrows Street, above and below the Riverways gage, in the former pond area, and in the lower Farley Bog and channel below, with more limited sampling in the Garner Bogs Figure 11) in spring (May-June) and fall (September) with a Smith Root backpack electrofisher operating at about 400 volts. The river was sampled in an upstream direction (Figure 9) and all Brook Trout were scanned for PIT (Passive Integrated Transponder) tags, measured for length in millimeters (mm) and weight in grams (g). Brook trout 80 mm or longer were tagged with a 12 mm FDX PIT tag (Figure 10).

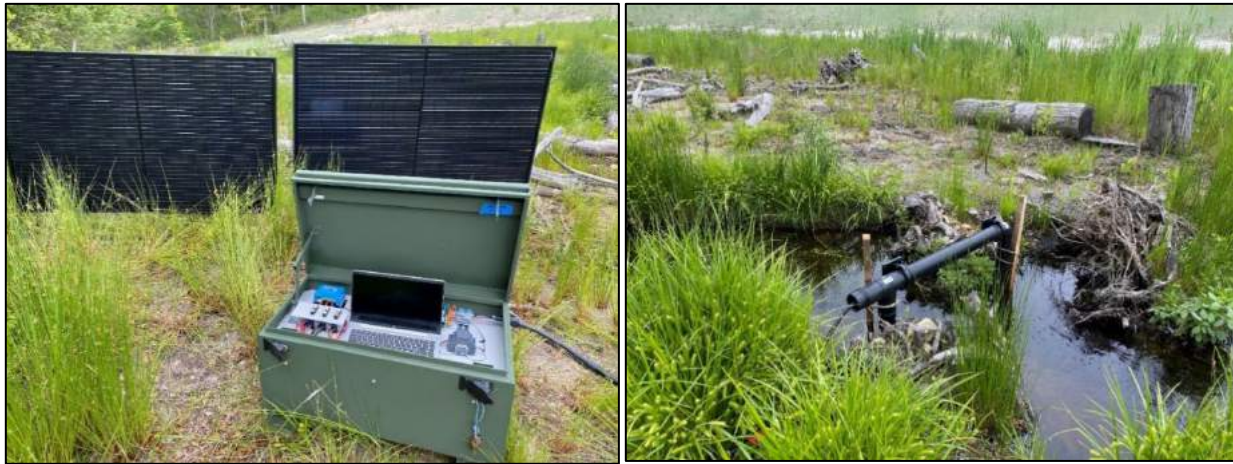
Figure 12: New antenna reader and solar panels (*left*) along with PIT antenna (*right*) installed on May 31, 2022, in the former pond area near the Falmouth Rod and Gun Club along with laptop for download. PIT-tagged Brook Trout are detected when they swim through the antenna (credit: Steve Hurley).

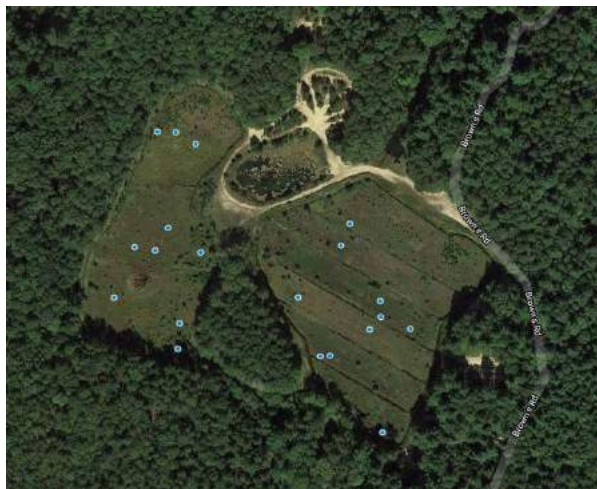
Figure 13: Garner Bog; circles represent permanent vegetation monitoring plots. Note this photo was taken prior to restoration of bog.

Woodwell, under contract to the Massachusetts Division of Ecological Restoration (DER), surveyed 20 randomly selected 3 x 3 m quadrats in Farley Bog and Garner Bog (Figure 13 and Figure 14). Surveys were carried out annually during peak growing season (August – September) in 2019 through 2022. Within each of these quadrat plots, all species were identified, and the percent cover estimated for each species. Each species was categorized as native/non-native, physical form (e.g., herbaceous, shrub, etc.), and by wetland indicator status. Additionally, the number of species present and the average plot percent cover of these categories was used to characterize the pre-restoration and post-restoration plant community composition at the former Childs River bogs. Analysis of the data was provided by Woodwell.

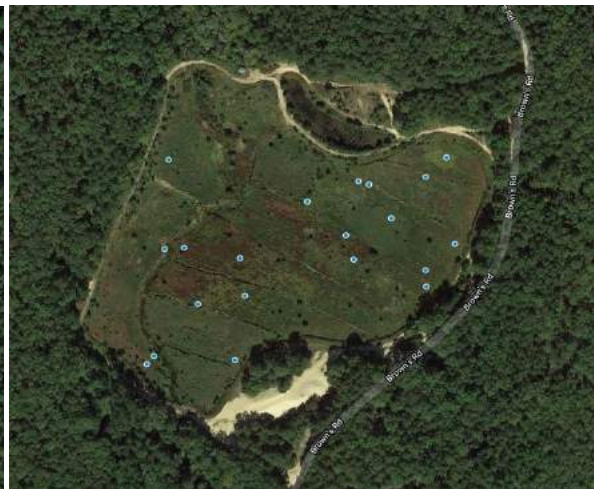
Figure 14: Farley Bog; circles represent permanent vegetation monitoring plots. Note this photo was taken prior to restoration of bog.

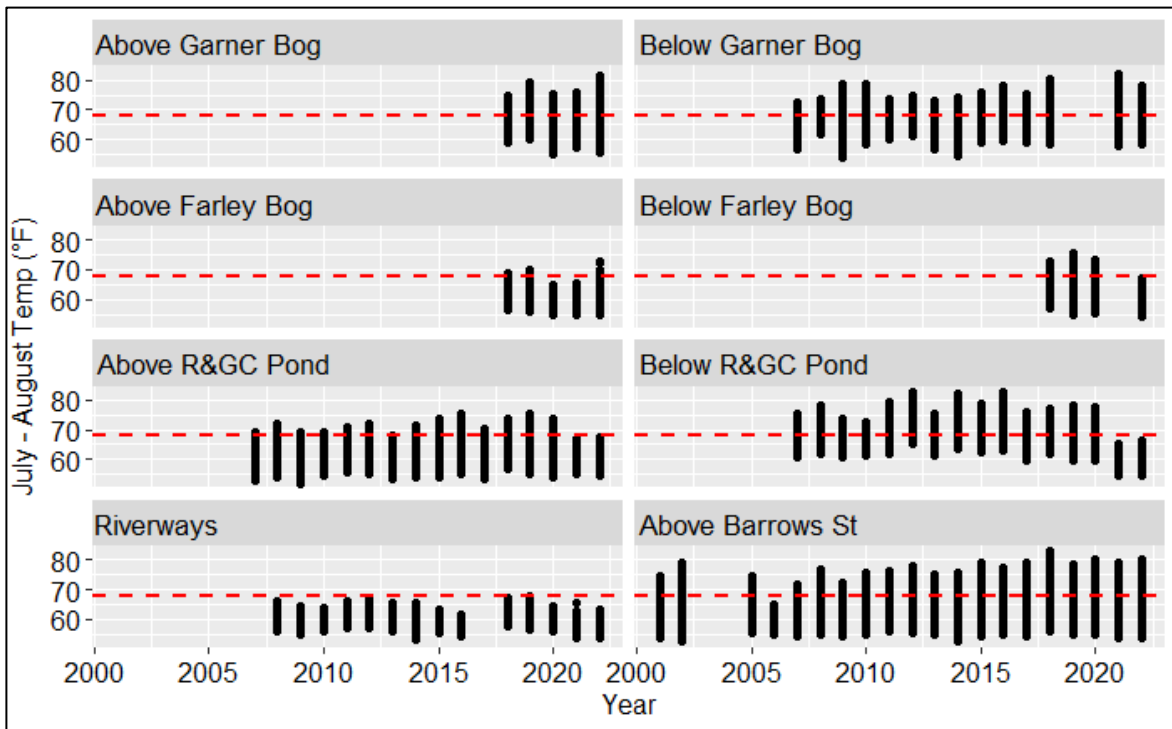
Figure 16: July and August temperature data from continuous datalogger monitoring stations on Childs River. Graphs depict range of temperatures over July and August for each year. The red dashed line represents the threshold for optimal fish habitat at 68°F. R&GC refers to the Rod and Gun Club.

Reducing summer water temperatures in the river was successfully achieved. Temperatures decreased following the restoration of the former bogs, removal of the ponds north and south of Carriage Shop Road, and replacement of the Carriage Shop Road culvert. The areas with the most significant drop in summer temperatures following construction completion in 2021 were below Farley Bog, above the R&GC Pond, and below the R&GC Pond (Figure 16). The former shallow ponds and bogs contained slow moving water flow creating conditions that warm the water temperature in the summer when days are longest, and the solar rays are most direct. When these features were removed and replaced with a newly constructed river channel with increased flow and better exchange with the groundwater table, the water temperature declined. The station located Above Barrows St is at the head of tide and is influenced by warmer tidal water temperatures downstream.

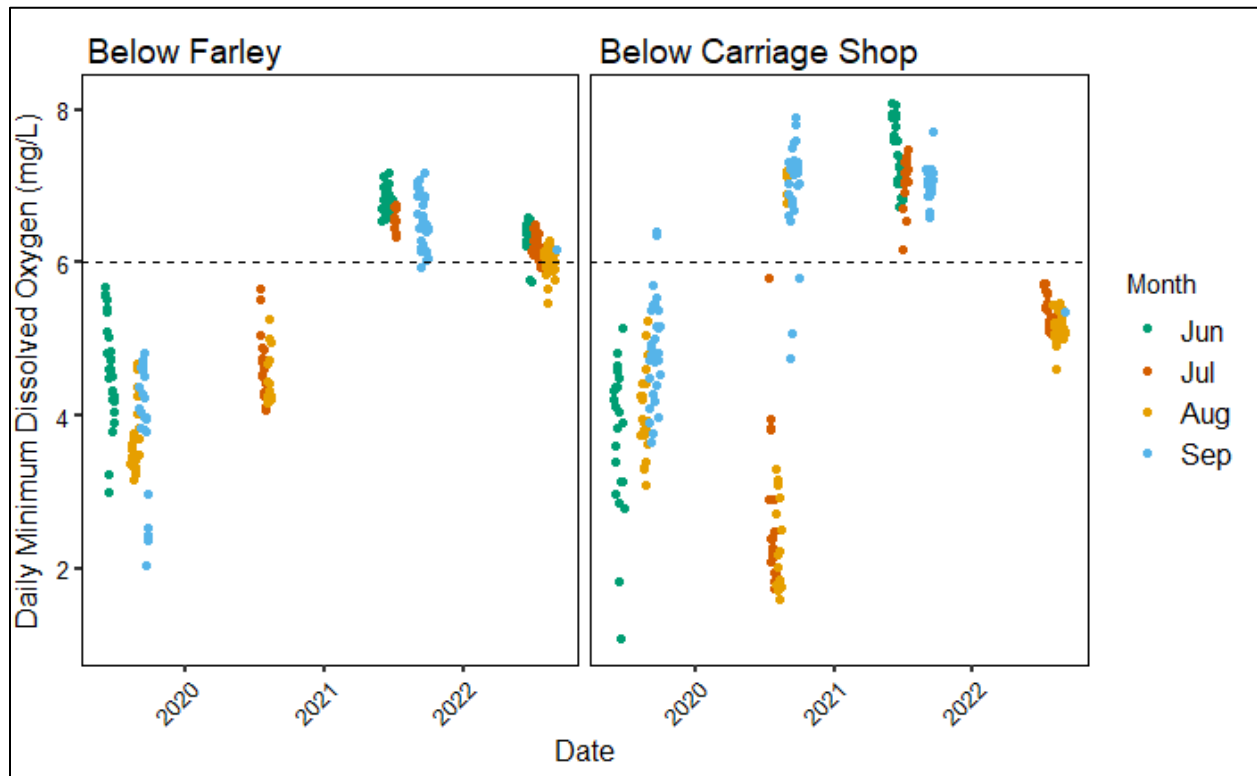
Figure 17: Graphs of daily minimum dissolved oxygen levels recorded from continuous dataloggers deployed on Childs River. Restoration of the Farley Bog was completed in spring 2021 and construction ended Below Carriage Shop Road in August 2021. The data from Below Carriage Shop clearly shows when the river was diverted to the byway channel in August 2020 (away from the RGC Pond) as dissolved oxygen levels increased quickly following this event.

In addition, following the construction phases (summer of 2021 for Below Farley and post-August 2021 for Below Carriage Shop), the summertime minimum dissolved oxygen (DO; Figure 17) levels increase. Cooler water holds more oxygen due to the laws of thermodynamics, so this increase in summer DO can be partially attributed to the colder water temperature. Additionally, faster moving water causes higher dissolved oxygen as the rippling water mixes with the air. Figure 17 shows the increase in the minimum daily DO at both monitoring stations. Moreover, data from Below Carriage Shop clearly shows when the river was diverted to the byway channel and away from the RGC pond as dissolved oxygen levels increased quickly following this event in August 2020. Below the 6 mg/L threshold represents a stressed environment for freshwater fish species.<sup>13</sup> Since the restoration, the DO has not dropped below 5 mg/L at either site, a marked improvement from previous levels which could fall as low as 1-2 mg/L (lethal level for fish). The drought in 2022 reduced groundwater levels which may have inhibited groundwater exchange and/or surface water flow causing the DO to be lower than in 2021.

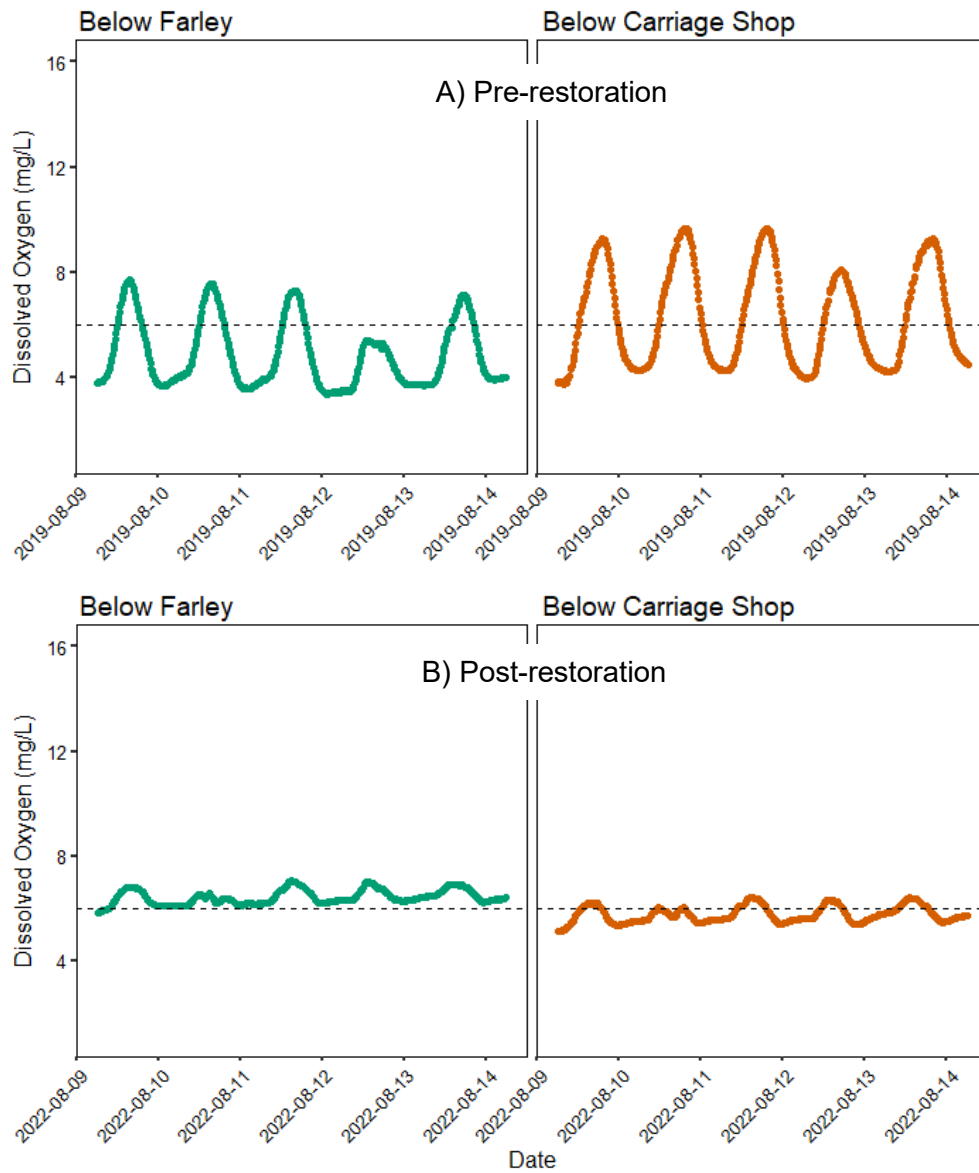
Figure 18: Dissolved oxygen fluctuations over a five-day period pre-restoration (A) and post-restoration (B). The dashed line represents the threshold for fish survival at 6 mg/L; below 6 mg/L is a stressful environment for freshwater fish.

The other noticeable improvement in DO is seen in the range observed in the summer months. Prior to restoration, dissolved oxygen levels fluctuated greatly on a diurnal pattern with very low, stressful levels occurring overnight and very high levels occurring during the day. Data collected after the restoration show less fluctuation and generally remain at or above the 6 mg/L threshold (Figure 18).

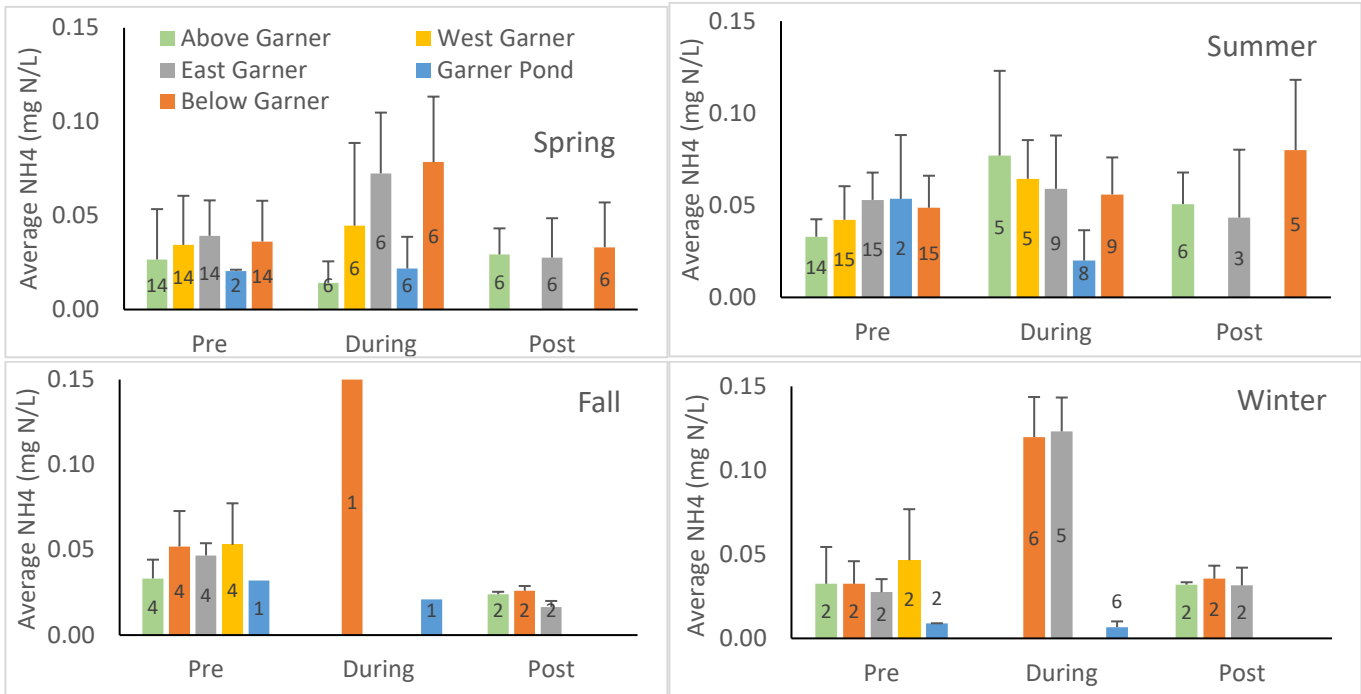
Figure 29: Average ammonium concentrations in the restored Garner Bog across construction phases for each season. Error bars represent standard deviation of the mean. The number of samples included in the mean are provided within each bar column.

**Garner Bog** - Ammonium levels were highest during construction in Garner Bog especially in the fall and winter 2020-2021 (Figure 29). The increased ammonium during construction was likely caused by a combination of factors include plant senescence and disturbance to the bacterial community as well as release from soils due to pressure change in pore spaces. The dissolved ammonium was also generally higher during the spring and summer which may be related to the season's warmer temperatures. Ammonium is largely unchanged between pre- and post-construction across seasons.

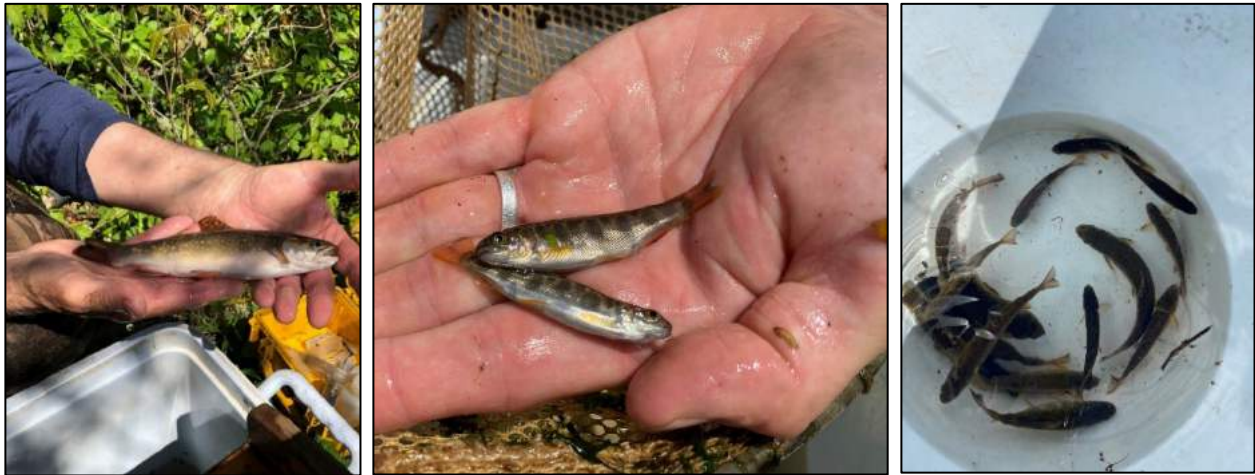
Figure 48: *Left*: Childs River Brook Trout May 2022 (credit: A.D. Colburn). *Center*: Young of year Brook Trout captured in the former pond area of the Childs River on May 18, 2022, indicating that spawning had occurred in or near this newly restored area (credit: MassWildlife). *Right*: Catch of Brook Trout in Farley Bog September 14, 2022 (credit: MassWildlife).

On May 18, 2022, nineteen Brook Trout were captured in the old pond area including 5 young-of year (YOY) indicating that spawning had occurred in or near the old pond area (Figure 48). Seventeen Brook Trout were captured in the new river channel of the former Farley Bog including four young of year indicating that spawning had occurred in or near the Farley bog area as well. Only two young of year were captured in the lower reaches of the river (runs 1-3) where spawning was previously known to occur. A total of 31 Brook Trout were captured in the lower reaches of the river (runs 1-3) and 36 Brook Trout were captured in the restored areas (runs 4-5) in the restored river channel (Table 2).

On September 13 and 14, 2022 the Childs River was again sampled by electrofishing and 84 trout were captured including 47 young-of-year (YOY) and 23 recaptures (Figure 48). Thirty-four trout were captured in the lower reaches including 15 YOY and 10 recaptures, 34 trout were captured in the old pond area including 18 YOY and 12 recaptures while 16 trout including 14 YOY and one recapture were captured in the former Farley bog area (Table 3). Based on the length frequency distributions (Figure 49), 2022 appeared to produce a good year class in the Childs River which may reflect the increased spawning areas created by the restoration of the former Farley Bog and former RGC pond area. Overall, the sampling to

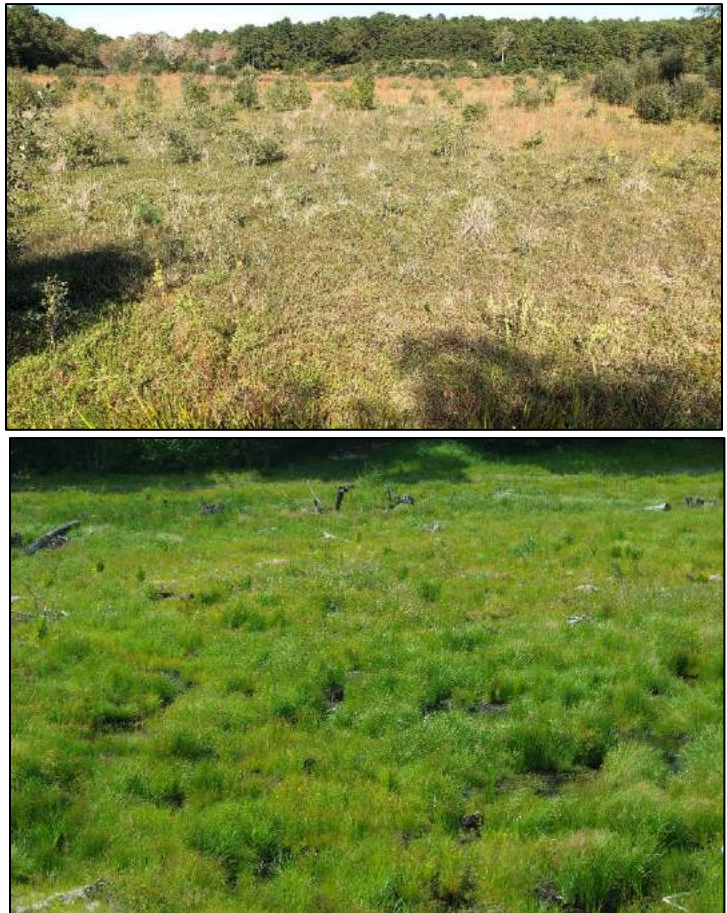
Figure 53: Top: Plant composition in Farley Bog pre-restoration in 2017 (credit: Chris Neill, Woodwell Climate Research Center). Bottom: Plant composition in Farley Bog post-restoration in 2021 (credit: Chris Neill, Woodwell Climate Research Center).

The plants in the former bog systems largely recolonized naturally from the seed bank although some plantings did occur on the edge and in the newly constructed ponds of the former bogs. Photos in Figure 53 show the change in vegetation and density of growth in Farley Bog from pre-restoration (2017) to post-restoration (2021). Since the bog construction was completed by spring 2021, the data from the vegetation survey conducted at the end of the first growing season in 2021 were used to compare pre- and post-restoration plant communities.

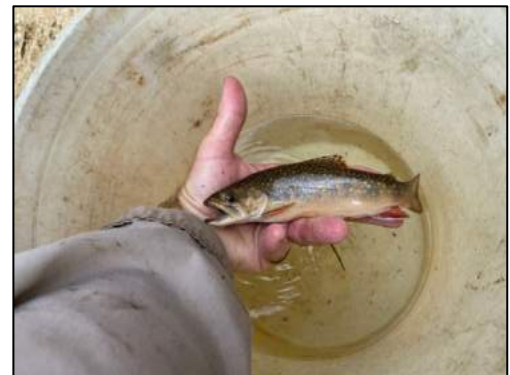
Figure 60: One of the two Childs River Brook Trout captured in the New Farley bog Channel, September 16, 2021 (credit: Steve Hurley).

The Childs River restoration effort successfully created new habitat for the Brook Trout as seen by the increased presence of this species north of the Carriage Shop Road and around the former Farley Bog (Figure 60). Evidence that the habitat has improved is available from the temperature and dissolved oxygen data but is also corroborated by the September surveys (data collected from 2006 through 2022) which showed that Brook Trout spawned successfully and in higher numbers than before the restoration.
