# CHASE GARDEN CREEK SALT MARSH Vulnerability Assessment

Jordan Mora, Eliza Fitzgerald, and Samantha Coccia-Schillo  
Association to Preserve Cape Cod  
*Project funded by the Lavori Sterling Foundation*

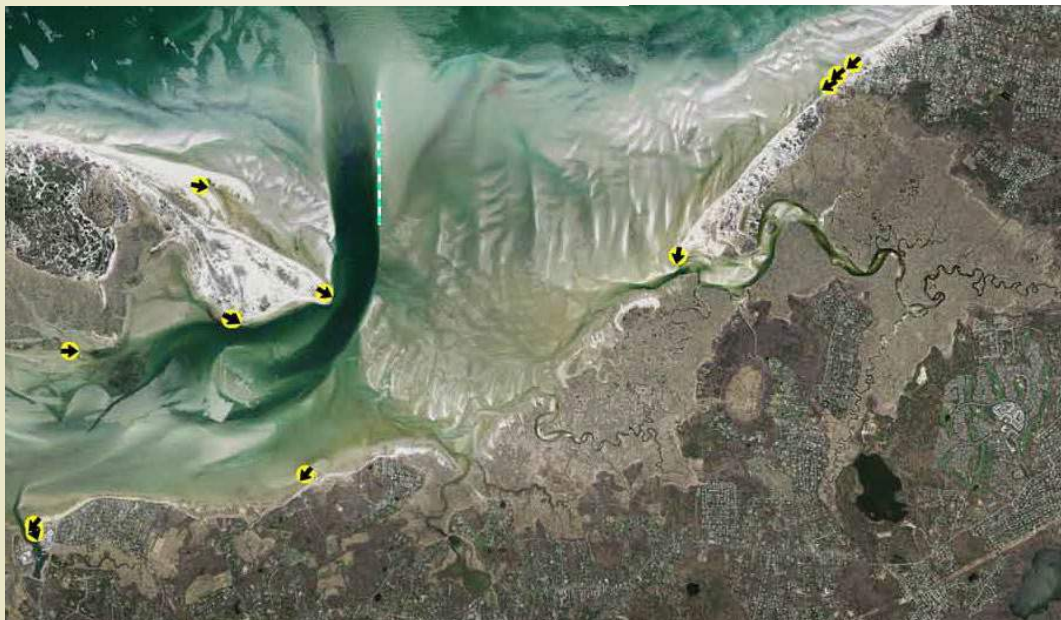
Figure 4. Composite historic transport map showing transport of sediment throughout the Cape Cod region. Each of the component maps was georeferenced and the arrows converted to vectors. The arrow length and position is depicted similarly to the original study map, except in cases where overlaps made the arrows illegible. Each study is color-coded according to the legend (Woodworth and Wigglesworth, 1934; Giese, 1964; Strahler, 1966; Fisher, 1979; FitzGerald, 1993). Giese (1964 data) analysis based in part on previous studies (U.S. Congress, 1959 & 1960).

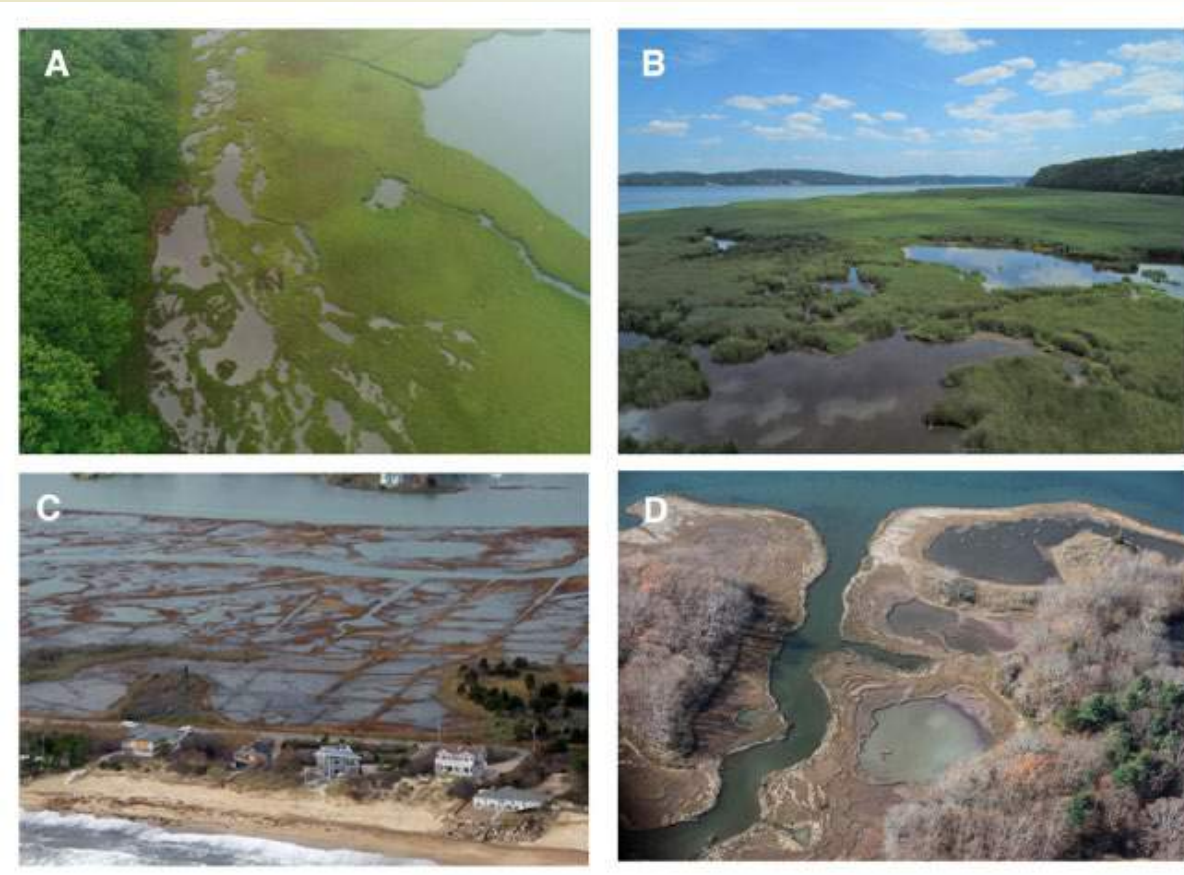
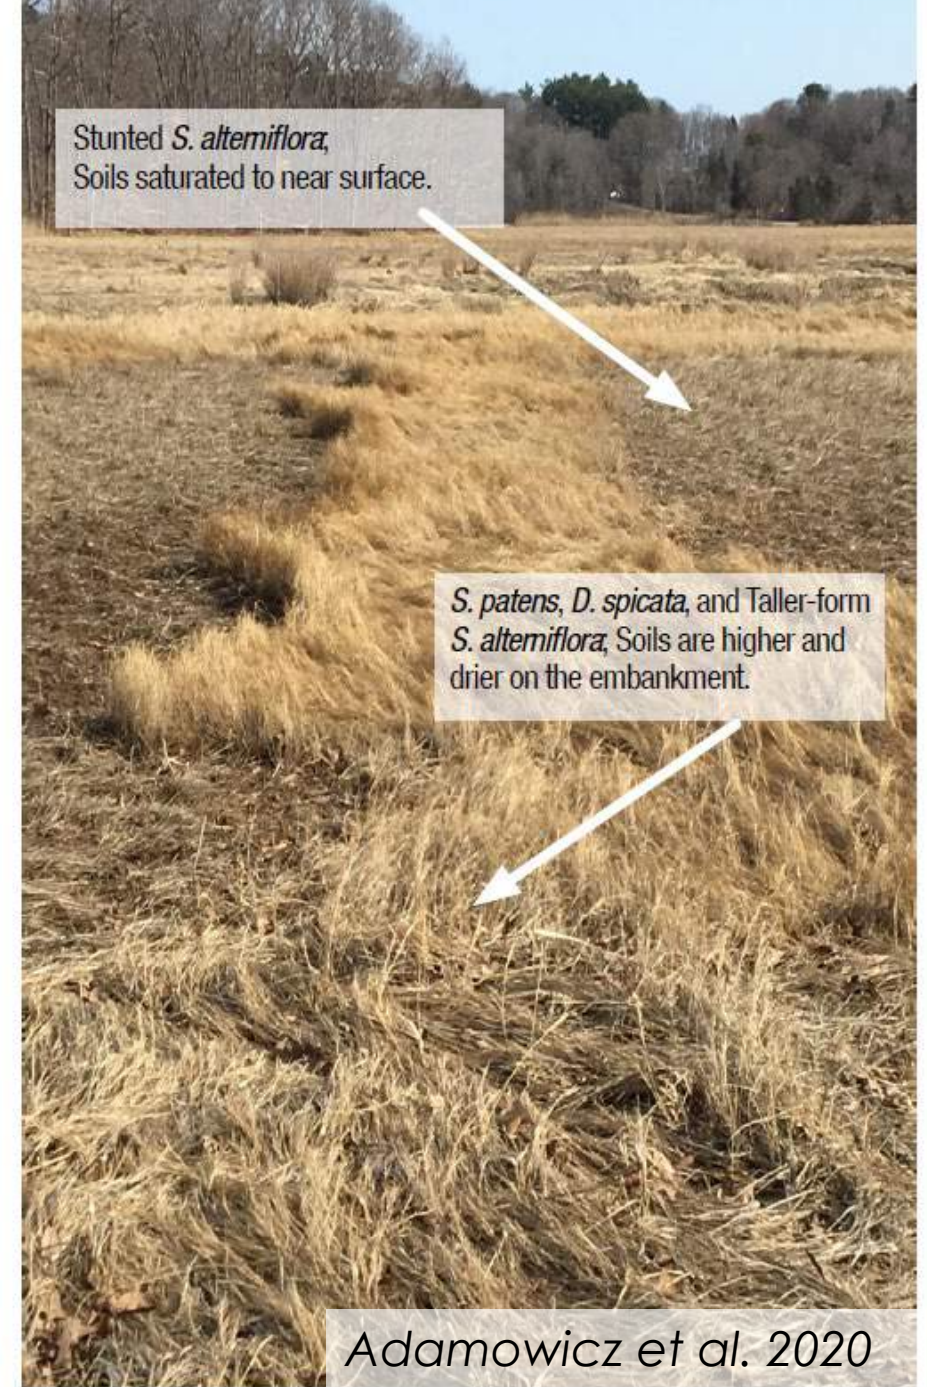
# Waterlogged Subsidence Trajectory (mega-pools)

- ▶ Poor drainage from embankments cause dieback of vegetation and root collapse

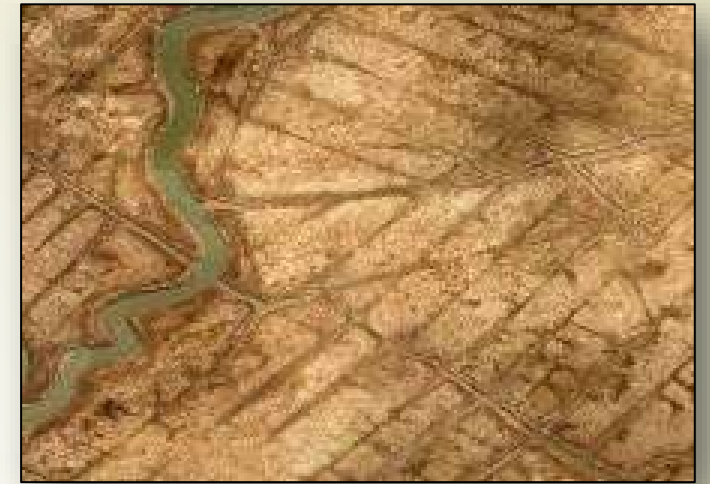
# Oxidation Subsidence Trajectory

- ▶ Aeration of root zone and increased decomposition

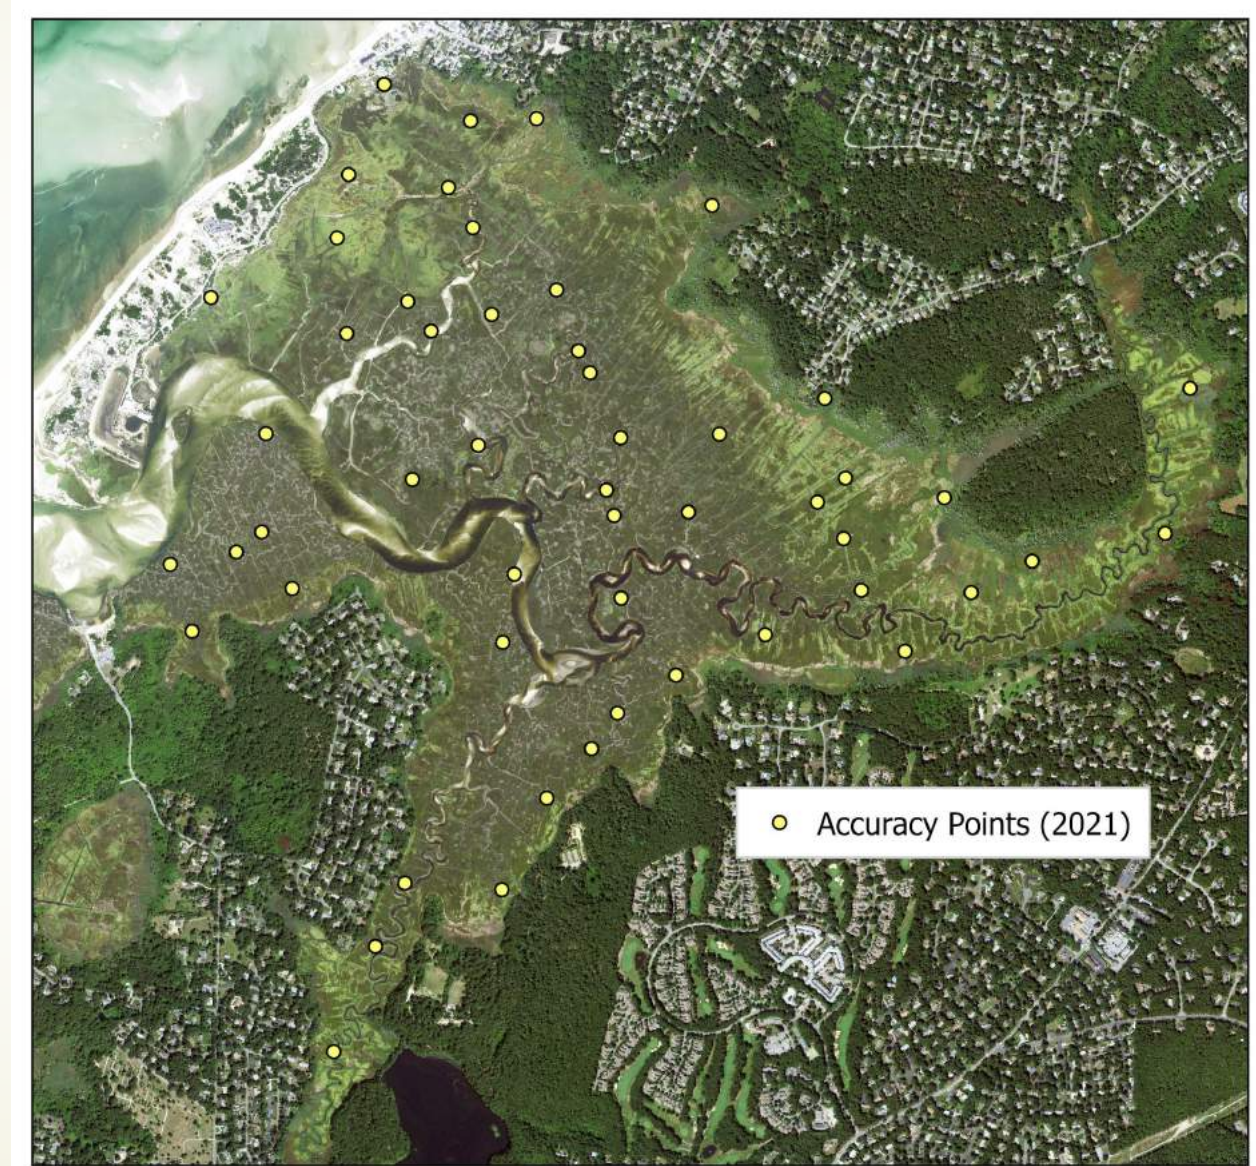
Using **Accuracy Assessments Tool** in ArcPro

- Generates randomized points
- Calculates confusion matrix (kappa coefficient)

**Interpretation of Kappa Coefficient**

Kappa Value	Level of Agreement	% Data is Reliable
0 - 0.20	None	0 - 4
0.21 - 0.39	Minimal	5 - 14
0.40 - 0.59	Weak	15 - 35
0.60 - 0.79	Moderate	35 - 63
0.80 - 0.90	Strong	64 - 81
0.90 - 1.0	Almost Perfect	82 - 100

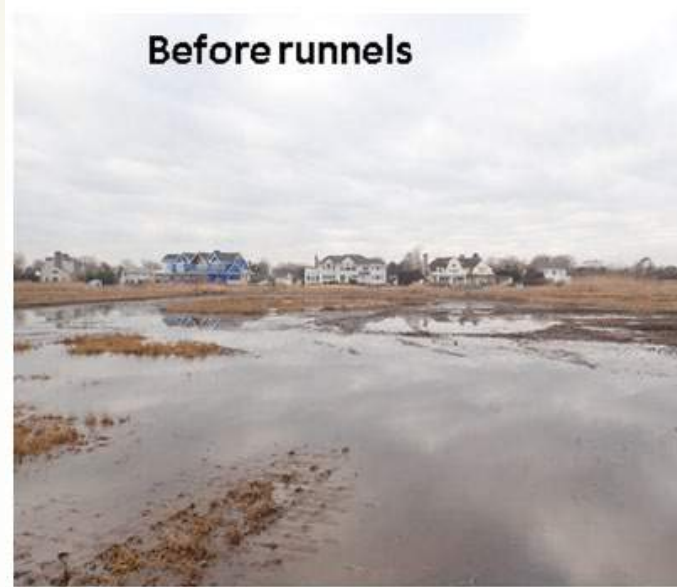
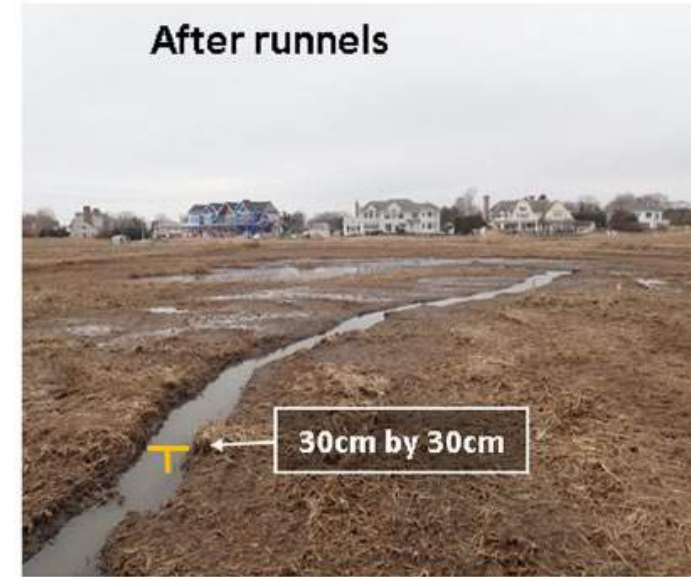
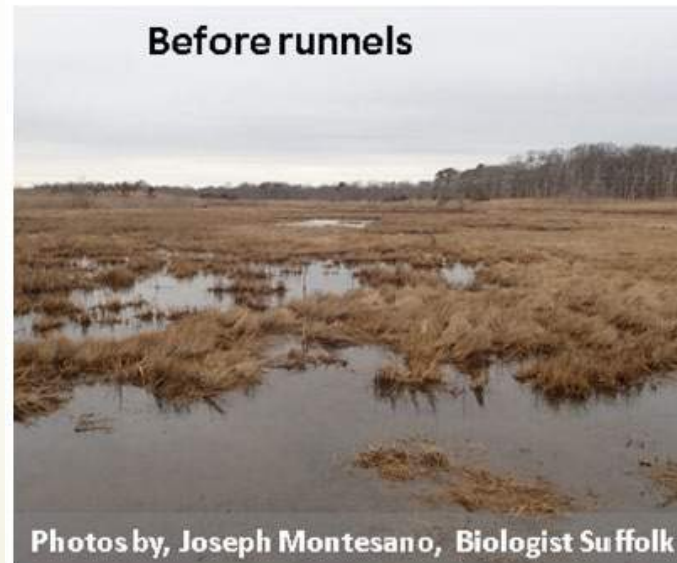
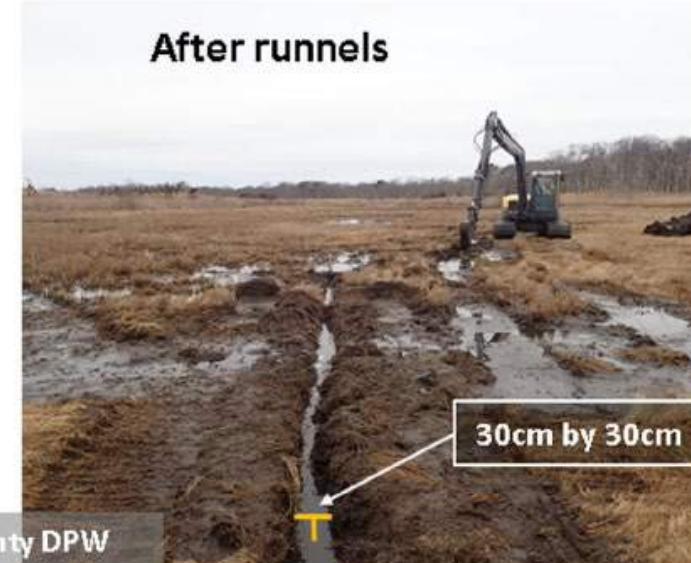
## ▶ Runneling

- ▶ Small channel (generally  $\leq 30$  cm wide and deep) that drains standing water on the marsh surface
- ▶ Constructed using hand-digging and/or low-ground\_pressure excavators or ditchers
- ▶ Vegetation recover within 3-5 years (Perry et al. 2021)

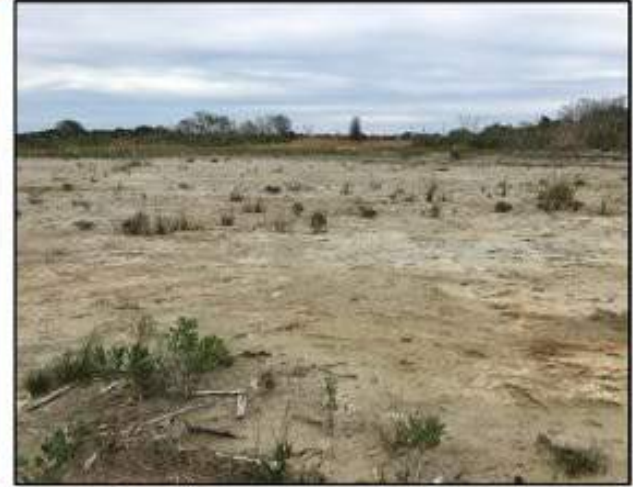
**C** 1 growing season

**D** 2 growing seasons

- Mow salt marsh perennial grasses from one or both sides of the treatment ditch
- Allow hay to air dry for 24 h prior to loosely braiding
- Fill ditch with 15–20 cm hay layer
- Lightly compact by foot
- Secure to the ditch bottom with twine and softwood grade stakes

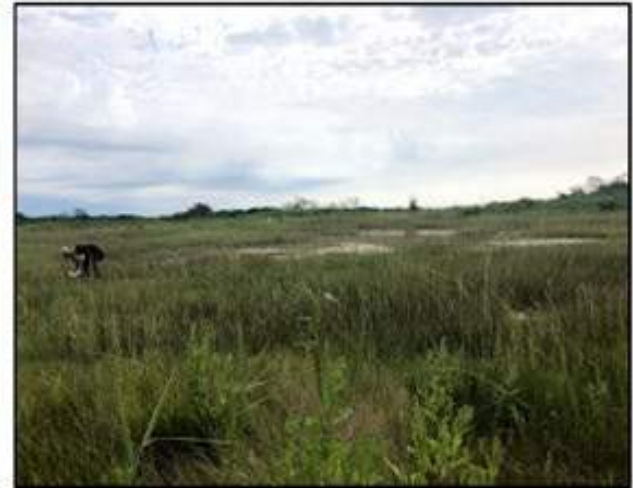
**F** 4 growing seasons
