# **Monitoring and Analysis of Eight Salt Marsh Tidal Restoration Projects on Cape Cod, Massachusetts**

**May 2024**

Prepared by: Association to Preserve Cape Cod

Prepared for: Massachusetts Division of Ecological Restoration

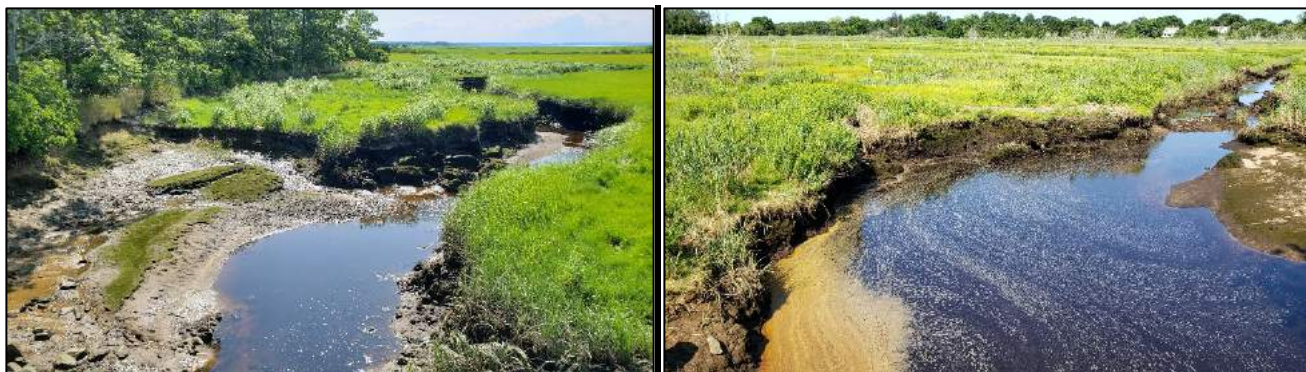
Reference marsh (left) and study marsh (right) photos taken on July 25, 2019.

During the 2019 field visit, erosion was observed along the tidal creek near the culvert in the reference and study marshes. Slumping was also observed in the reference marsh along the tidal banks farther away from the culvert. Additionally, clumps of peat were washed up on the surface of the study marsh with *S. alterniflora* growing on them, suggesting that the peat clumps eroded from the banks and floated onto the surface of the marsh during a high tide (for more details regarding the 2019 site visits, see Appendix E).

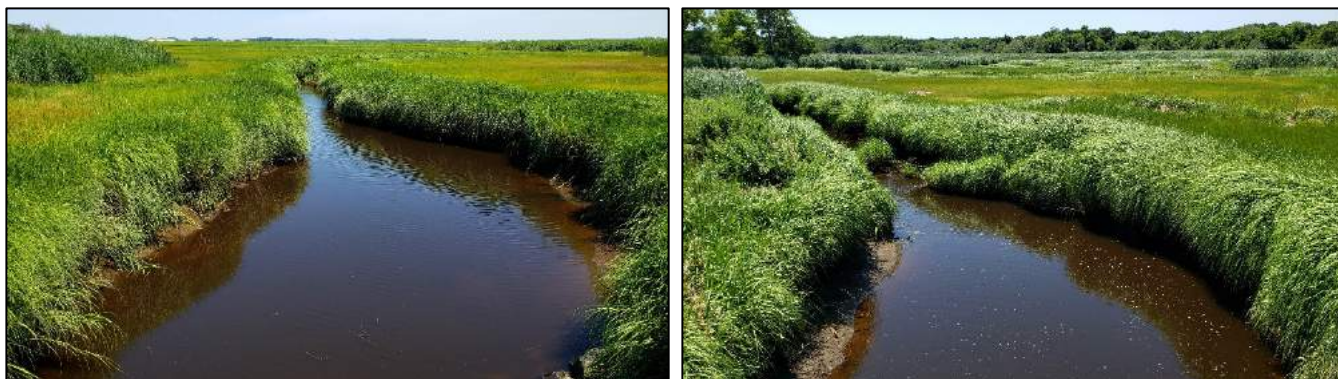
Reference marsh (left) and study marsh (right) photos taken on July 25, 2019.

In 2019, APCC staff noted that both concrete box culverts under Route 6A and the train tracks were in good condition and showed no signs of degradation. There were also no signs of erosion along the creek edges of the reference or study marshes (for more details regarding the 2019 site visits, see Appendix E).

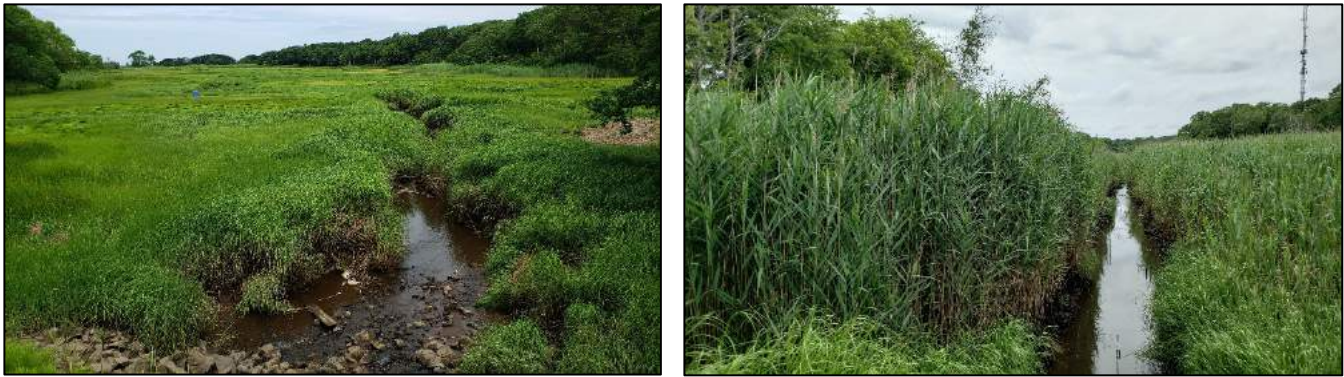
Reference marsh (left) and study marsh (right) photos taken on July 24, 2019.

Between 2007 and 2011, there were no significant trends in any of the plant community types within the reference marsh. During the 2019 site visit, there was a build-up of wrack observed along the upland transition edge of the eastern side of the reference marsh. There was also noticeable bank slumping and some erosion on the reference side of the marsh. Most of the erosion was observed at the bends in the tidal creek.

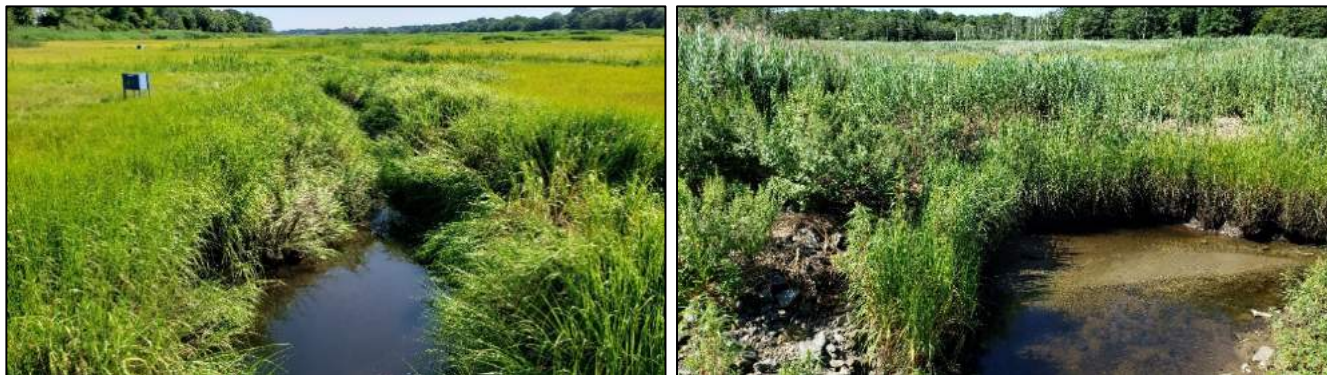
Reference marsh (left) and study marsh (right) photos taken on August 15, 2019.

During the 2019 field visit, APCC staff noted that *Phragmites* was still limited in its distribution to upland transition areas at the edges of the reference marsh. Also, *Phragmites* within the study marsh was still present in similar locations and approximately the same height. These observations corroborate the trends analysis which showed no change in *Phragmites* at Quivett. APCC staff also noted that although the box culvert appeared in good condition, there were three boards in place across the top of the culvert. Additional details from the 2019 site visit are available in Appendix E.

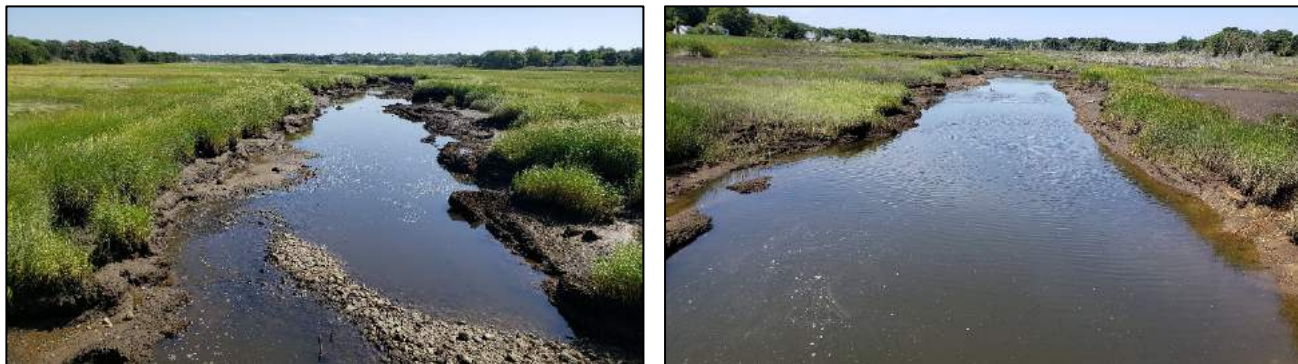
Reference marsh (left) and study marsh (right) photos taken on August 20, 2019.

Observations from the 2019 field site visit included a note regarding the culvert, which was found to be in good condition and was not blocked by sediment or rocks. APCC staff noted that in both the reference and

study areas, the main creek channel appeared to have widened because of restoration (compared to photos from 2009), and there were also signs of erosion on the creek bank edges. Additional details from the 2019 site visit are available in Appendix E.

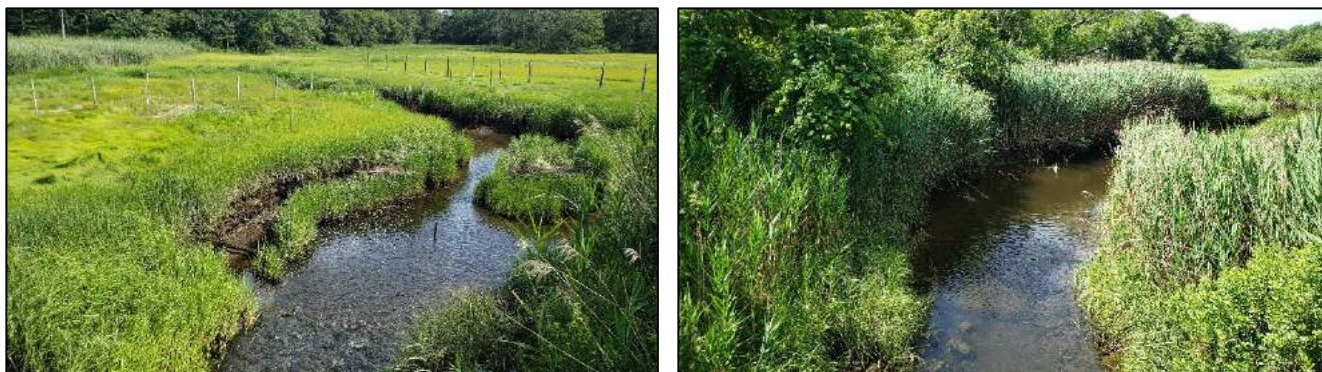
Reference marsh (left) and study marsh (right) photos taken on July 25, 2019.

During the 2019 site visit, APCC staff noted that the culvert opening for the restoration project appeared to be in good condition, but some stones along the edges of the culvert had slumped into the tidal creek. On the reference side, there were some areas where the creek appeared to be undercutting the banks and causing erosion. However, the creek banks on the study marsh did not appear to show signs of erosion or change. Additional details from the 2019 site visit are available in Appendix E.

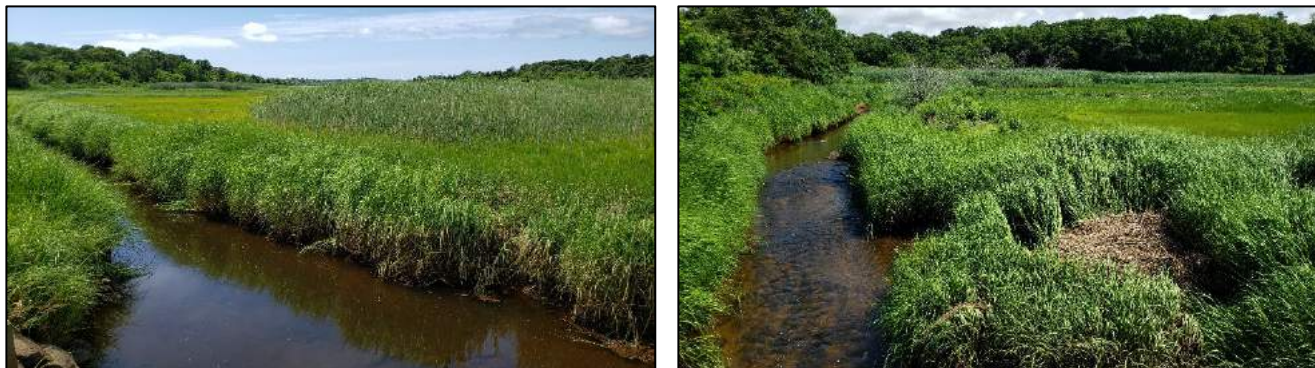
Reference marsh (left) and study marsh (right) photos taken on July 24, 2019.

During the 2019 field assessment visit, there was no visible evidence of bank erosion on the reference or study side of the marsh. The culvert was unblocked and in good condition. Additional details from the 2019 site visit are available in Appendix E.

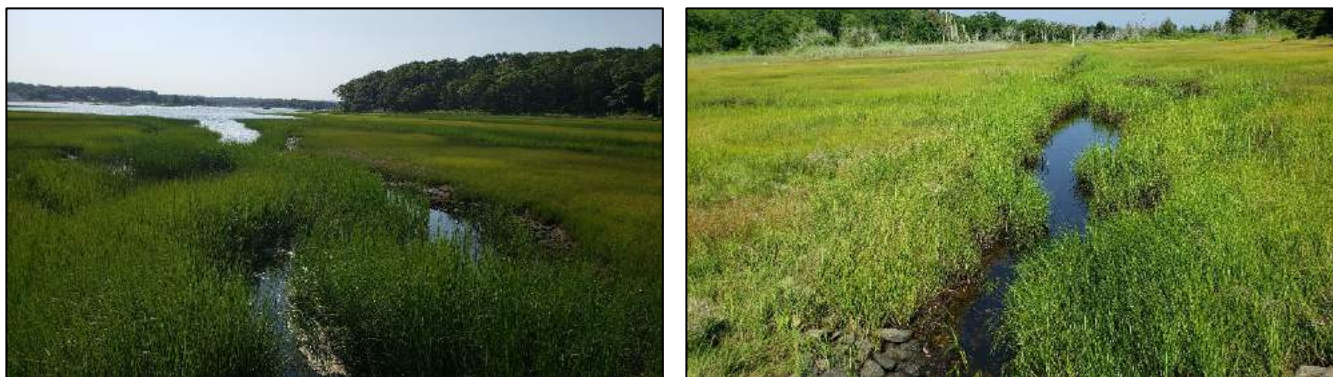
Reference marsh (left) and study marsh (right) photos taken on July 31, 2019.

During the 2019 site visit assessment, APCC staff noted that the edges of the tidal creek in the reference marsh had bare areas and the stems of *S. alterniflora* had a shredded appearance, which can be indicative of *Sesarma reticulatum* (purple marsh crab) herbivory. The study marsh also showed signs of dieback along the creek banks. Most of this dieback was located closer to the culvert and was not noted farther up the tidal creek. *Phragmites* was observed on the edges of the study marsh and did not appear to be expanding into the marsh interior. Additional details from the 2019 site visit are available in Appendix E.

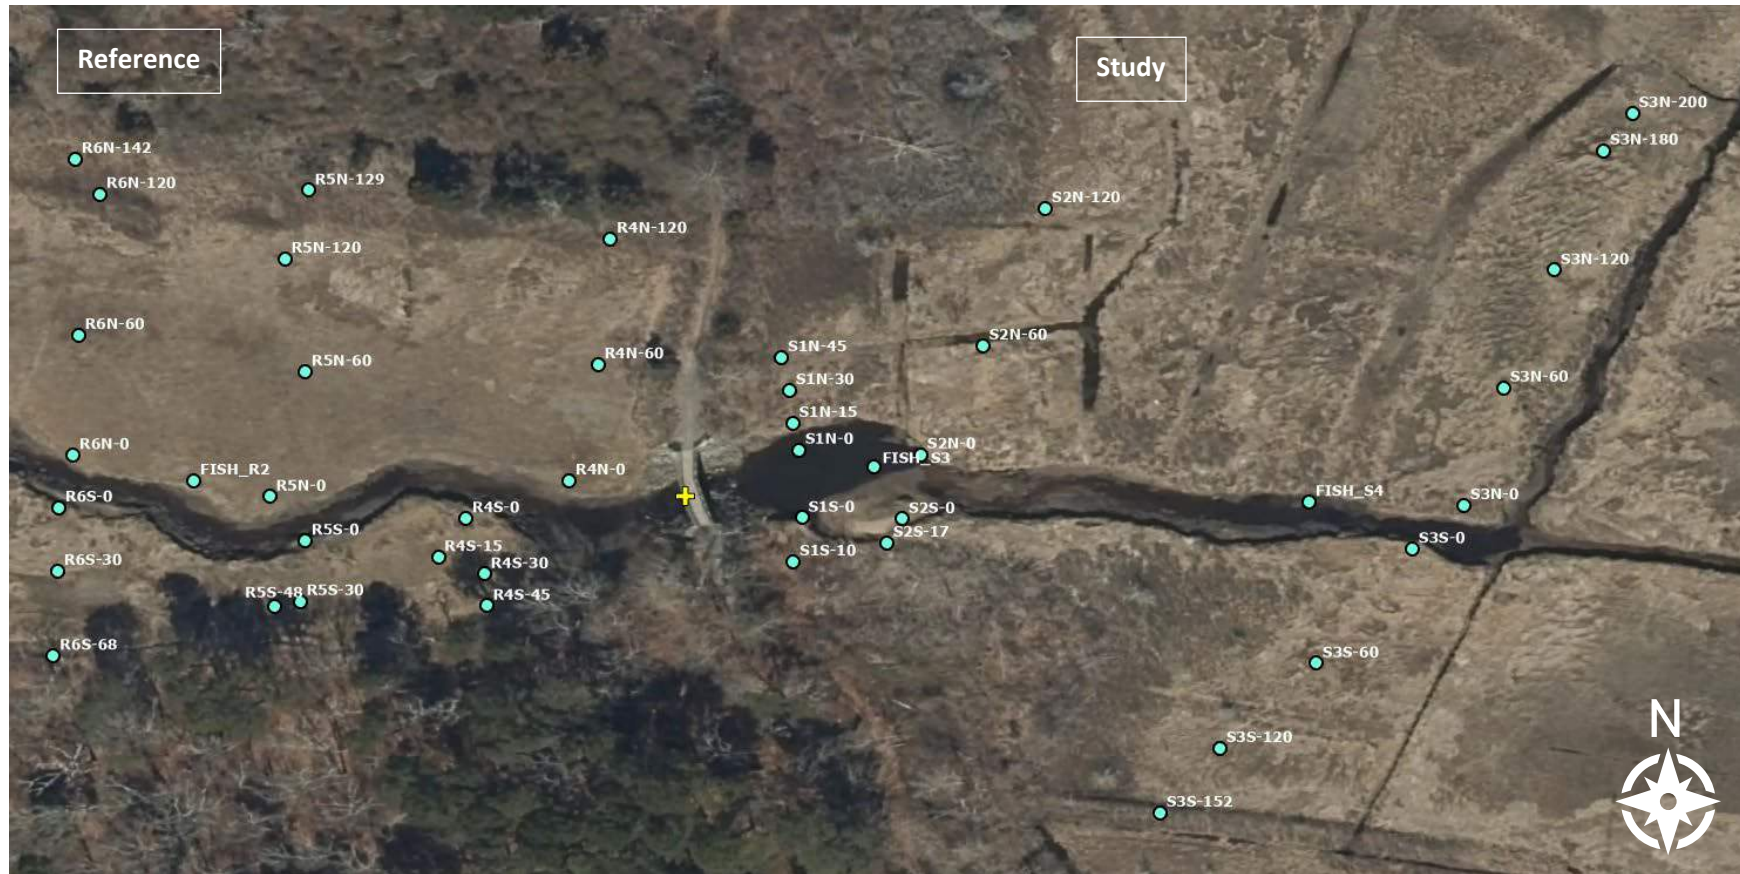
Figure A1: Vegetation plots at Bass Creek salt marsh restoration site in Yarmouth, MA. Yellow marker indicates location of former tidal restriction.

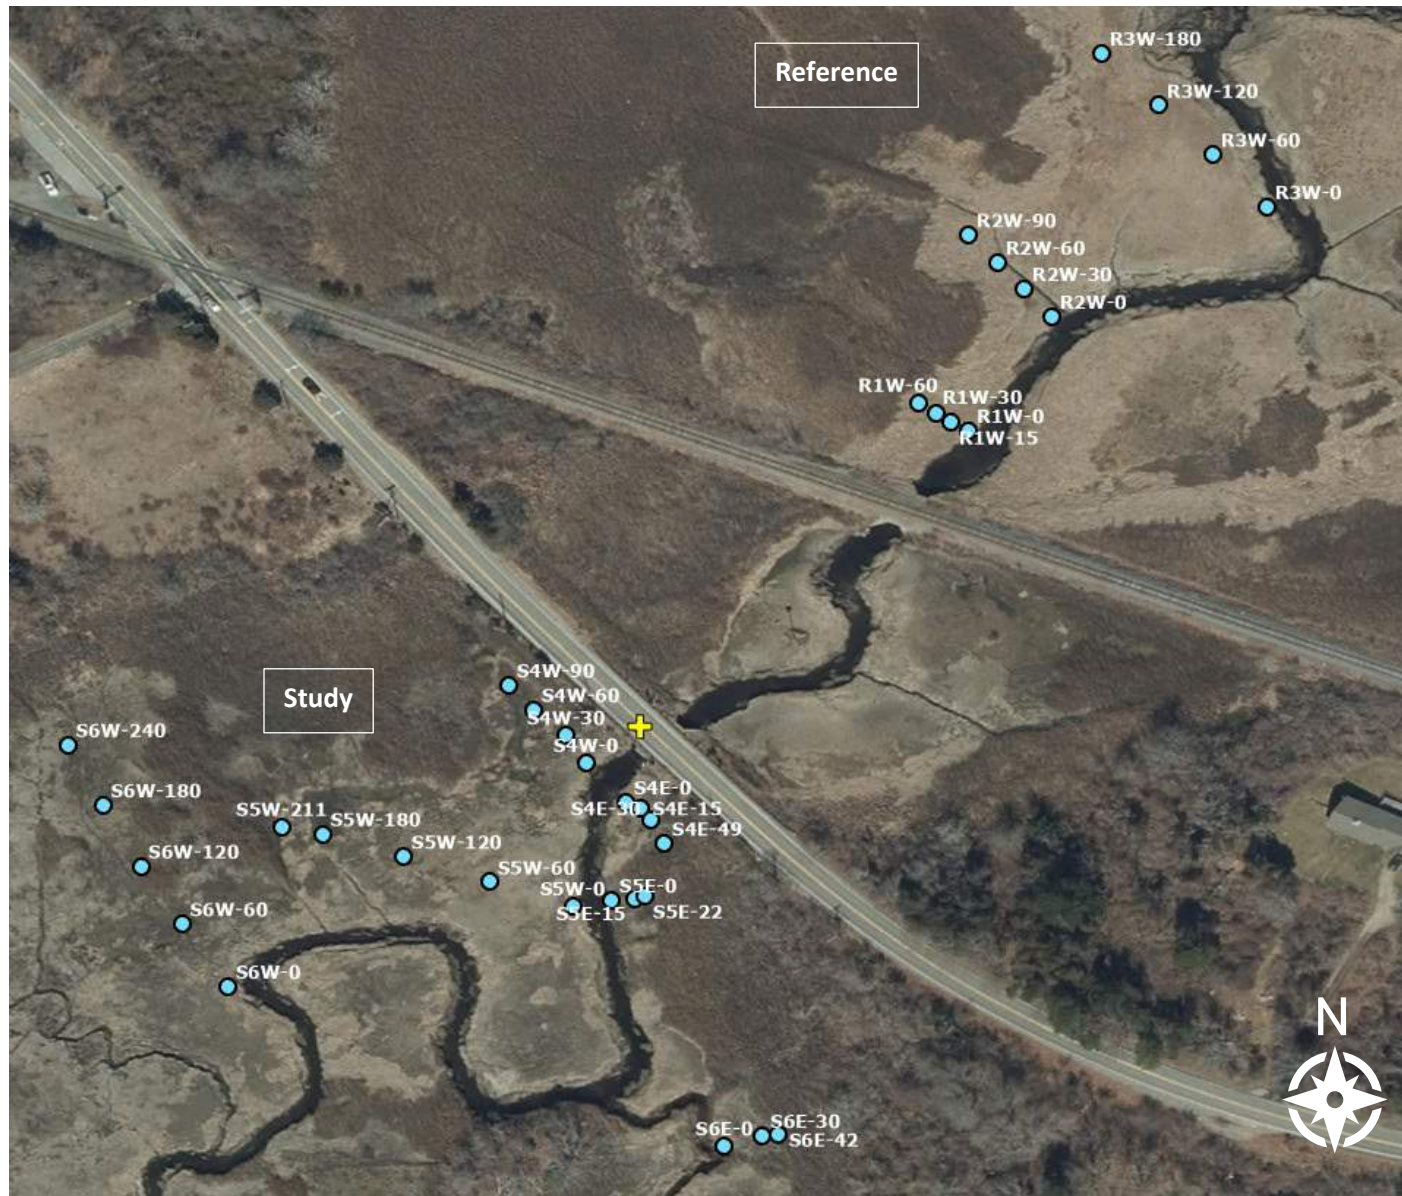
Figure A2: Vegetation plots at Bridge Creek salt marsh restoration site in Barnstable, MA. The yellow marker represents the former tidal restriction removed in 2005. The Bridge Creek restoration project occurred in two phases. In 2003 an under-sized culvert beneath an active railroad line was replaced. In 2005 an under-sized culvert beneath Route 6A was replaced. The restoration monitoring data presented in this report were collected for the second phase of the project.

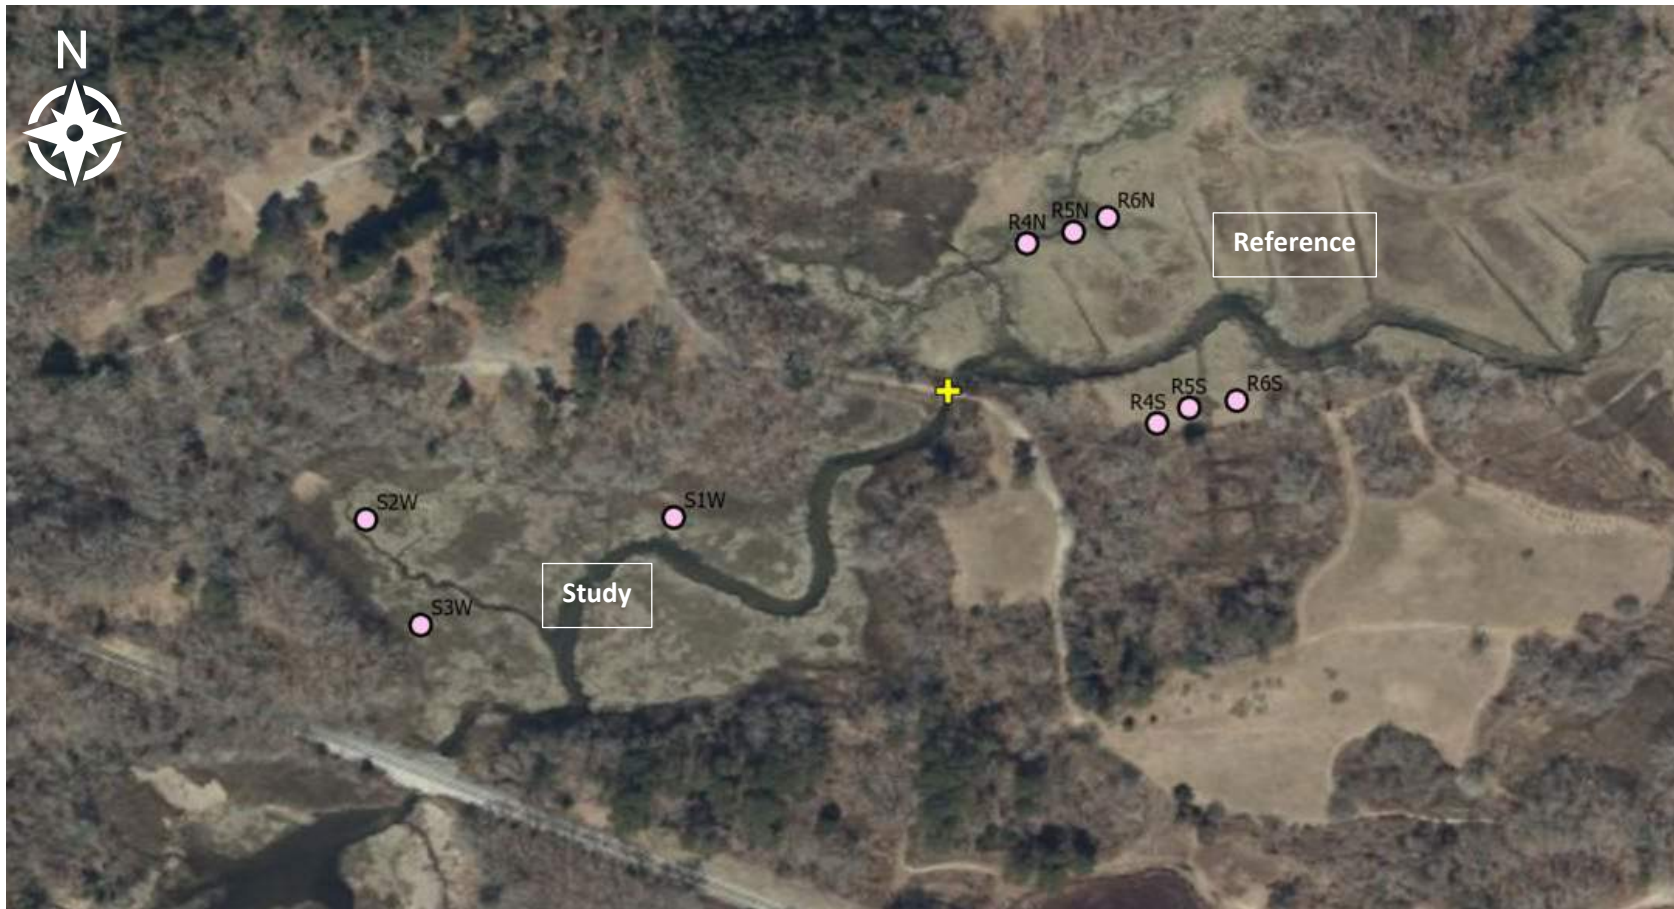
Figure A5: Starting point for each transect at State Game Farm in Sandwich, MA. The yellow marker represents the former tidal restriction. Note: plot points are unavailable.

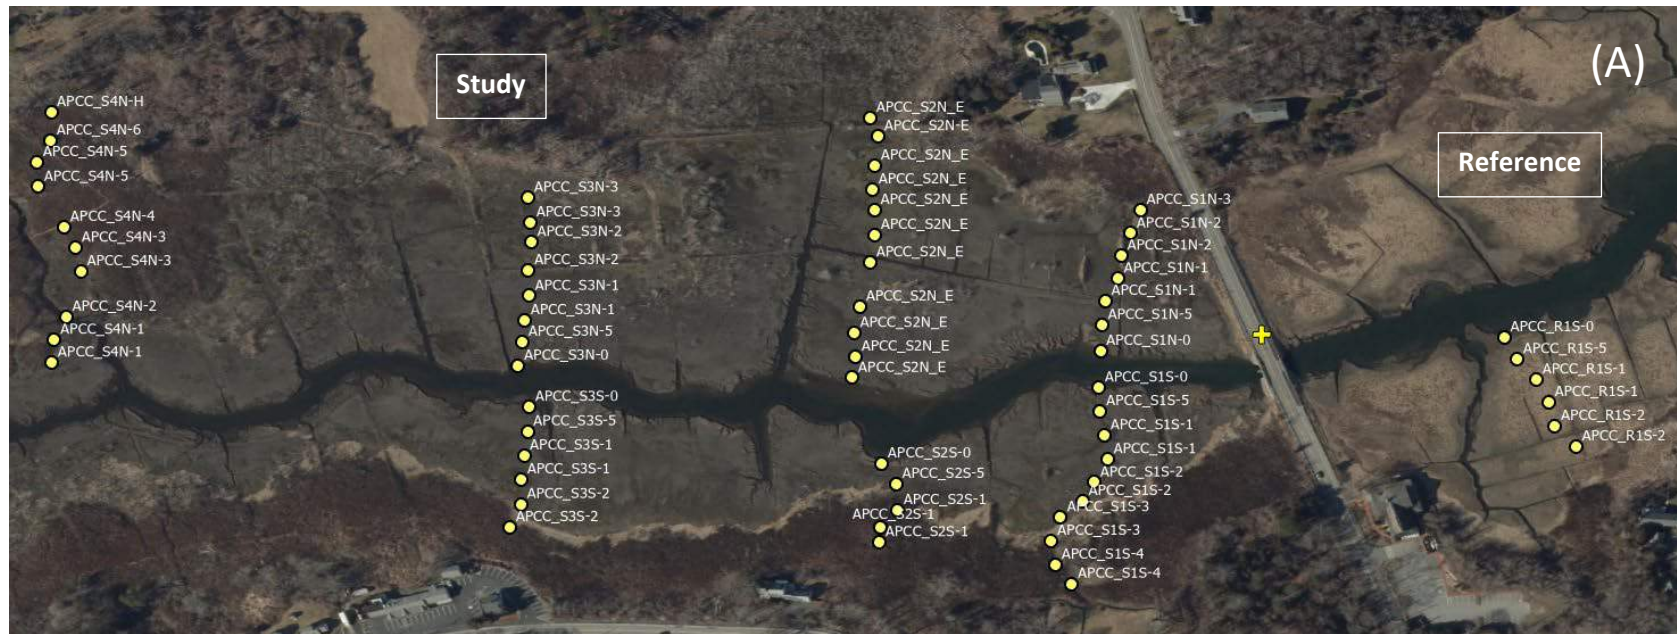
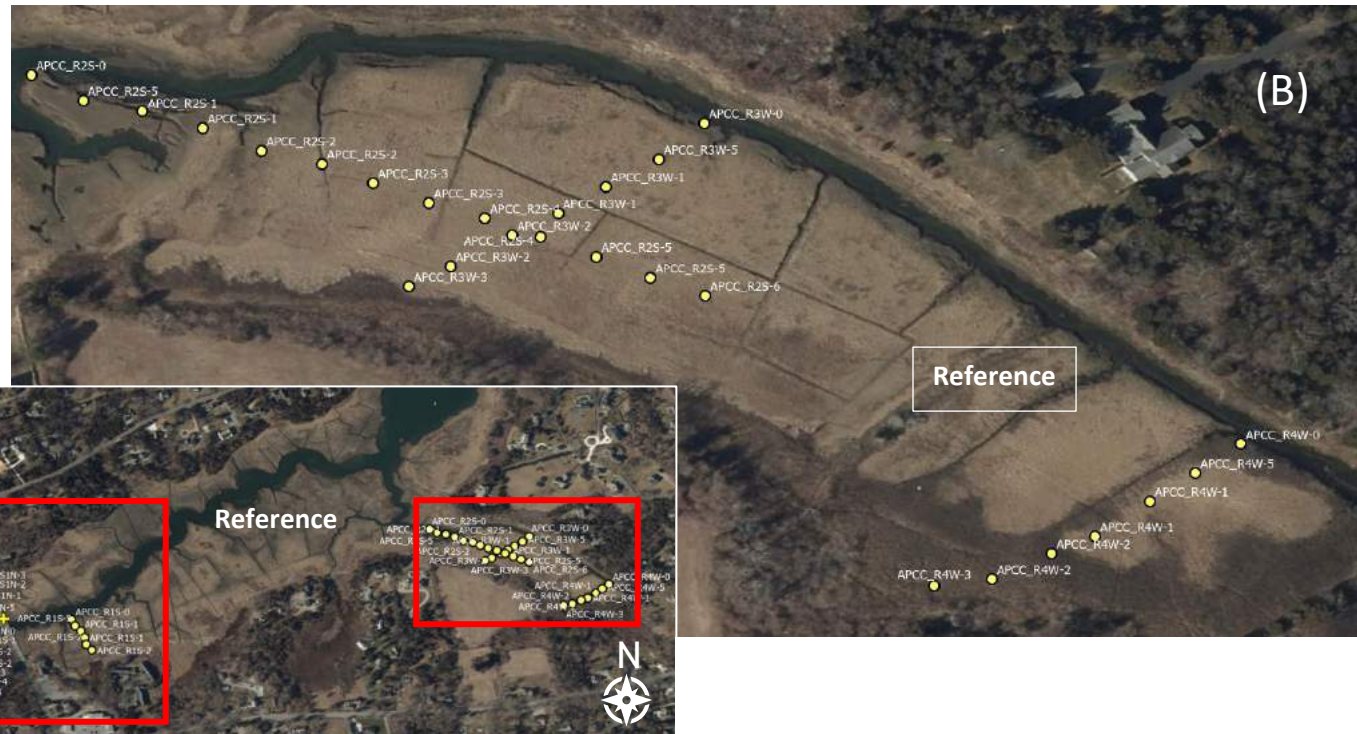
Figure A6: Vegetation plots at Sesuit Creek salt marsh restoration site in Dennis, MA. The yellow marker (+) represents the former tidal restriction. A: western extent; B: eastern extent; C: overview. Transect R2S was not monitored consistently over time; some years not included in analysis.

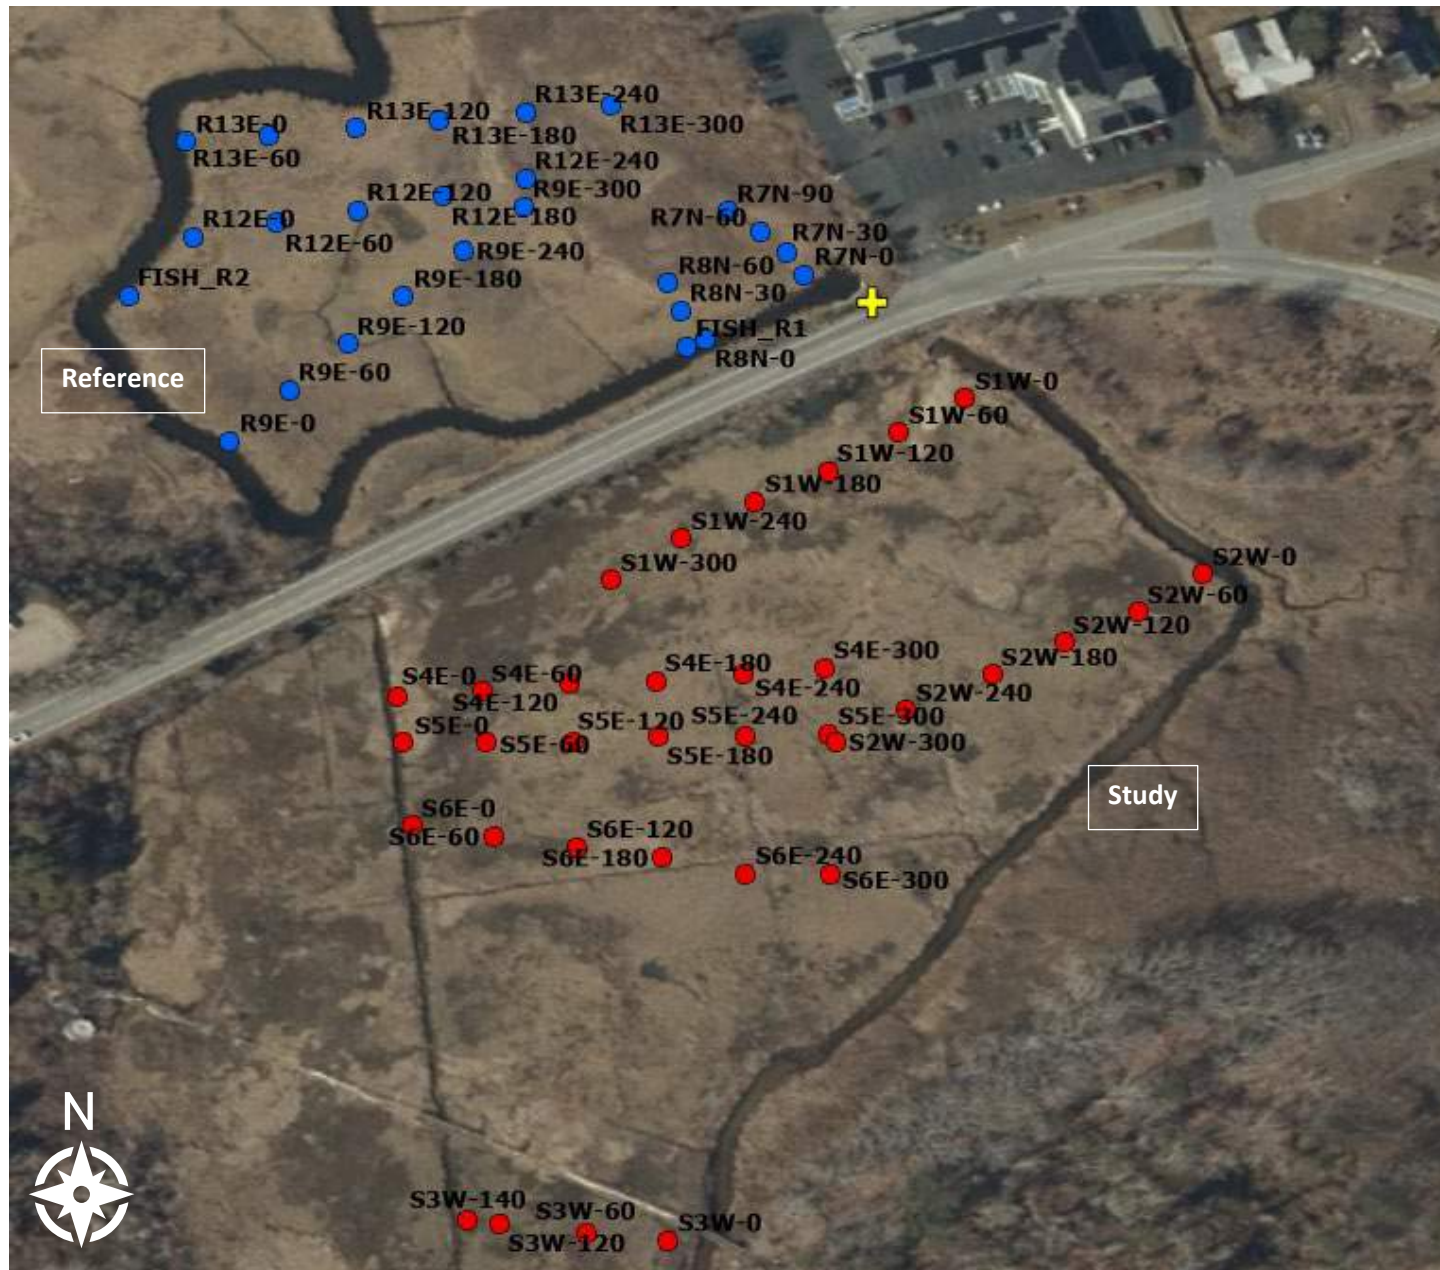
Figure A7: Starting point for each transect at Stony Brook in Brewster, MA. The yellow marker represents the former tidal restriction.

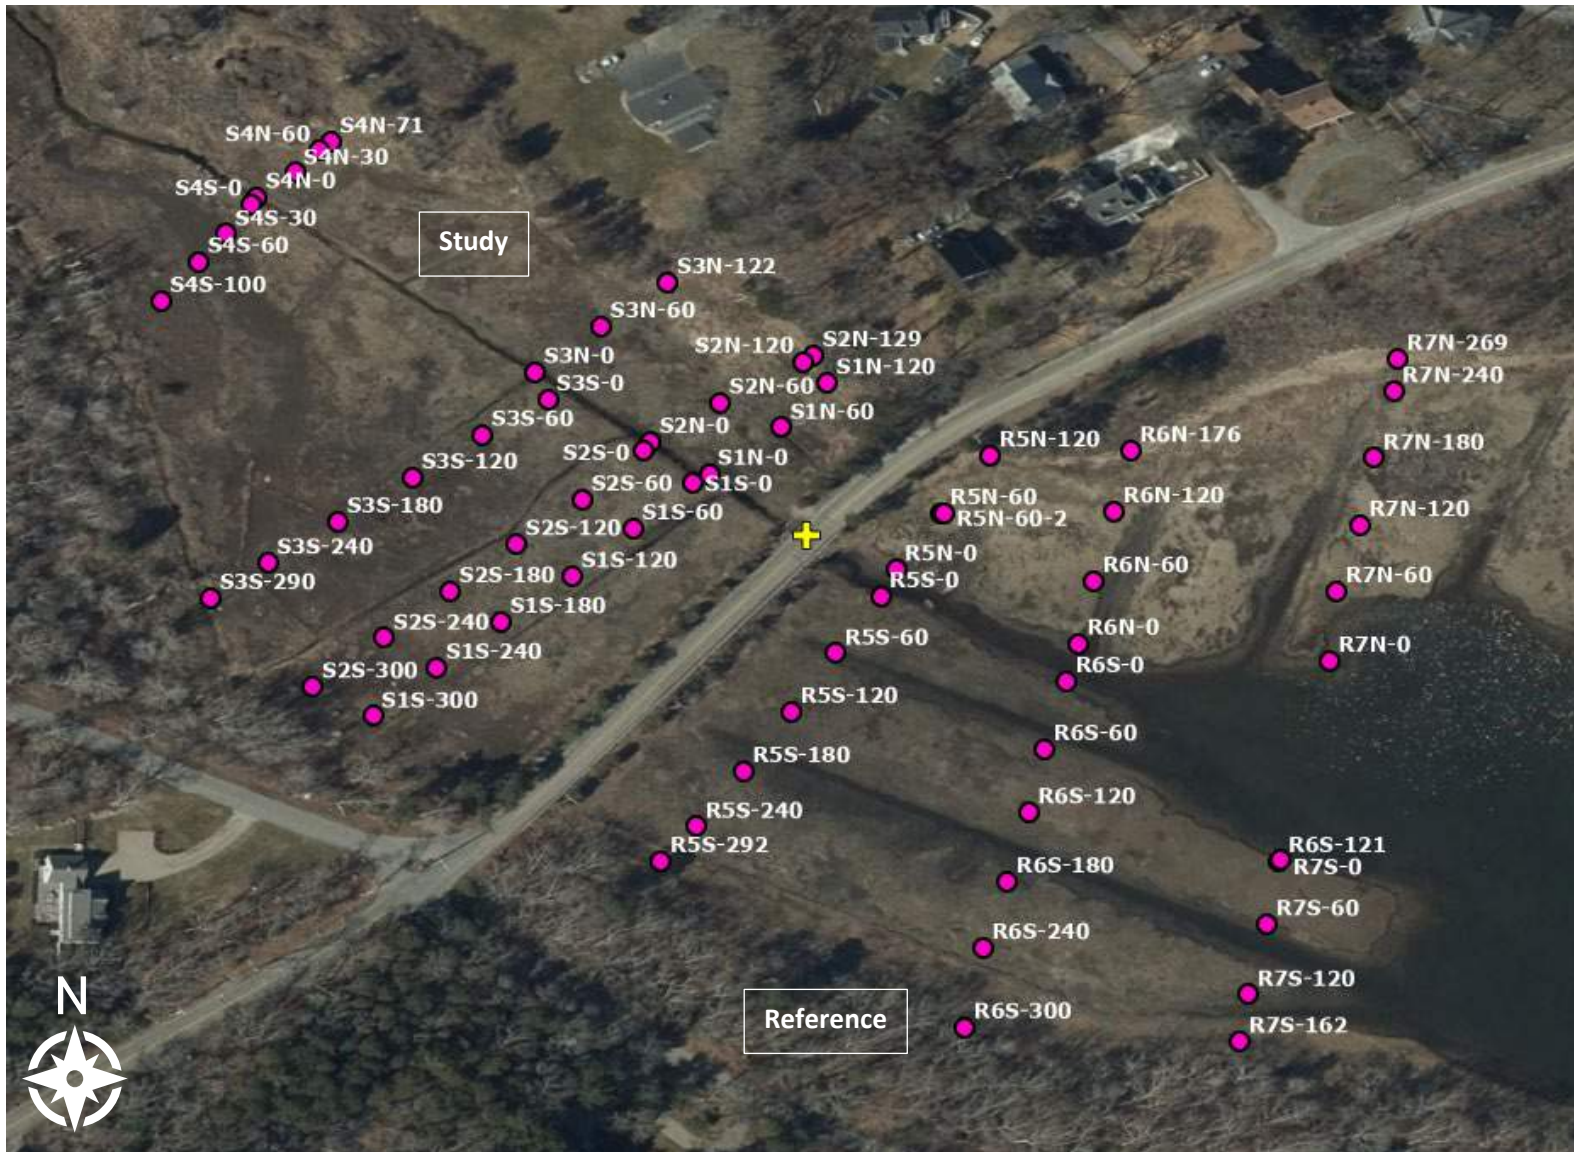
Figure A8: Starting point for each transect at Wings Neck in Bourne, MA. The yellow marker represents the former tidal restriction.

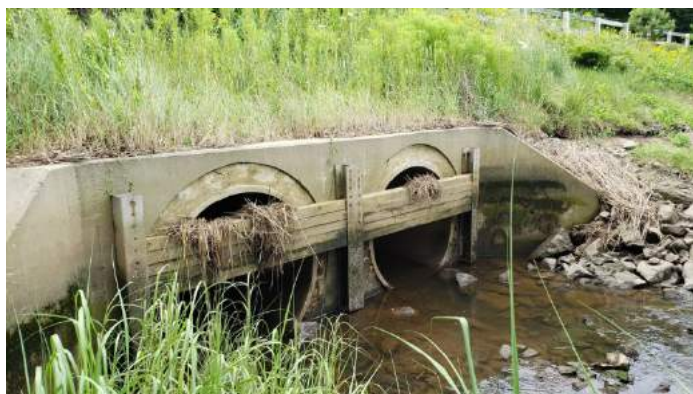
No stakes were found along transects R6W, R6E, and R7E. There was noticeable evidence of bank slumping and some erosion on the reference side of the marsh. Most of the erosion was observed at the bends in the tidal creek. Based on data from monitoring up to 2011, many of the halophytes seem to be unchanged on

the reference side, and there was a healthy middle to high marsh plant community growing on the reference side. Native *Phragmites* was found on the western side of the reference marsh during past mapping efforts. Two river otters were observed in the tidal creek on the reference side. Also, salt reedgrass (*Spartina cynosuroides*) was growing along transect R6E. Ten boards were blocking the two circular culverts (five boards on each culvert) which appeared to be reducing the tidal flow during high tide into the restored side of the marsh (see photo).
