## **Vulnerability Assessment of Chase Garden Creek**

Year 1 Annual Report: March 2023 – January 2024

Association to Preserve Cape Cod

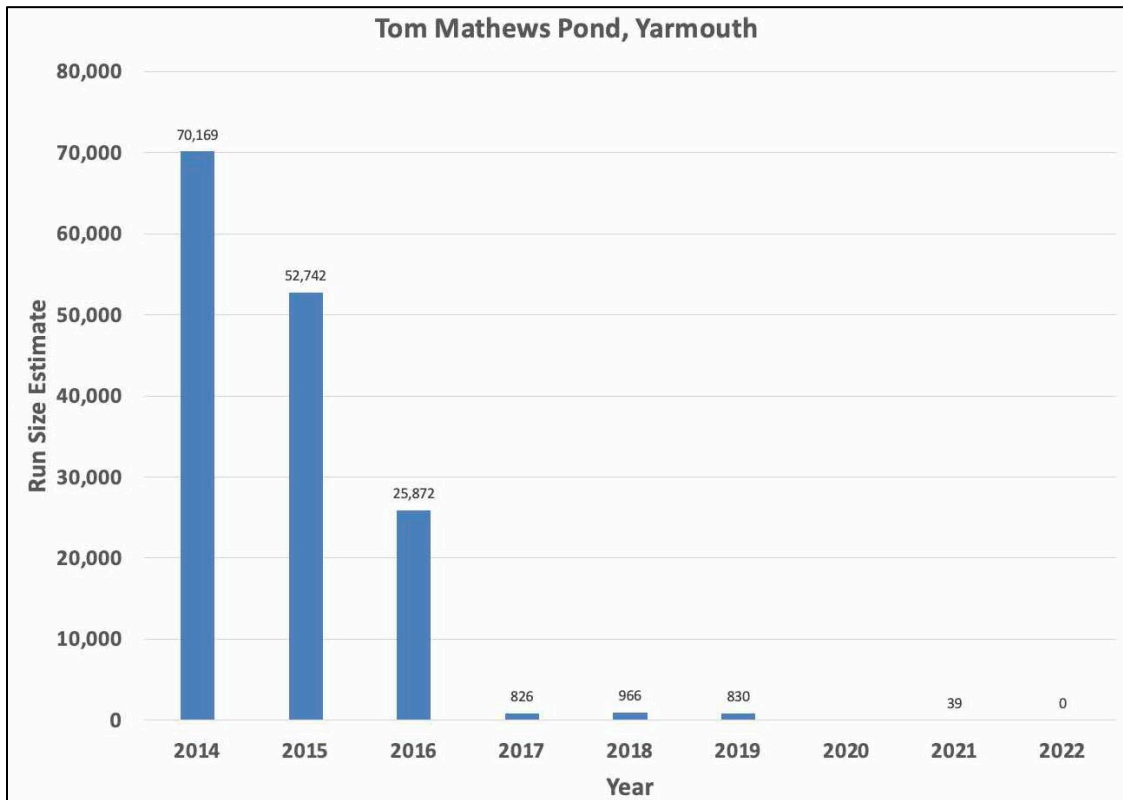
Figure 4: Estimated herring run sizes based on volunteer counts of river herring. Volunteers collected herring counts and the Division of Marine Fisheries calculated estimated run sizes. Data are from APCC’s Herring Monitoring Program for Tom Mathews Pond.

The Massachusetts Division of Marine Fisheries (DMF) conducted a 2012-2013 analysis of the fish passage and water quality at Tom Mathews Pond, which drains to Chase Garden Creek via White’s Brook (Archer and Chase, 2022). This study indicated that water quality parameters were outside of the acceptable criteria range for river herring during the spawning period of May-September for temperature, pH, total nitrogen and phosphorous, and stream flow. During the same timeframe, the degraded state of the fish ladder, which was deemed impassable for migrating adults on several occasions during the spawning and nursery periods in 2012-2013, prompted the replacement of the fish ladder in 2014. APCC also conducted volunteer herring counts from 2014 to 2022, partnering with the pond’s landowner (Bass River Rod & Gun Club). While the herring run estimate was over 70,000 in 2014, estimates began to decline rapidly thereafter, despite the replacement of the fish ladder in 2014 (Figure 4). The continued decline of herring counts since 2014 indicated that water quality issues may be preventing herring migration to and from Tom Mathews Pond (Archer and Chase, 2022). Thus, Tom Mathews Pond was identified as an impaired habitat for river herring and American eel in 2022. Herring counts were discontinued in 2023 in order for planned restocking of river herring to “restart the run.” If restocking was in fact accomplished in 2023, volunteer herring counts may resume in 2024 to document whether restocking succeeds in restarting the run (J. Muramoto, personal communication from Bass River Rod & Gun Club).

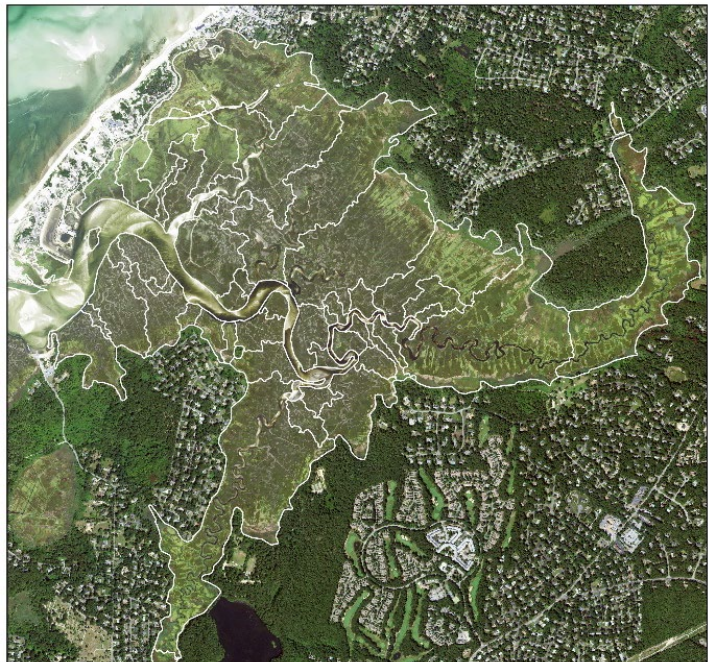
Figure 5: Aerial imagery of Chase Garden Creek showing the individual tidesheds obtained through the United States Geological Survey (Ackerman et al., 2021).

APCC completed a landscape-scale assessment of the Chase Garden Creek salt marsh using GIS-based mapping software. APCC applied an unvegetated to vegetated ratio (UVVR) analysis. This is a broad-scale method used to assess sea level rise vulnerability of each salt marsh tideshed, defined here as an area of marsh which floods and drains as one unit. The tideshed GIS layer used for the APCC analysis was obtained from a collaborative project led by the United States Geological Survey and MA Office of Coastal Zone Management (Ackerman et al., 2021; Figure 5).

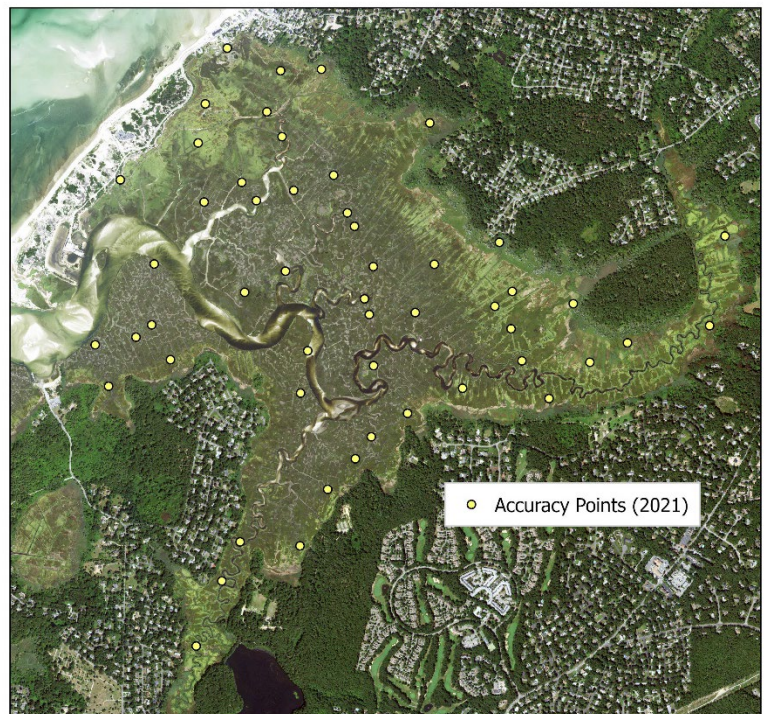
Figure 8: Map of Chase Garden Creek salt marsh showing randomized accuracy assessment points generated by tool in ArcGIS Pro.

Another part of the McKown and Burdick (2023) protocol involves generating an accuracy assessment of the unvegetated and vegetated classification. This is an important step to judge the accuracy of the ArcGIS Pro tool in discerning the different pixel assemblages between these two cover types. In order to complete this step, APCC utilized tools available in ArcGIS Pro to create randomized points for testing accuracy (Figure 8). Since ground-truthing the 2018 and 2021 field conditions was not an option, these points were analyzed using the NAIP and most recent aerial imagery (ortho-imagery downloaded from MassGIS). Each point was reviewed individually by APCC staff and placed in a cover type category (vegetated or unvegetated). After identifying the cover type, the tool provides a Confusion Matrix table (Table 1) including a Kappa Coefficient which can be used to assess the overall accuracy of the output. This step was completed for the 2016 and the 2021 imagery classifications.

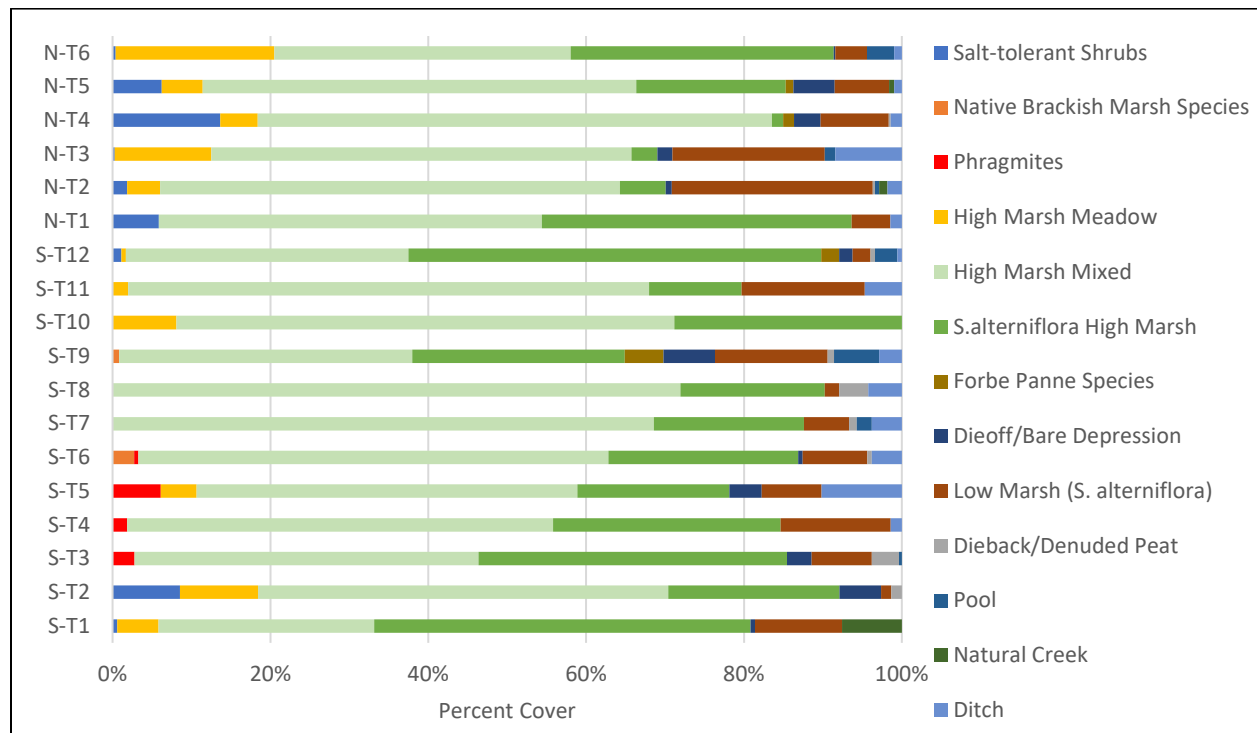
The plant species community results from the MarshRAM assessment conducted at the Chase Garden Creek salt marsh are provided in Figure 12. The most prevalent species community observed was “mixed high marsh” which included high marsh species, such as *Spartina patens*, *Distichlis spicata*, and *Juncus gerardii*, combined with short-form *Spartina alterniflora*. The second most prevalent community was “*S. alterniflora* high marsh,” a monoculture of the short-form variety of this species. Finally, “low marsh,” or zones dominated by tall-form *S. alterniflora*, were observed frequently as well. These three community types are indicative of frequently inundated zones, probably flooded on a daily or twice daily basis. Where *S. alterniflora* grows to the taller variety, these areas of the marsh are well-drained during low tide. However, where *S. alterniflora* is stunted (short-form variety) this indicates that the soil, or peat, stays fully saturated even when the tide is low creating a low-oxygen environment which is more stressful for the plant as it has a harder time absorbing oxygen from the roots. Taken together, the overall results indicate that the marsh area nearest the upland, and therefore highest in elevation, was low in the marsh tidal range and flooded regularly.

Figure 12: Results from the salt marsh rapid assessment method (MarshRAM) survey conducted at Chase Garden Creek showing the percentage of each plant community observed along each transect.

By comparing the different transects, several key distinctions can be seen across the various areas of marsh (Figure 12). First, the northern transects (N-T1 through N-T6) were comprised of more salt-tolerant shrubs, mainly *Iva frutescens*, and had greater percentages of “high marsh meadow” than the other areas of marsh. Second, the non-native variety of *Phragmites australis* was observed at the upper end of several of the southern transects (S-T3 through S-T6). *Phragmites australis* is common at the upland marsh edge where the fresher groundwater is accessible and saltwater flooding is more limited. Lastly, S-T7 through S-T9 were among the shortest transects due to the smaller width of marsh in this area and did not contain any higher marsh zone communities, such as “high marsh meadow” or “salt-tolerant shrubs.”

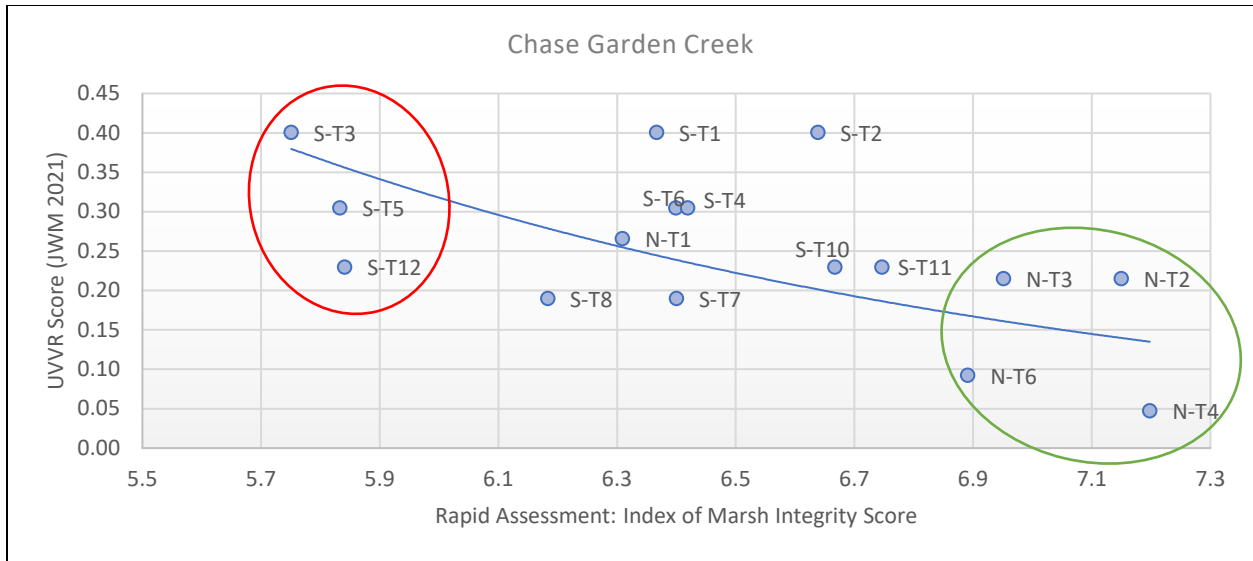
The results from the MarshRAM survey generally corroborate the findings from the UVVR assessment such that the areas of the marsh with higher UVVR generally had lower IMI scores and vice versa (Figure 14).

Figure 14: Index of Marsh Integrity (IMI) plotted against the UVVR score for the corresponding tideshed in Chase Garden Creek salt marsh. Note: N-T5 and S-T9 UVVR not included because transect crossed multiple tidesheds. The red circle indicates sites with correlated results of poor integrity or high vulnerability across methods. The green circle indicates sites with similar results of high integrity and low vulnerability across the two assessment methods.

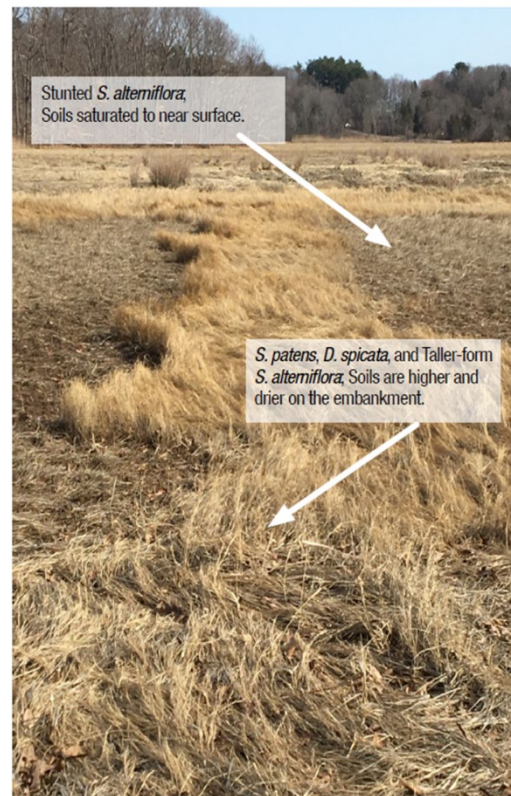
Figure 16: Image from Adamowicz et al. (2020) showing the impacts of historic embankments on salt marsh vegetation.

Second, ditch remediation is a method of filling ditches using natural salt marsh processes to restore groundwater table depths and reduce decomposition. Restoration practitioners mow salt marsh perennial grasses from one or both sides of the treatment ditch at the end of the growing season and fill the ditch with a 15–20 cm “hay” layer. The layer is lightly compacted and secured with fibrous twine and softwood stakes which will naturally biodegrade. This practice allows sediment and other particulates to accumulate in the ditch and research shows that plants will revegetate these areas within 3 years (Burdick et al., 2020).

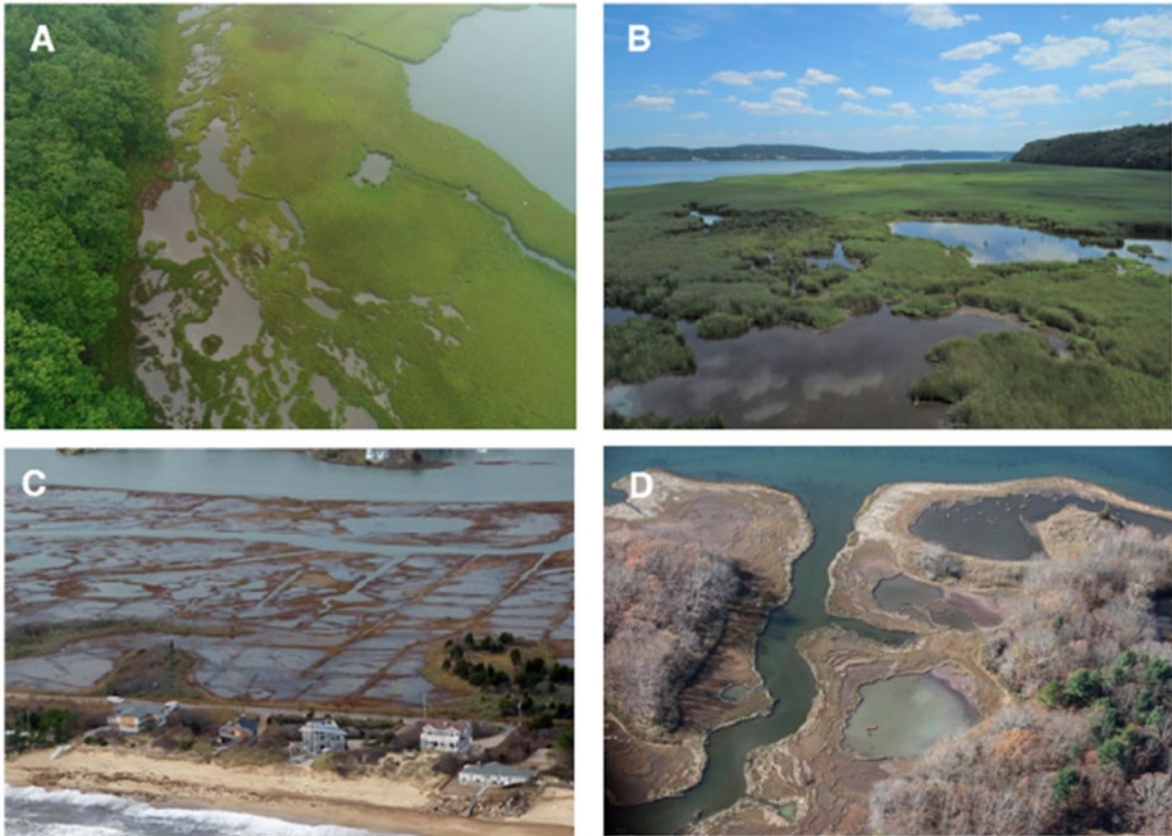
adapted to intermittent flooding. The resulting mortality of the plants leads to a scenario called “root collapse” whereby pore spaces in the roots, normally maintained by oxygen held in the root tissues, are lost producing a deflation in marsh elevation (DeLaune et al., 1994; Turner et al., 2004). This type of subsidence trajectory is often observed where man-made embankments (e.g., deposited ditching spoils, dikes, etc.) obstruct the outgoing tide (Figure 16). If the trajectory is not curtailed, large pools of water form on the marsh surface and expand over time (Watson et al., 2022, Figure 17).

Figure 17: Image from Watson et al. (2022) showing pools formed in various northeastern salt marshes of the USA due to the waterlogged subsidence trajectory.

In an attempt to reverse and eliminate subsidence trajectories from continuing to degrade New England salt marshes, wetland scientists have implemented various restoration strategies with promising results. First, runneling is the creation of small grooves in the marsh (generally  $\leq 30$  cm wide and deep) to drain standing water on the marsh surface. They are normally constructed using hand-digging and/or low-ground pressure excavators. Studies show that by implementing runnels, the vegetation recovers in these previously waterlogged areas within 3-5 years (Perry et al., 2021; Watson et al., 2022).
