Post-Restoration Vegetation and Water Level Monitoring Report

Post-Restoration, Year 1 (2025)

Hinckleys Pond – Herring River Headwaters Eco-Restoration Project
Jenkins Bog and Warner Bog
Harwich, Massachusetts

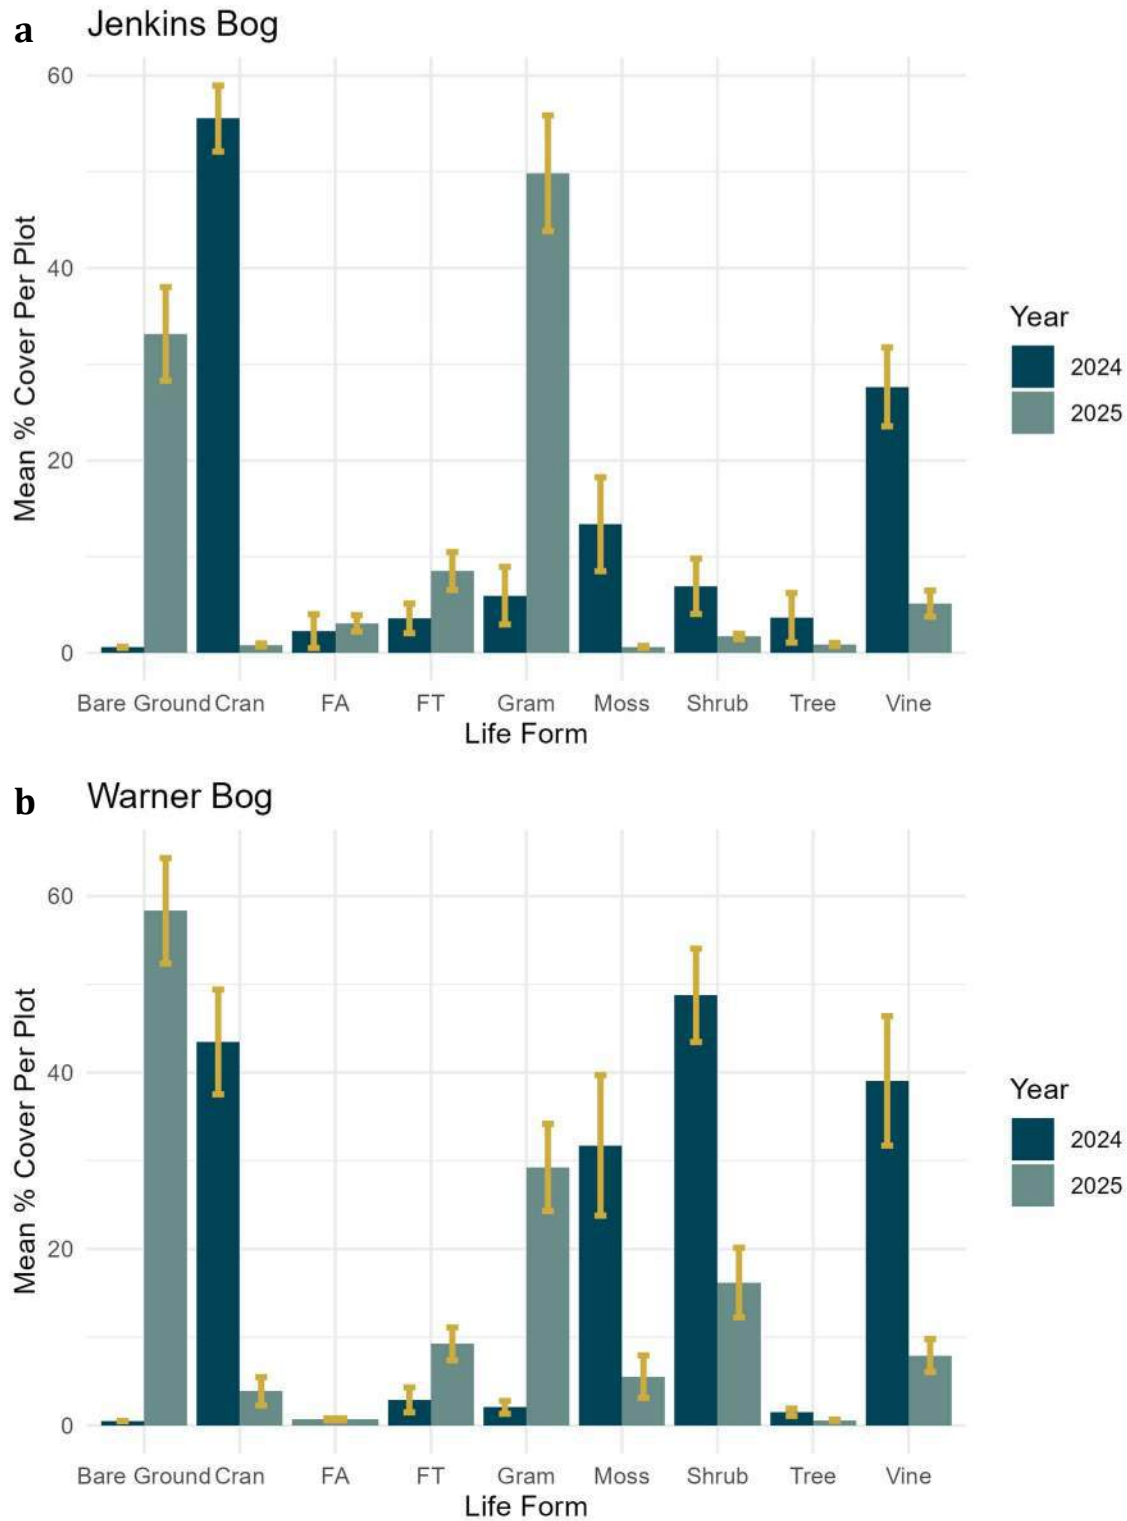
Figure 2. Mean per plot percent cover of plant life forms at (a) Jenkins and (b) Warner Bogs separated into years 2024 and 2025 for pre- and post-restoration. Gold bars show \pm the standard error. ‘Cran’ = cranberry; ‘gram’ = graminoid, ‘FT’ = forb terrestrial, ‘FA’ = forb aquatic.

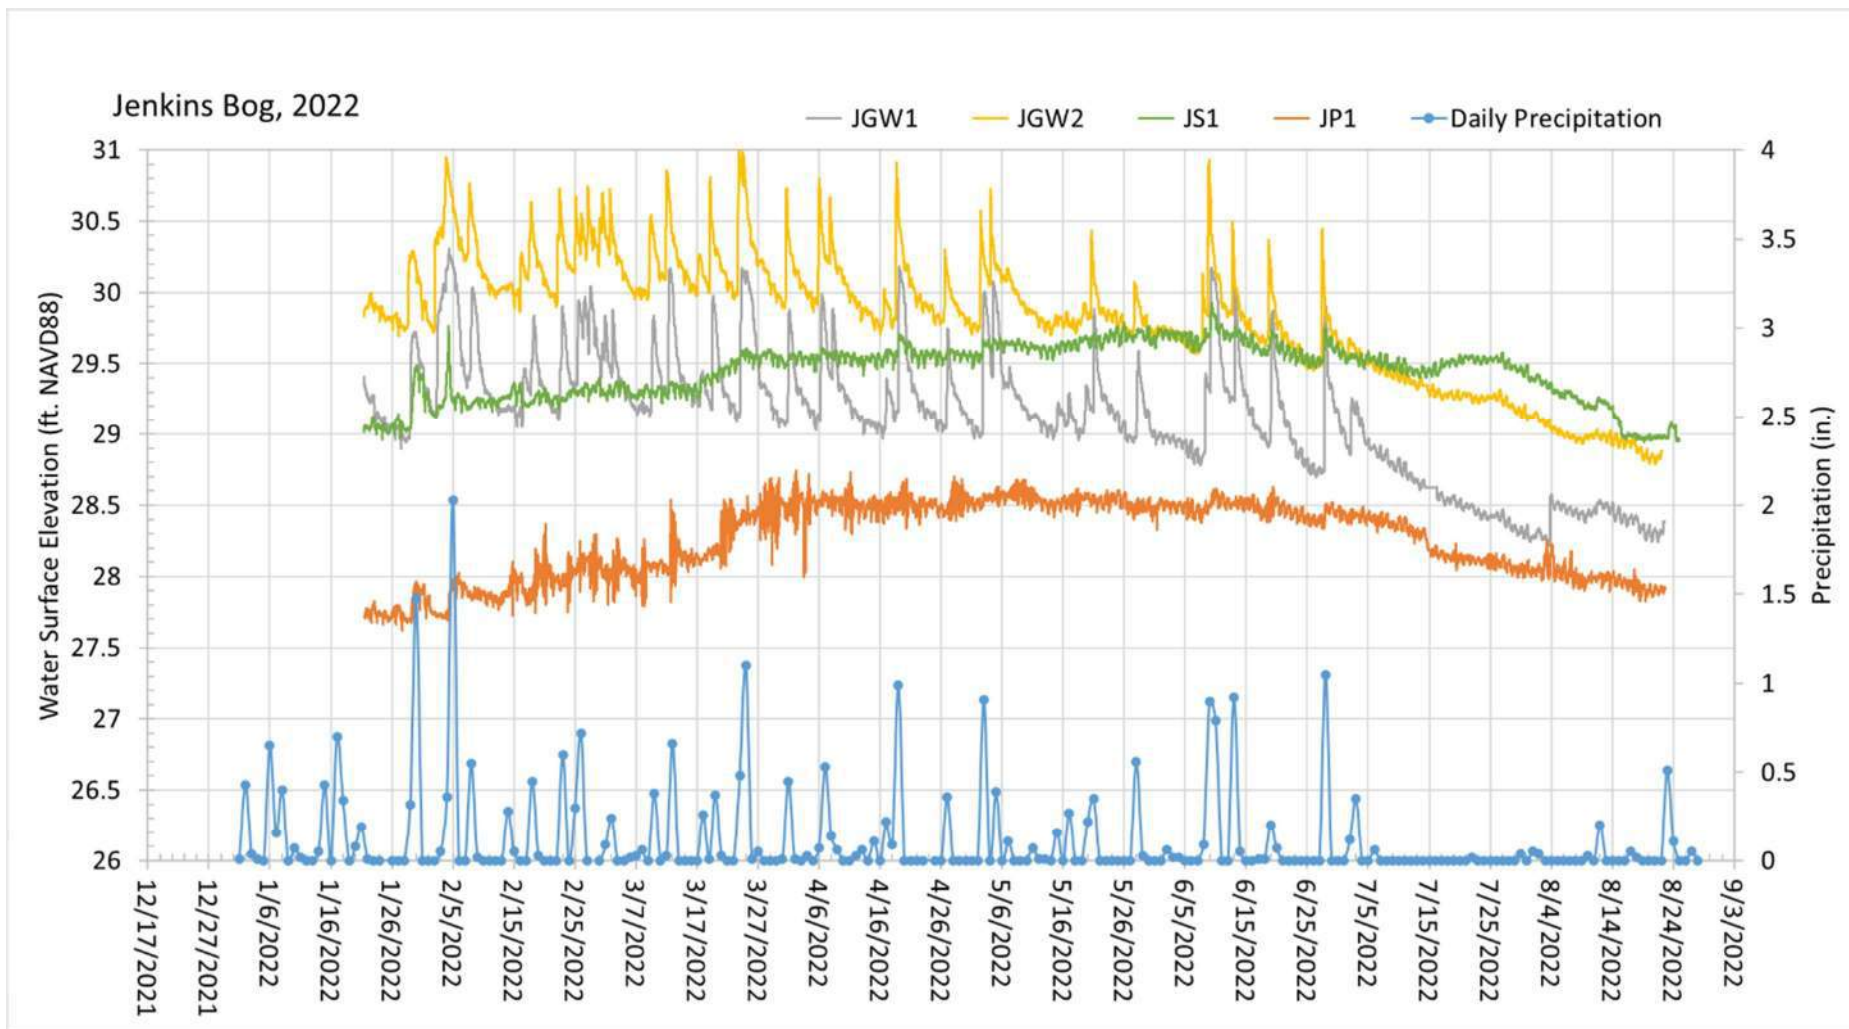
Figure 3. Water level data from Jenkins Bog, January-September 2022.

Results of the pre-restoration water level monitoring from January to September of 2022 can be found in Figure 3 and Figure 4. The pre-restoration water level monitoring reveals the range of water levels at the site as well as the responsiveness to precipitation, as the period of observation coincided with an unusually wet winter followed by a relatively dry spring that progressed into a severe drought during the summer. Surface water levels, the loggers placed in ditches (JS1 and WS1) and in Hinckleys Pond (JP1 and WP1), remain relatively consistent, fluctuating less than 0.5 feet due to precipitation events during the observation period. Groundwater (WGW1, JGW1, JGW2), on the other hand, fluctuates by as much as a foot in response to large precipitation events.

Even during a period of extreme precipitation variation, water levels at the site remained in a fairly tight band with water levels at Jenkins Bog ranging 1.5 to 2.0 feet and water levels in Warner Bog ranging 1.3 to 1.9 feet (Table 9).

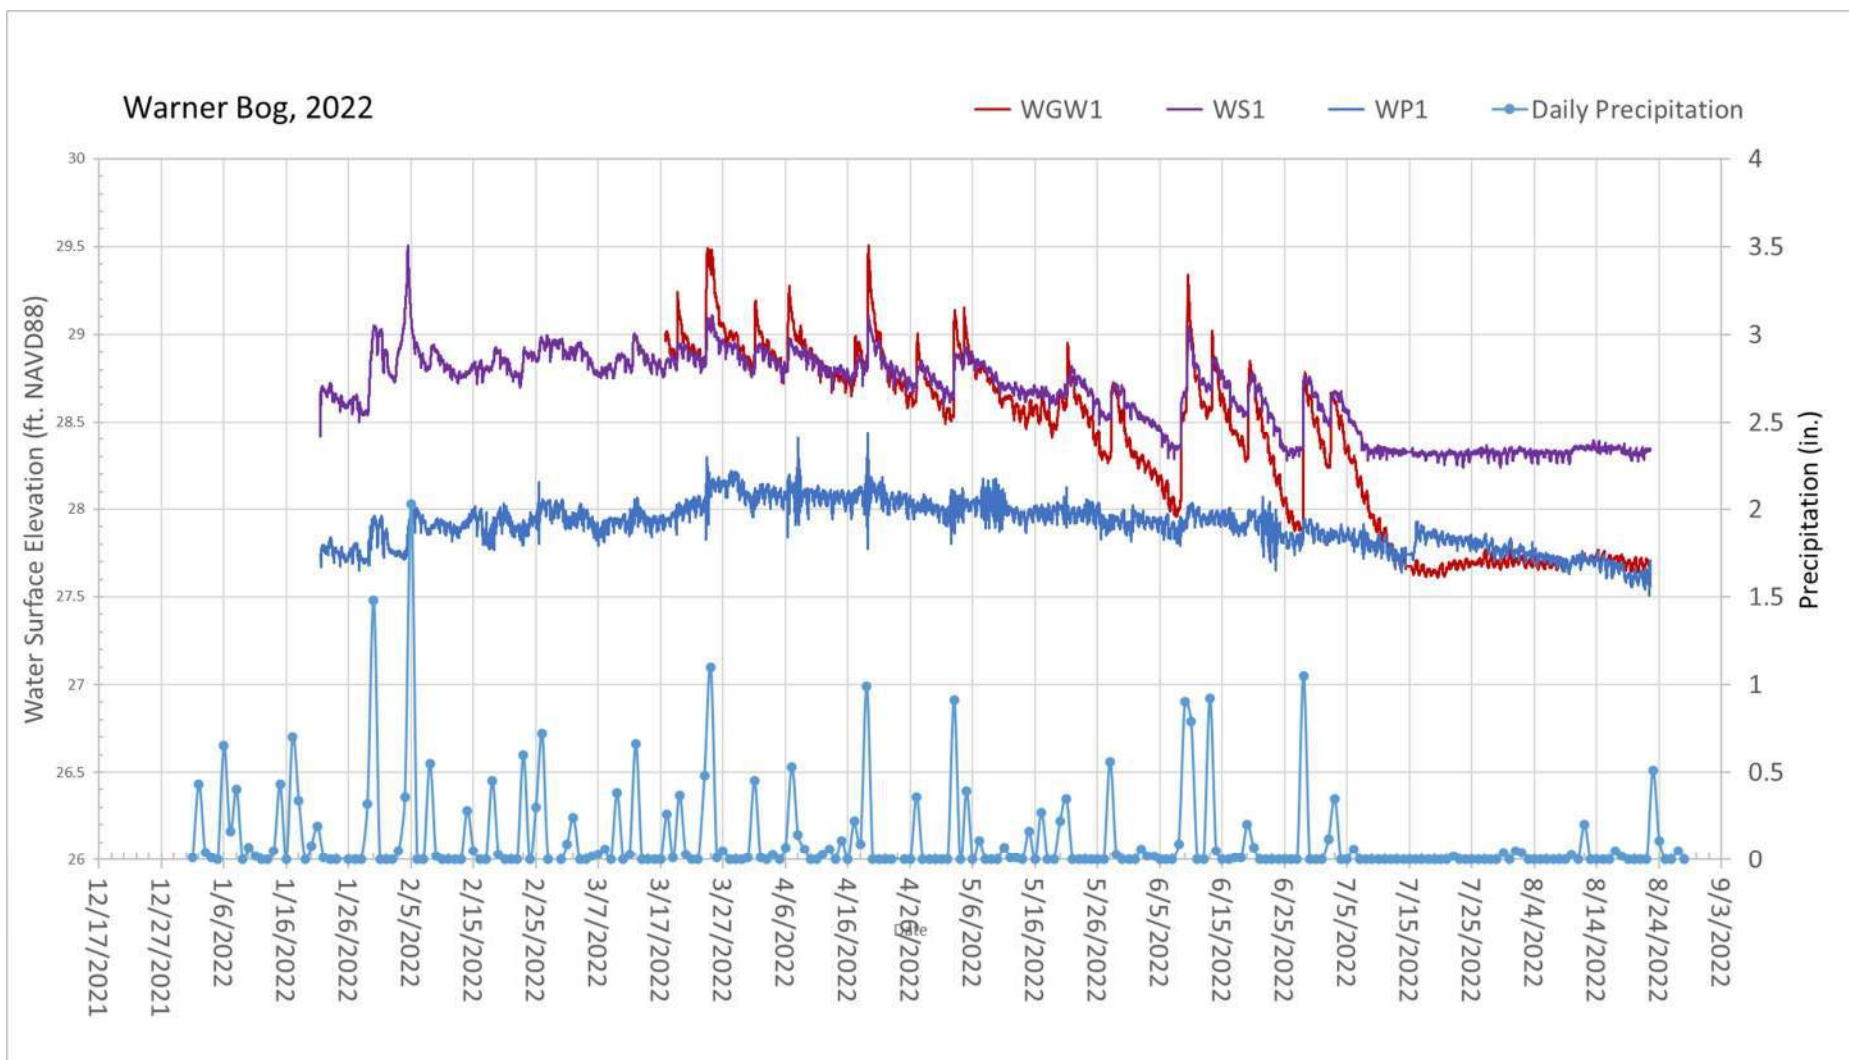
Figure 4. Water level data from Warner Bog, January-September 2022.

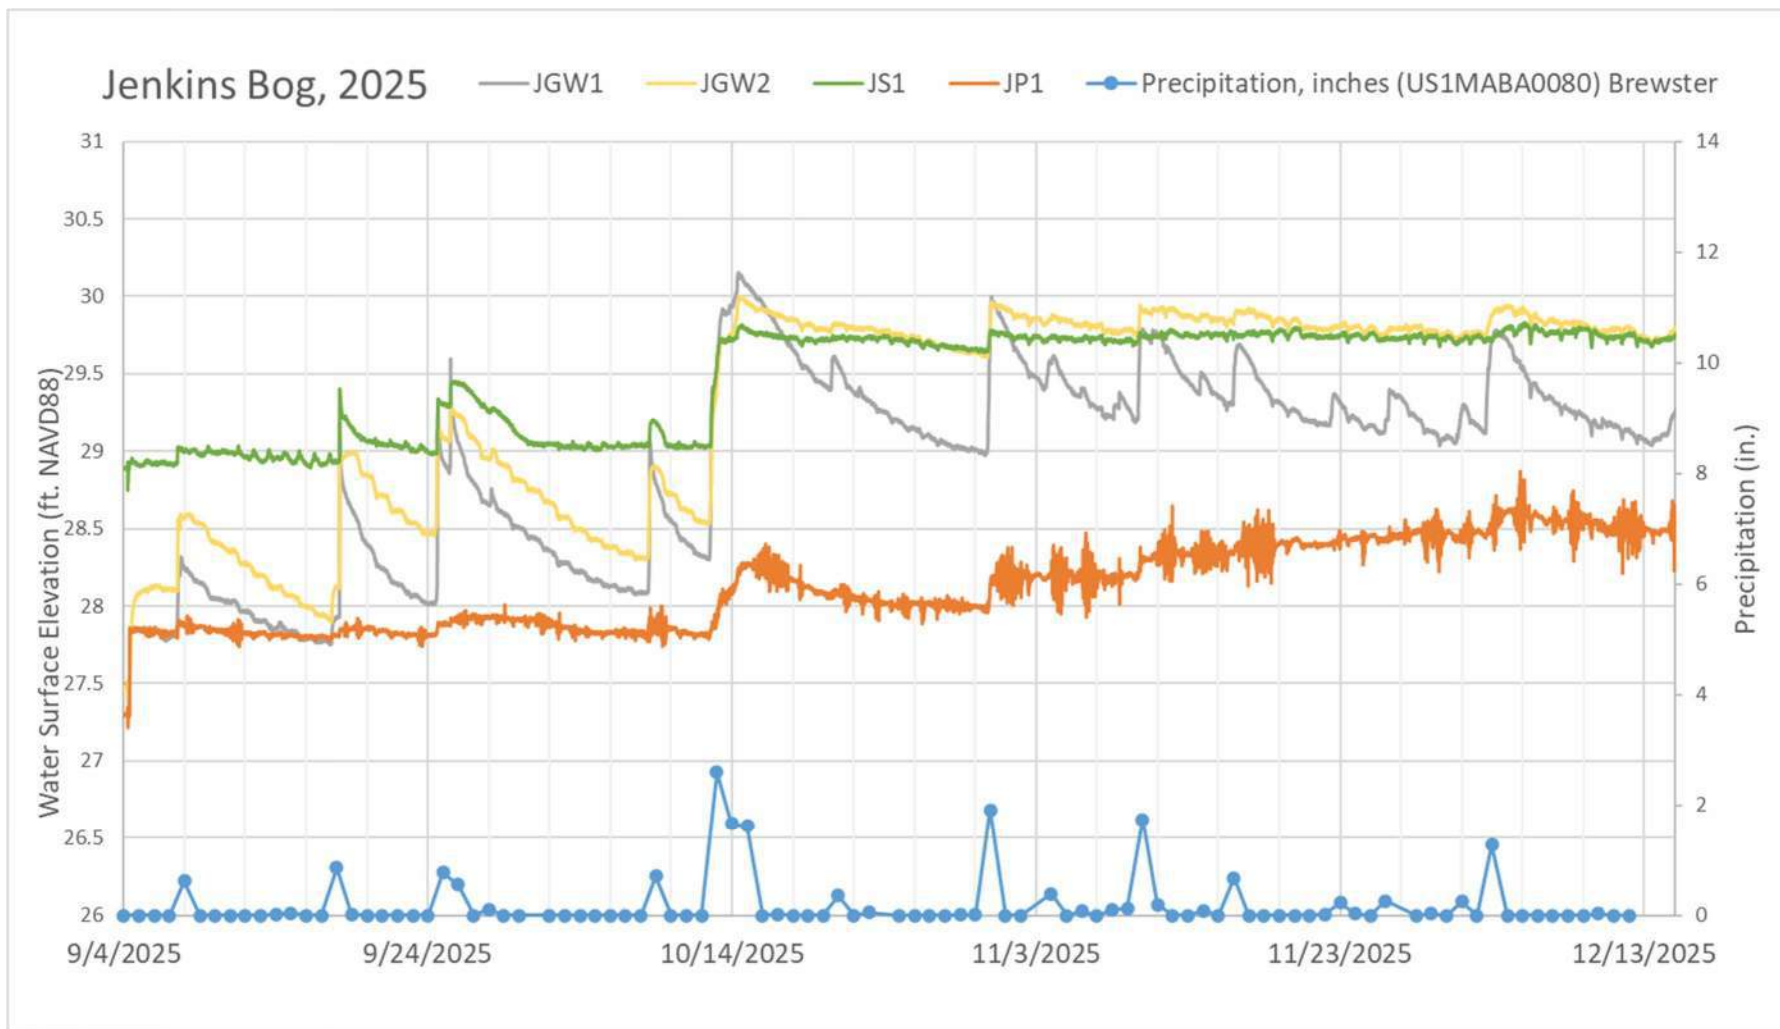
Figure 5. Water level data from Jenkins Bog, September-December 2025.

Results of the post-restoration water level monitoring from September to December of 2025 can be found in Figure 5 and Figure 6. Summary statistics for each monitoring location during pre- and post-restoration monitoring can be found in Table 9.

Across both monitoring periods, groundwater elevations exhibited greater overall variability than surface water elevations; the ranges and standard deviations of groundwater levels generally exceeded those observed in surface water loggers across the site (Table 9). Comparison of pre- and post- restoration summary statistics shows no consistent shift in mean or median elevation for either groundwater or surface water wells. Groundwater wells (WGW1, JGW1, JGW2) remained highly responsive to precipitation events during both monitoring periods, and surface water wells (JS1 and WS1) also showed responses to precipitation, though with smaller absolute ranges of fluctuation than groundwater wells. Pond water level (JP1 and WP1) at Jenkins bog was more variable than Warner, which may be due to greater wind and wave activity on the Jenkins side (Figure 5 and Figure 6). Additional years of water level monitoring during the same time of year are required to provide meaningful insight into post-restoration hydrologic conditions.

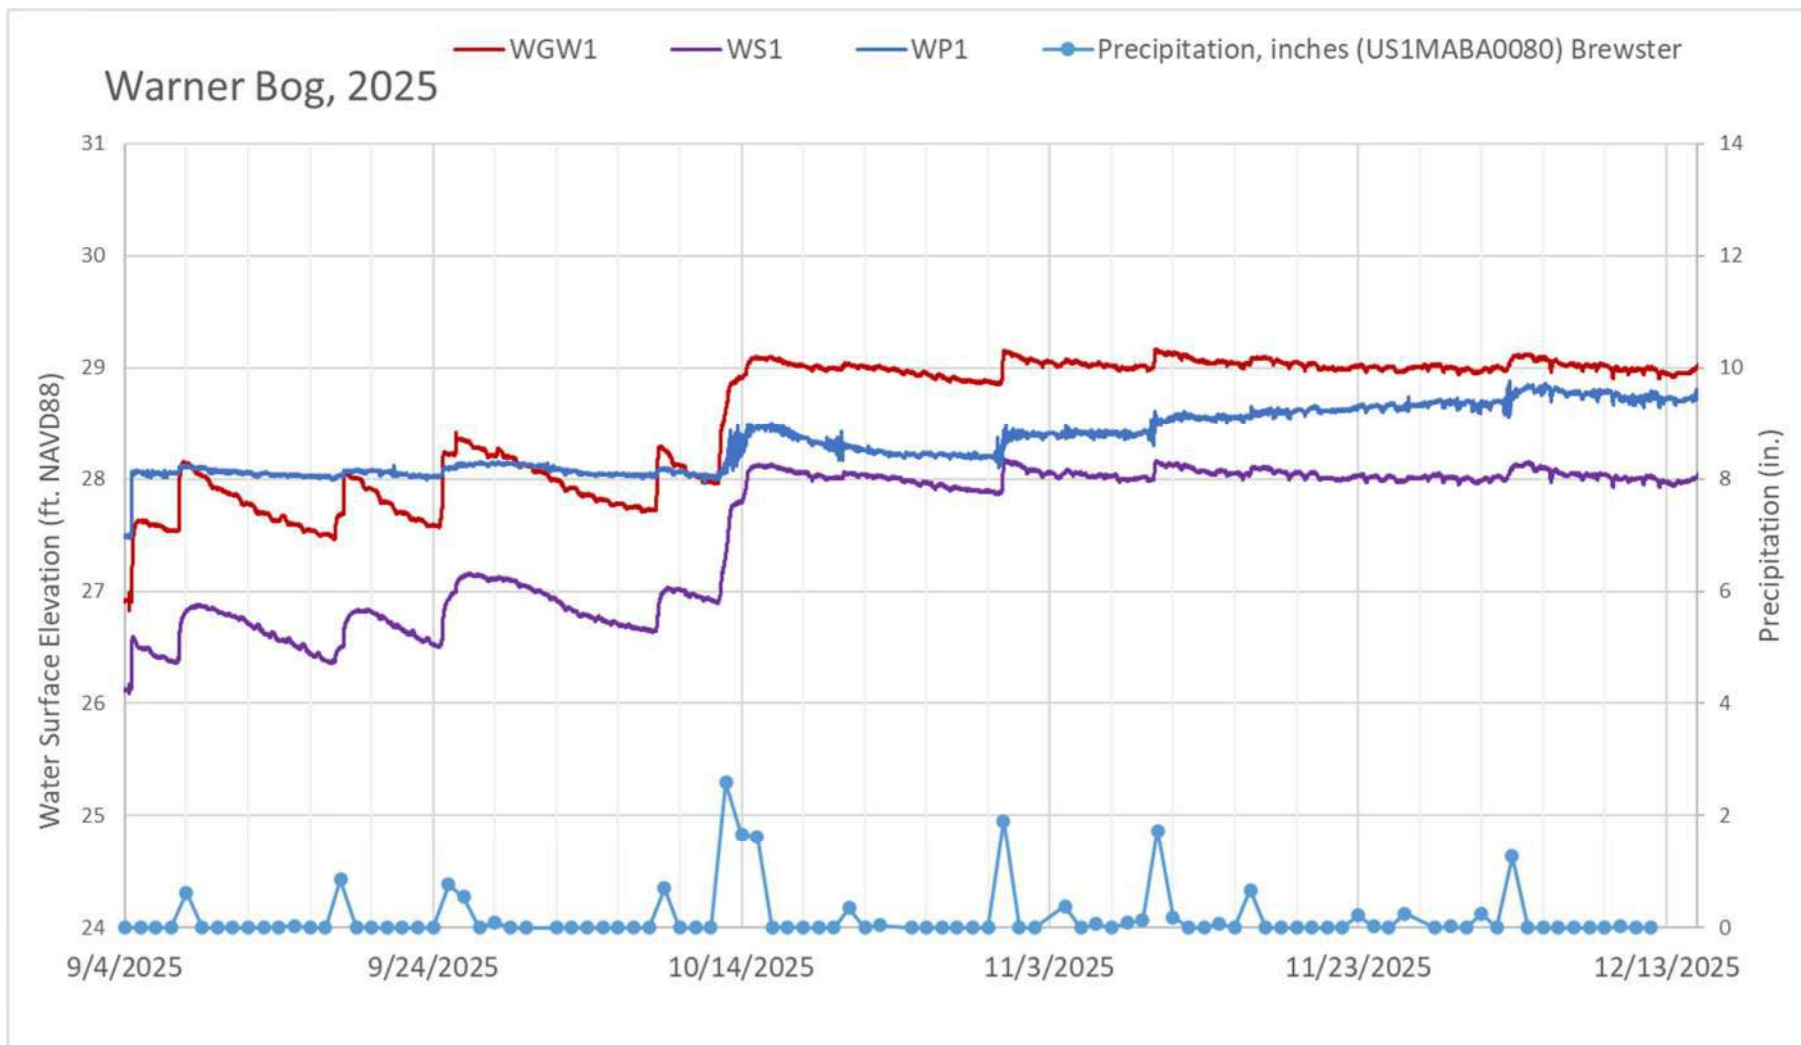
Figure 6. Water level data from Warner Bog, September-December 2025.

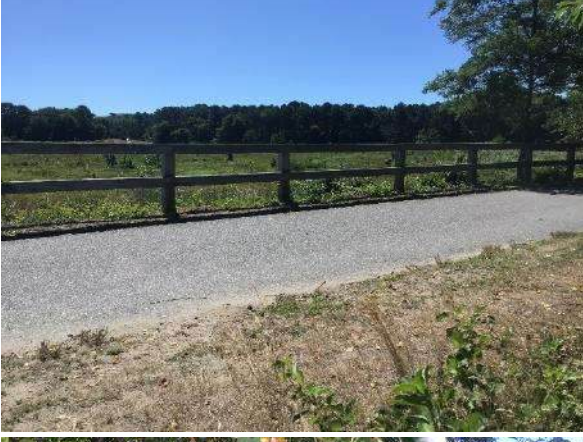
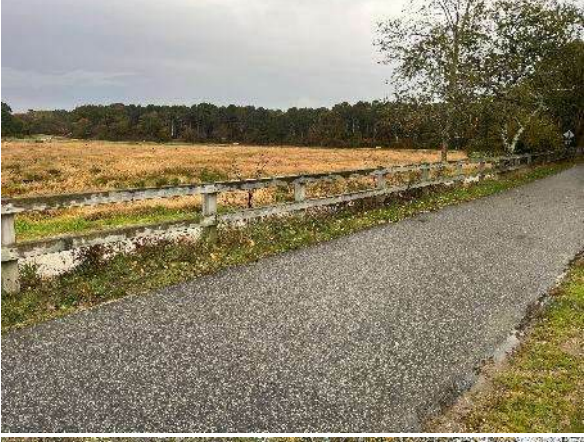
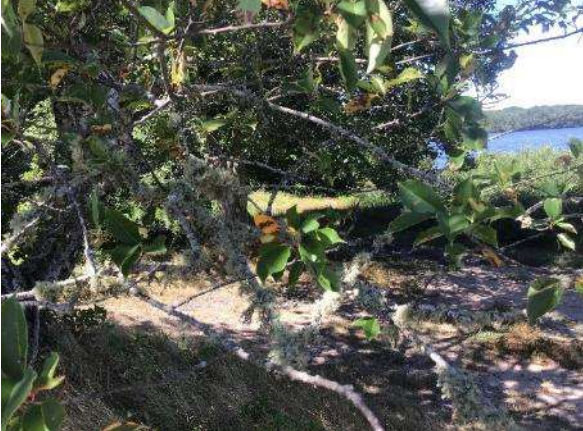
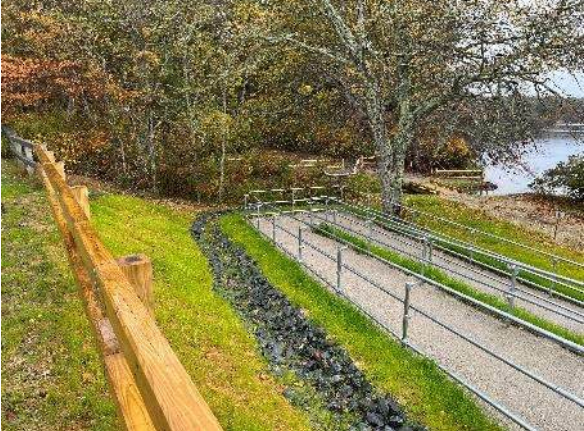
Jenkins Bog, Photo Station 6

6	Jenkins	No	2024: <i>Toxicodendron radicans</i> , <i>Rubus flagellaris</i> , <i>Smilax glauca</i> , <i>Agrostis scabra</i> . 2025: Limited disturbance at the photo point during construction; similar species present. Trail constructed where the dirt road was prior to construction. Seed mix with cover crop beginning to emerge along the side slopes to the bog and on either side of the trail.
7	Jenkins	No	2024: <i>Erigeron canadense</i> , <i>Agrostis scabra</i> , <i>Smilax glauca</i> , <i>Rubus flagellaris</i> . 2025: This area was disturbed and graded during construction with new trails constructed. Mostly cover crop beginning to emerge with some <i>Rubus flagellaris</i> growing as well.

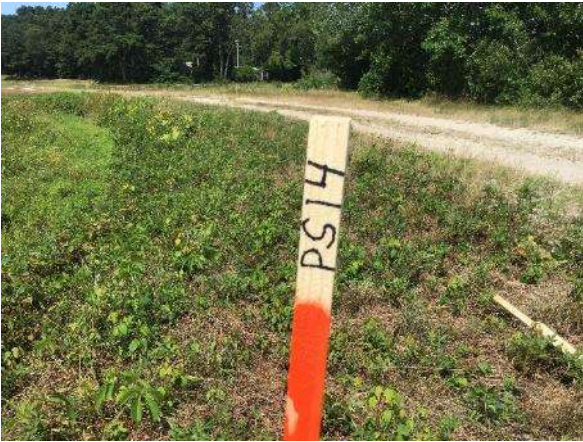
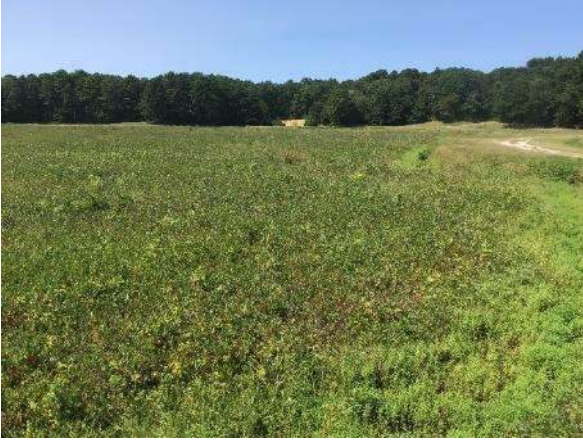
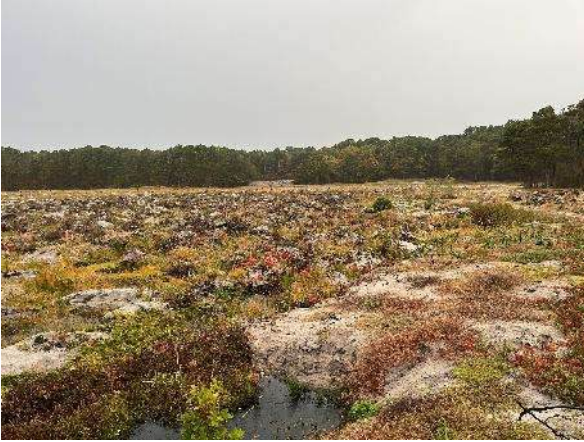
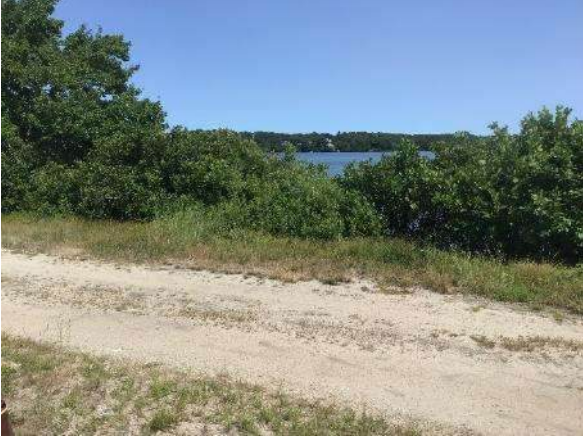
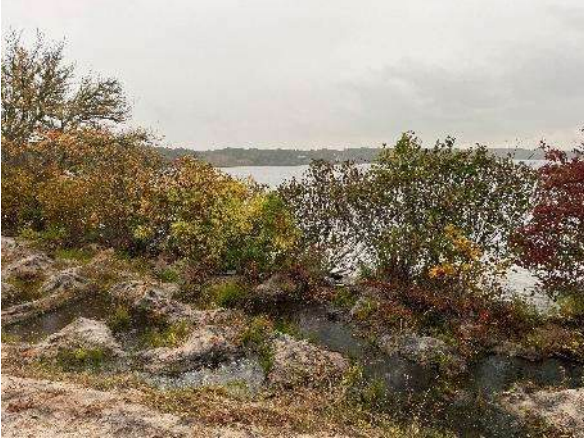
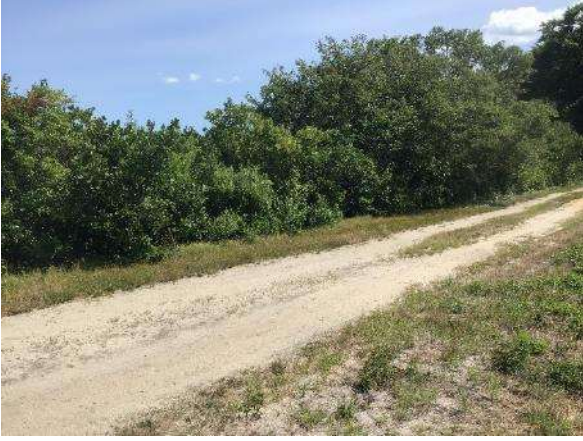
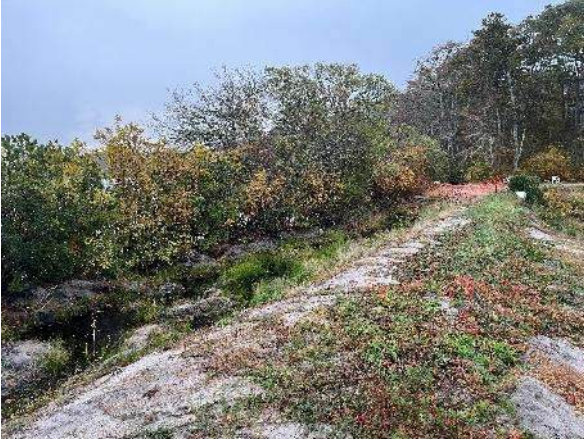
Warner Bog, Photo Station 13

<p><i>*Stake in photo is incorrectly labeled. The correct Photo Station ID is PS13.</i></p>		
North
