# Pre-Restoration Vegetation Monitoring Report Pre-Restoration (2024)

Hinckleys Pond – Herring River Headwaters Eco-Restoration Project  
Jenkins Bog and Warner Bog  
Harwich, Massachusetts

**FEBRUARY 2025**

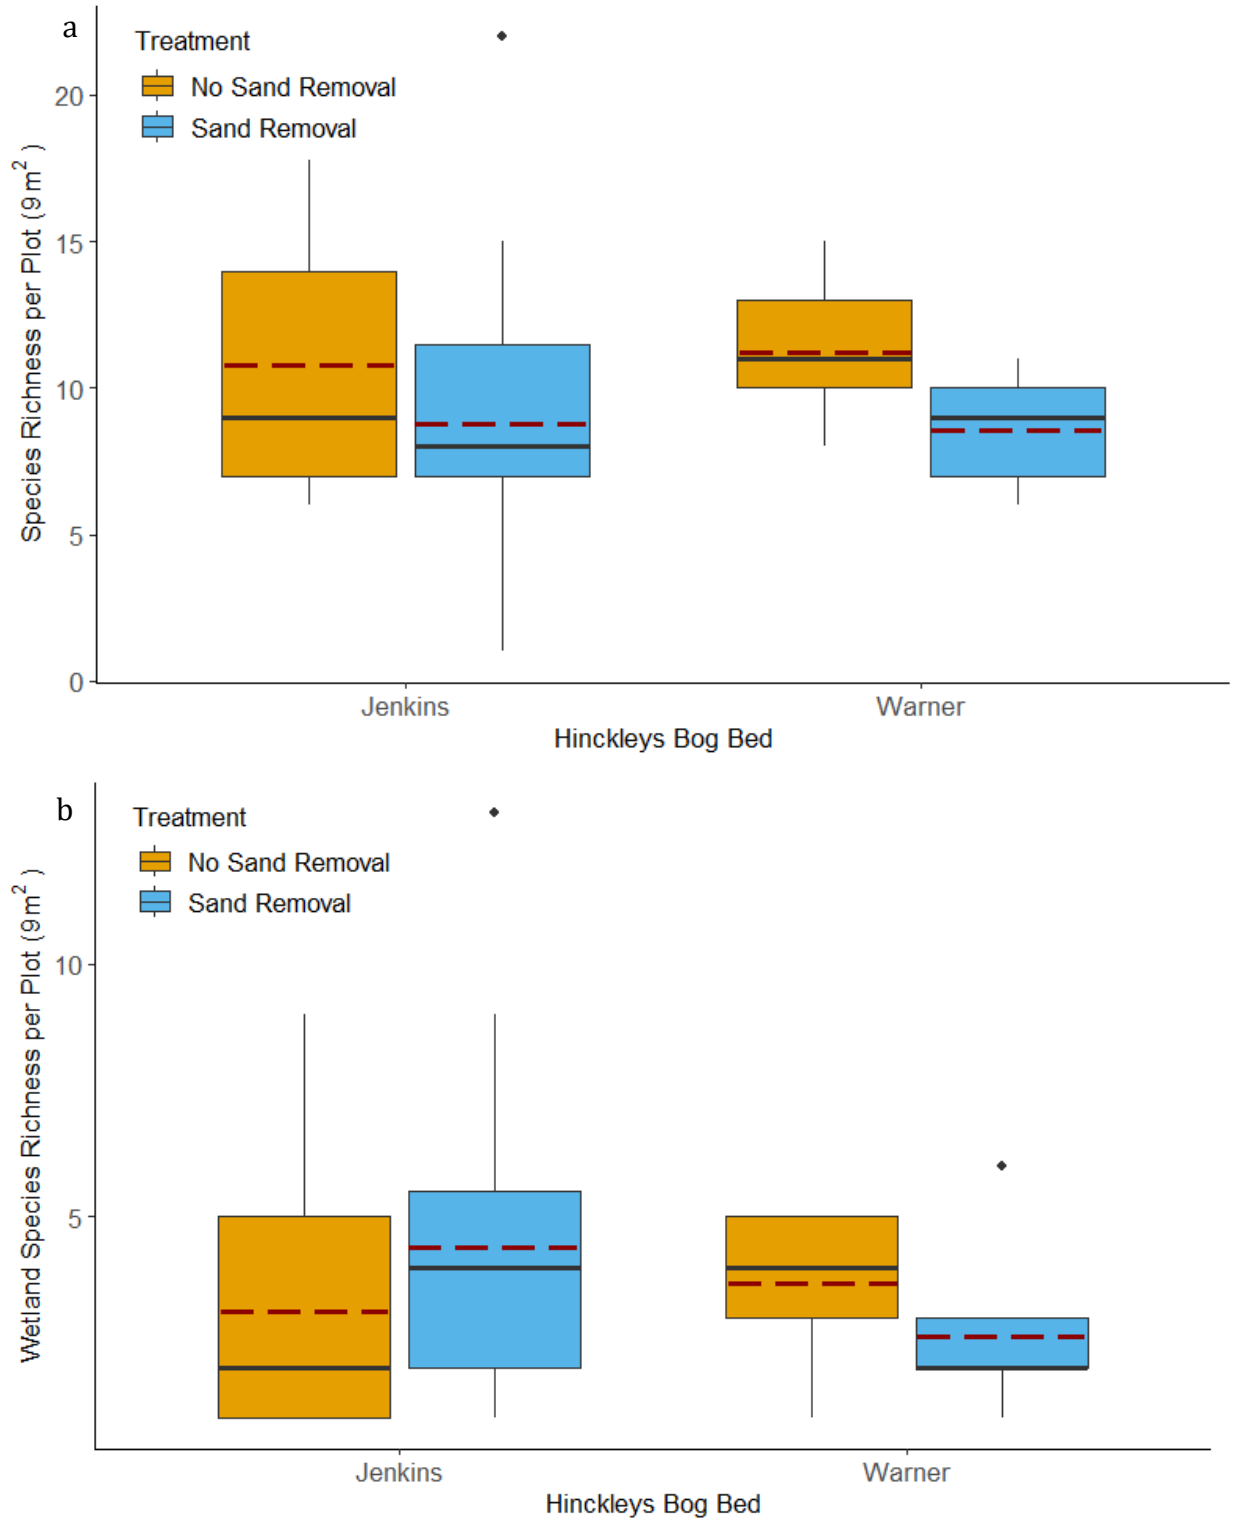
Figure 1. Per plot species richness (a) and wetland species richness (b) in areas slated for sand removal and no sand removal during restoration at Jenkins and Warner Bogs. Boxes show the middle 50% of the data. Horizontal black lines indicate the median value and dashed red lines indicate mean value within each box. Vertical black lines encompass additional data points up to 1.5 times the interquartile range. Outliers are indicated with individual points.

This report summarizes the pre-restoration vegetation monitoring. Between the two bog cells, we recorded 57 total plant species, of which 50 were native. At Jenkins Bog, 48 of 53 species were native, and at Warner Bog 25 of 28 species were native (Table 4). At both bogs, mean species richness per plot was between 9 and 10 and mean wetland species richness was between 3 and 4 (Figure 1), though there was more variation at Jenkins than Warner (Table 5). At Jenkins, there was no difference between mean species richness or mean wetland species richness in the sand removal and no sand removal locations. At Warner, there were significantly more species per plot in the no sand removal area ( $p = 0.02$ ), and there were marginally more wetland species per plot in the no sand removal area ( $p = 0.08$ ).

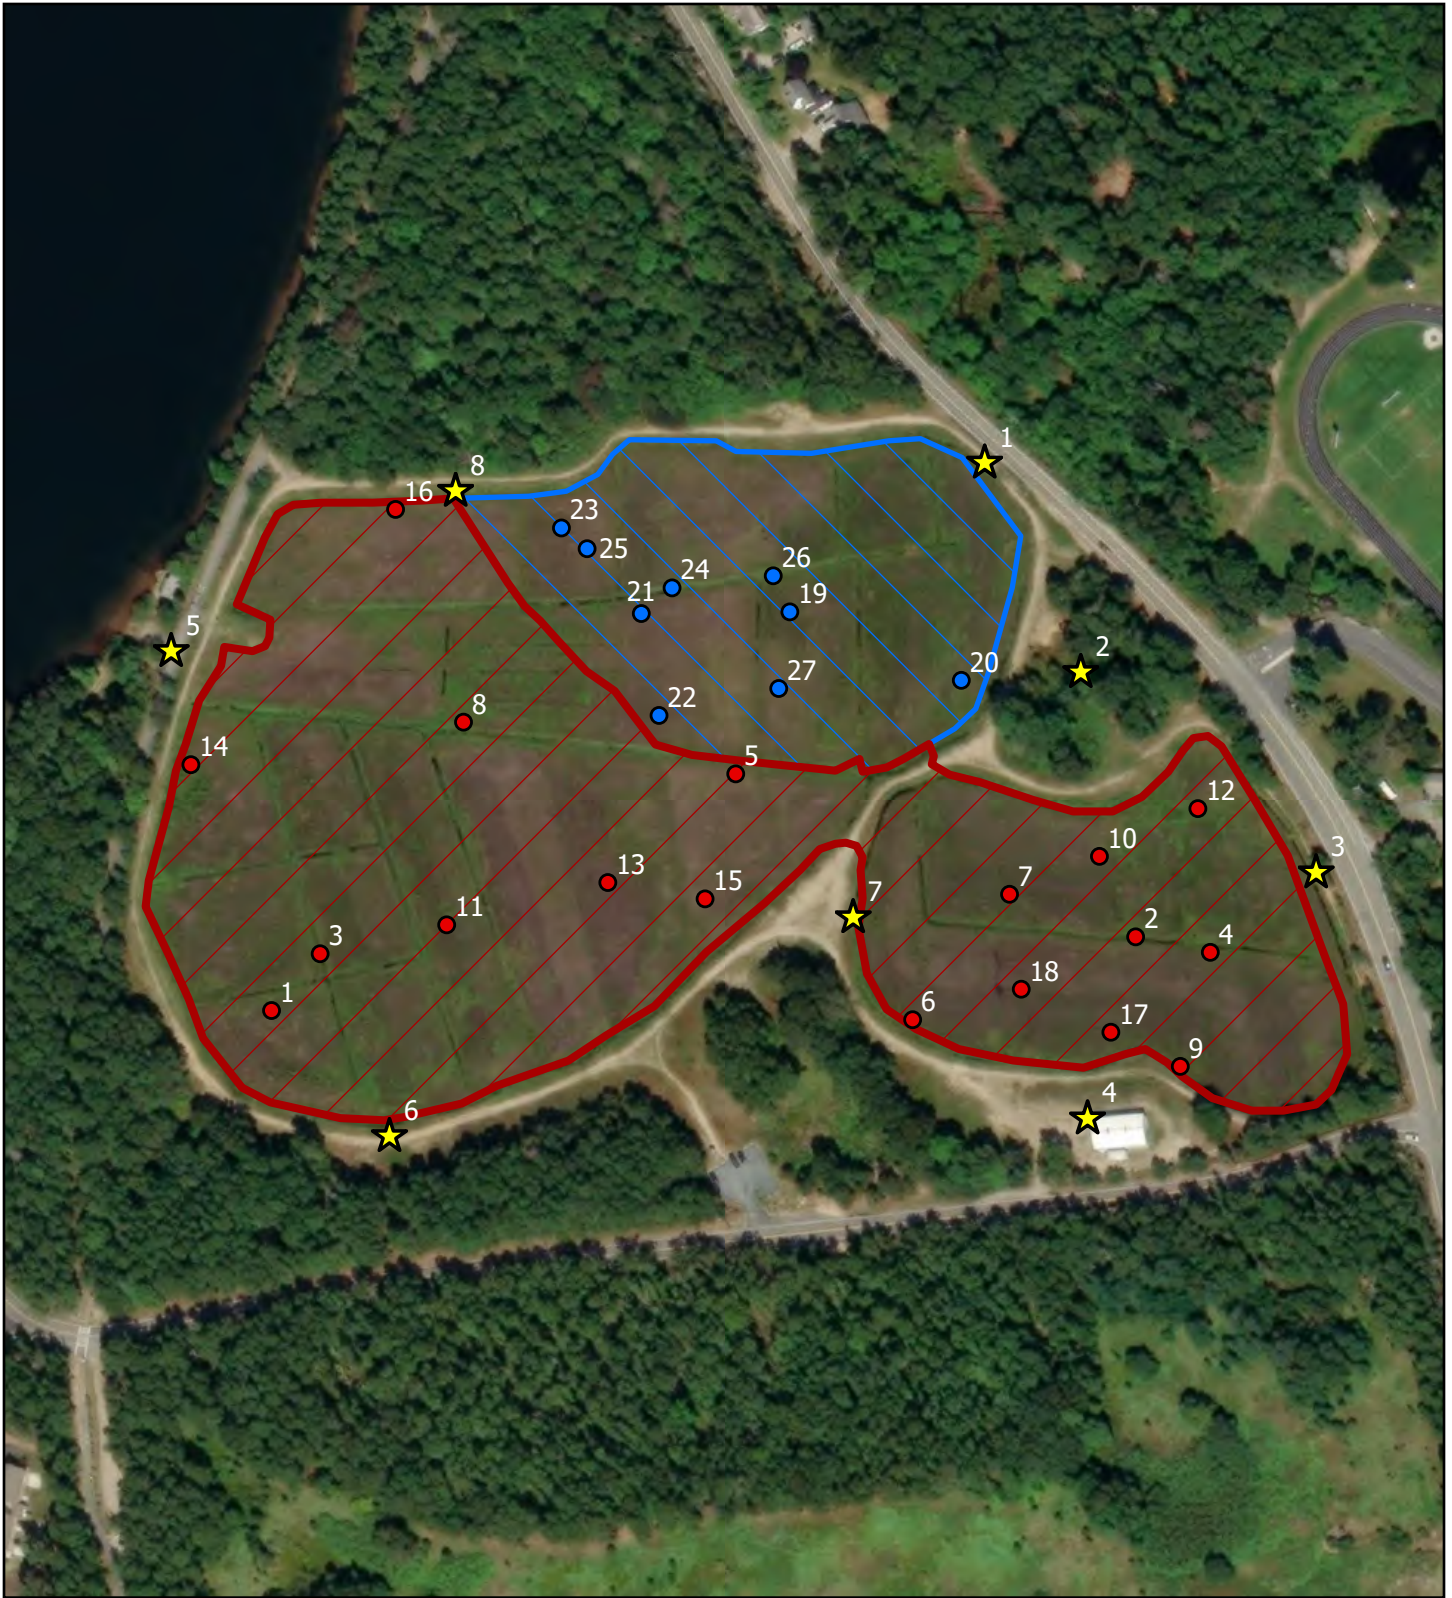
**Vegetation Monitoring Map**

Jenkins Bog  
Harwich, MA

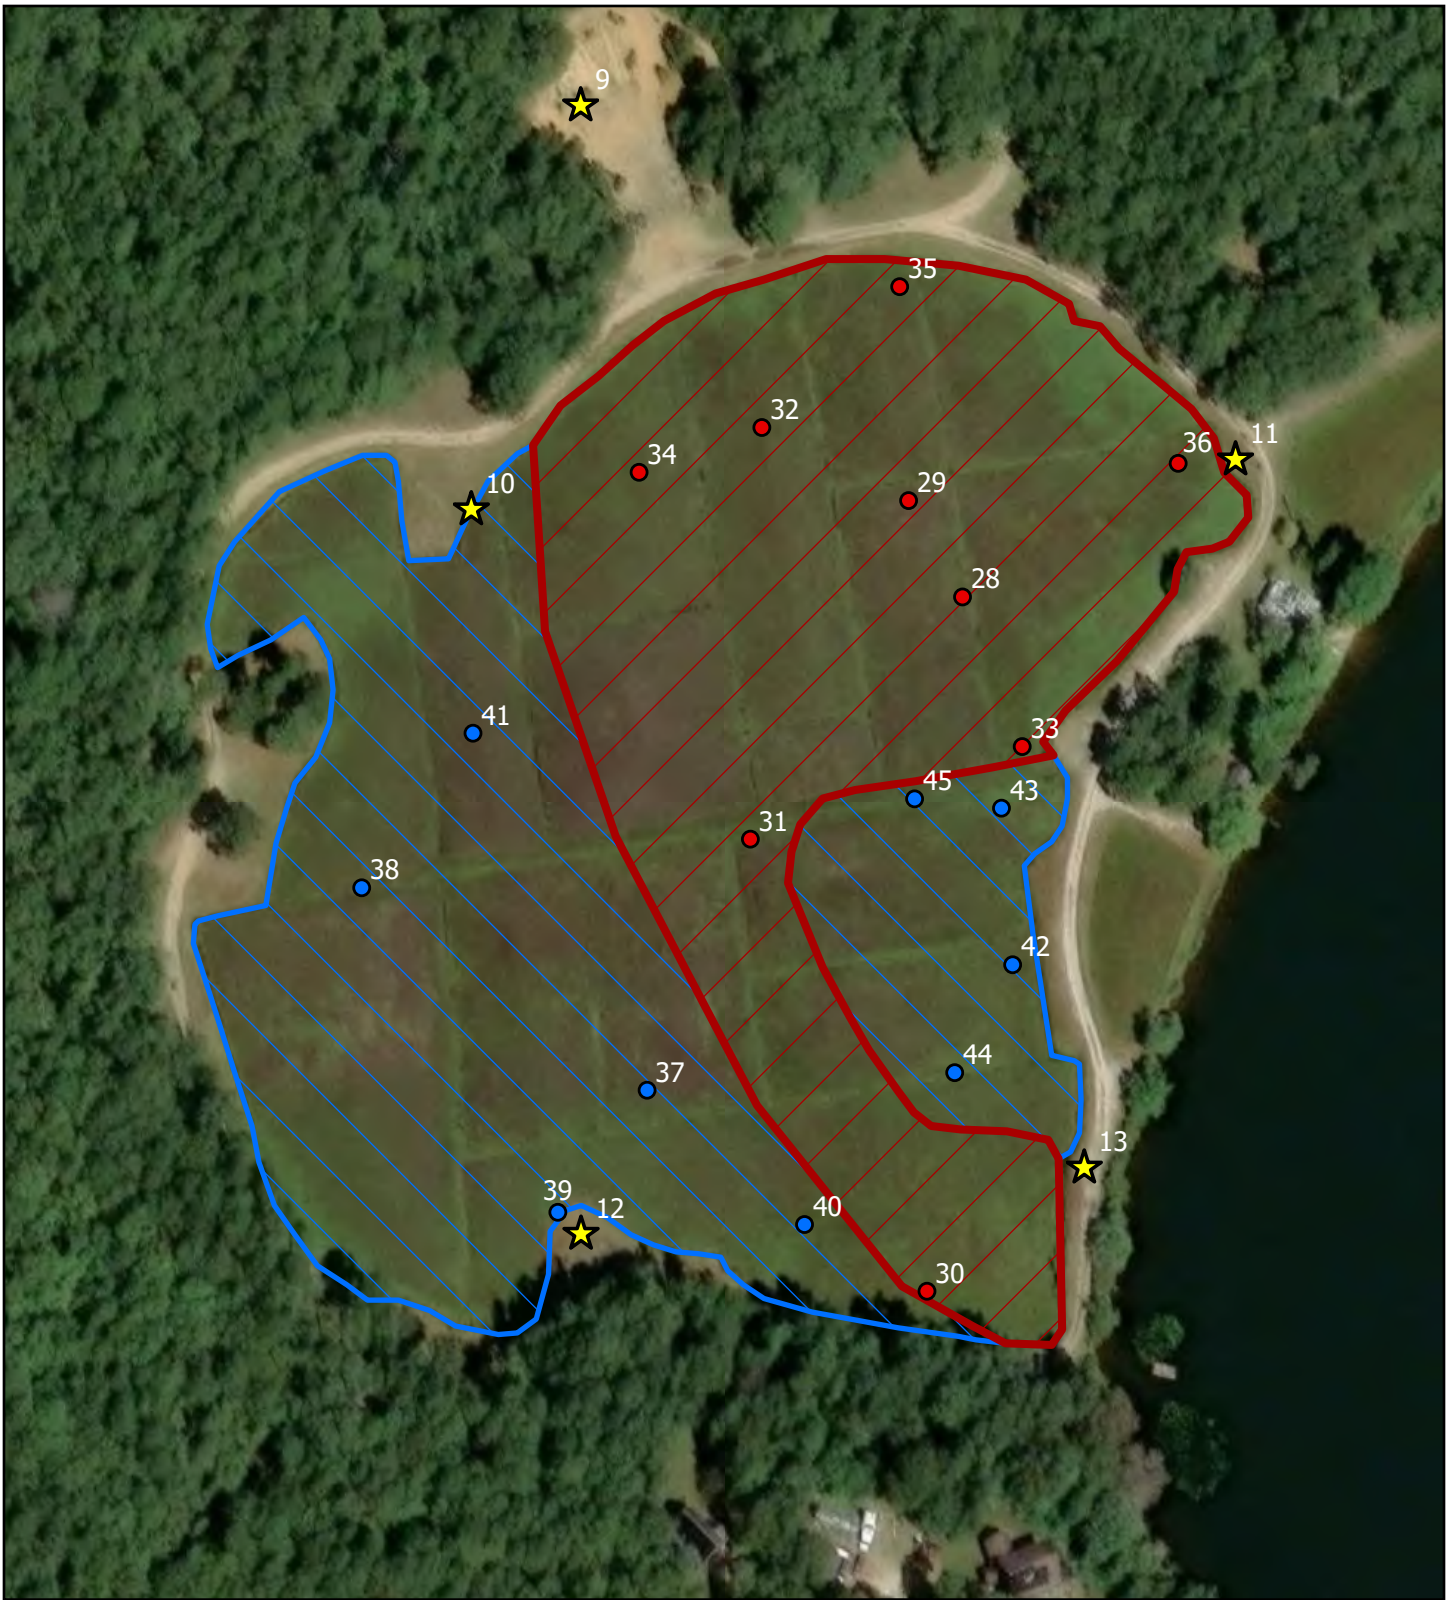
**Vegetation Monitoring Map**

Warner Bog  
Brewster & Harwich, MA
