Project: Yarmouth Comprehensive Stormwater Management Assessment
Municipality: Town of Yarmouth

Curve Hill Road BMP Summary

Standish Way BMP Summary

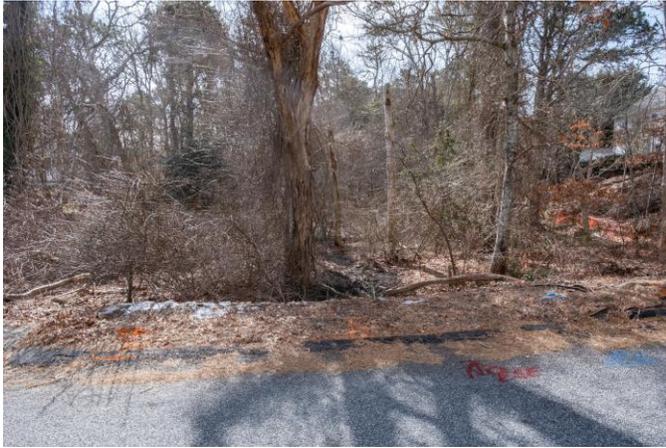
Before: Curve Hill Road site before construction showing large overgrowth of brush and invasive vegetation. Credit: Gerry Beetham for the Association to Preserve Cape Cod.

The main water quality BMPs constructed at Curve Hill Road include a water quality unit and constructed stormwater wetland to treat and manage runoff from a total drainage area of 13 acres, including 32% impervious surface (4.15 acres). The drainage area encompasses Curve Hill Road, as well as drainage captured through a series of catchbasins along Great Western Road. The water quality unit removes the majority of the sediment before the pretreated stormwater discharges to the constructed wetland. The constructed wetland is designed with three deep pools, connected by a series of micropools, with areas of low and high marsh. Excess stormwater that enters the constructed wetland overflows via a spillway. The design life of the constructed wetland is 20 years.

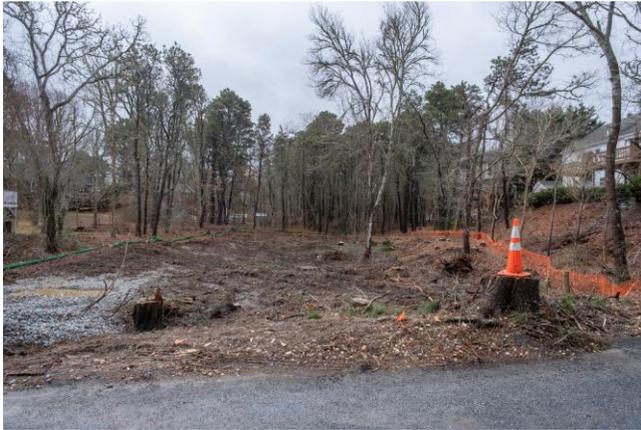
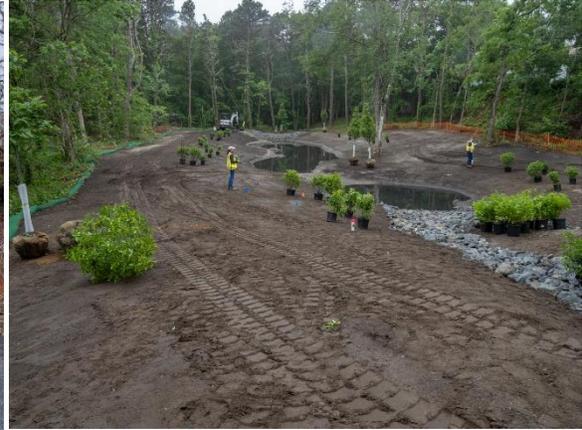
During: Curve Hill Rd after clearing of existing vegetation (left) and following construction of wetland pools during planting (right). Credit: Gerry Beetham

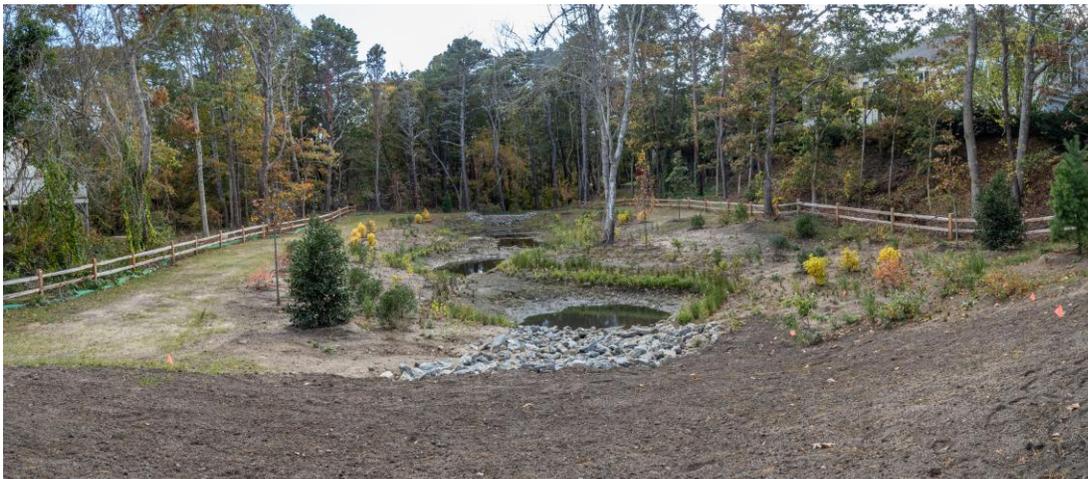
After: Curve Hill Rd following construction completion. Credit: Gerry Beetham

This constructed stormwater wetland system was built to treat the 1-inch storm, equal to 15,065 cf of runoff. Based on performance curves treating the 1 inch of runoff for the constructed stormwater wetland,¹ this system will remove 32% of the nitrogen², 53% of phosphorus³, 65% of bacteria⁴, and 80% of sediment⁵ for an estimated removal of 25.2 lbs of nitrogen, 6.0 lbs of phosphorus, 777 billion colonies of bacteria, and 2,997 lbs of sediment on an annual basis⁶.

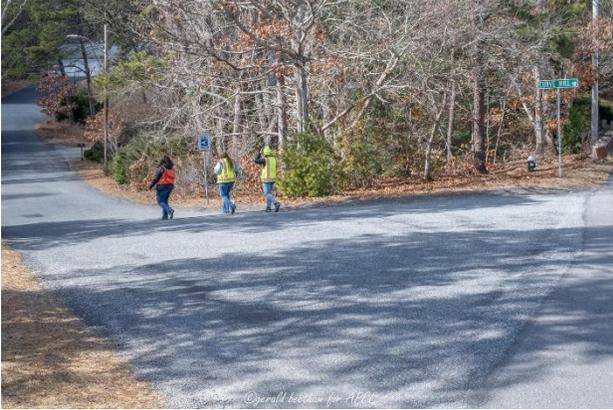
Before: Site assessment showing intersection of Great Western Road (at right) draining down gradient to Curve Hill Road (left) and the proposed location of the constructed wetland to the far left outside of the image. Credit: Gerry Beetham

This project also included the construction of new drainage infrastructure to connect existing Great Western Road drainage to the water quality unit on Curve Hill Road underneath the roadway. This was done to abandon the existing 18" corrugated metal pipe located on private property with no Town easement for maintenance, which had conveyed the Great Western Road runoff to the area where the constructed wetland was built. The drainage infrastructure included three new manholes, the replacement of an existing manhole, and installation of 24" drainage pipe.

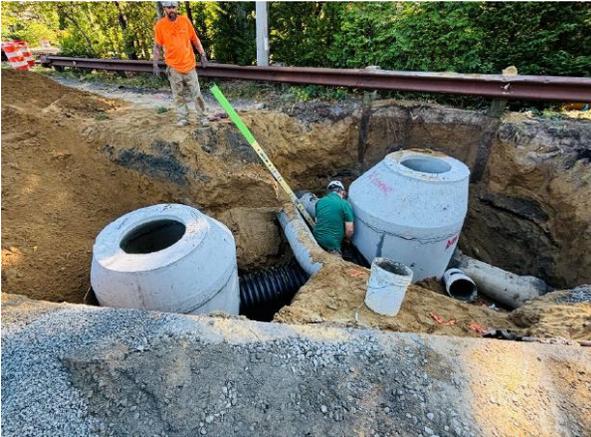
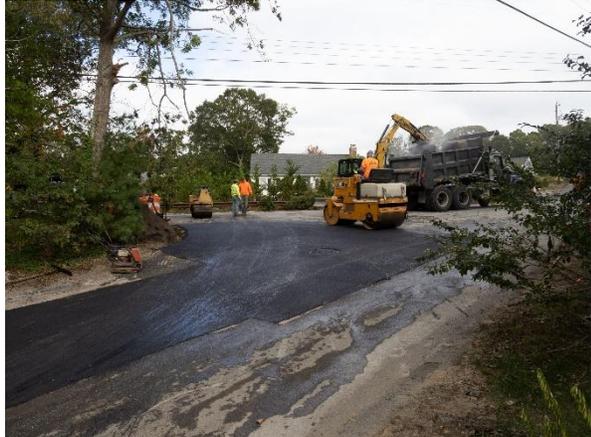
During: Installation of new infrastructure at Great Western Road including deep manholes and piping (left – Credit: Horsley Witten Group) and repaving of the area from Great Western down Curve Hill Road (right – Credit: Gerry Beetham) to connect to the constructed wetland.

Additional scope of work was identified at Curve Hill Road during construction warranting replacement of existing drainage pipes and structures to connect flow from Great Western to the proposed constructed wetland at Curve Hill Road. Additional design work for Great Western was completed in June of 2025 and the project put out to bid in July. Following a bid protest and rebidding of the project Dubis was selected as contractor for the Great Western Road scope and a pre-construction meeting held in September 2025. Construction was completed over a three week period in October 2025.

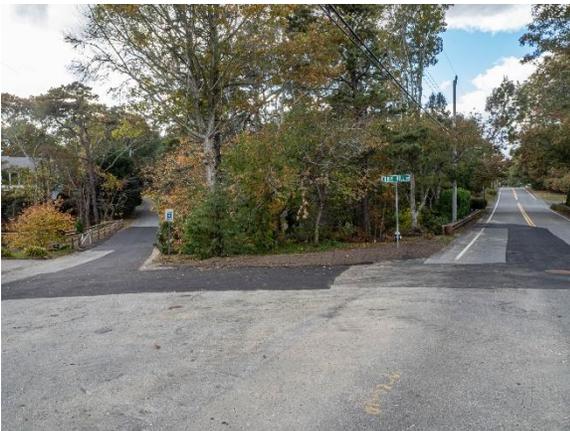
After: Underground drainage indicated by newly paved area to replace failed pipe connection from Great Western (right of image) to Curve Hill Road (left side of image). Credit: Gerry Beetham

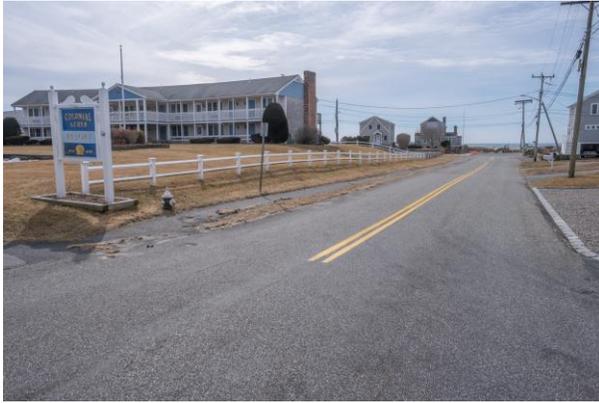
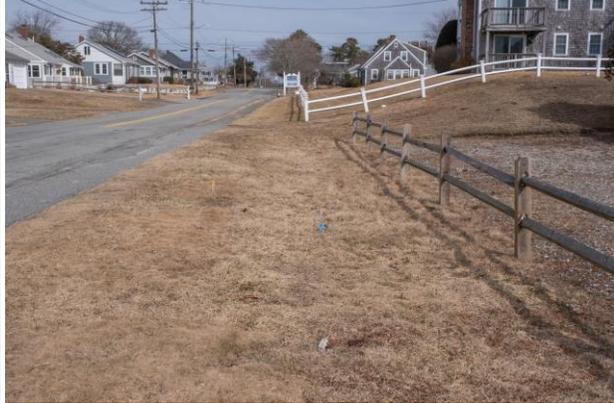
Before: Standish Way before construction looking toward Lewis Bay at location of proposed tree trench (left) and upgradient away from Lewis Bay at the proposed location of the bioretention (right). Credit: Gerry Beetham

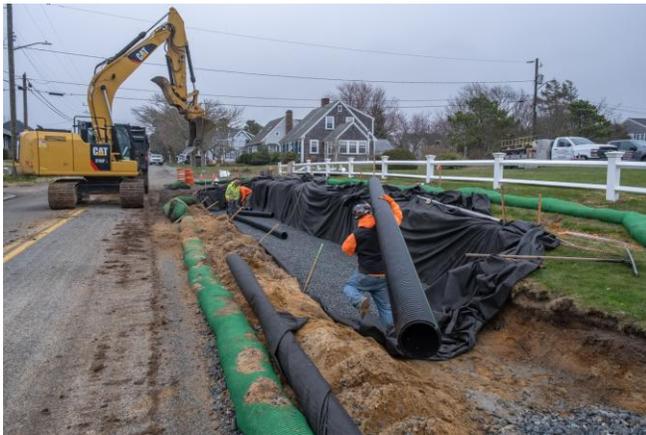
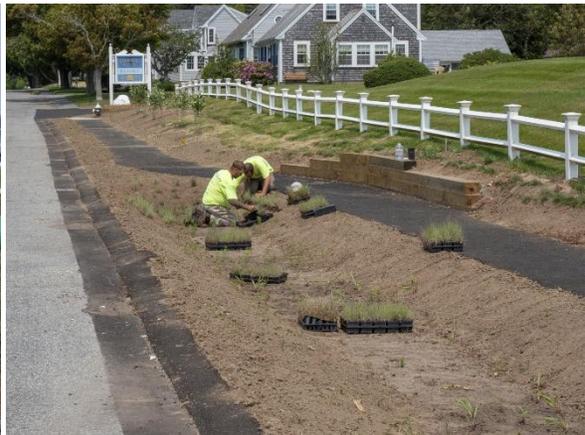
During: Underground pipes being installed at Standish Way to connect the catch basin and water quality unit to the tree trench (left) and planting of the bioretention (right). Credit: Gerry Beetham

A water quality unit with an open grate captures stormwater as it flows down the road, providing pretreatment to remove the majority of the sediment and oil and grease. The pretreated stormwater then discharges into an infiltration trench filled with stone and planted with native shrubs where it is filtered and infiltrated into native soils. The downgradient road runoff flows along the berm into a paved flume and sediment forebay for pretreatment, and then into a bioretention. The bioretention removes pollutants as stormwater filters through the bioretention soil and is taken up by the native plants. Overflows from these systems during larger storm events will continue down the road as they did in preconstruction conditions. The design life of the water quality unit, infiltration trench, bioretention, and porous pavement is approximately 20 years.

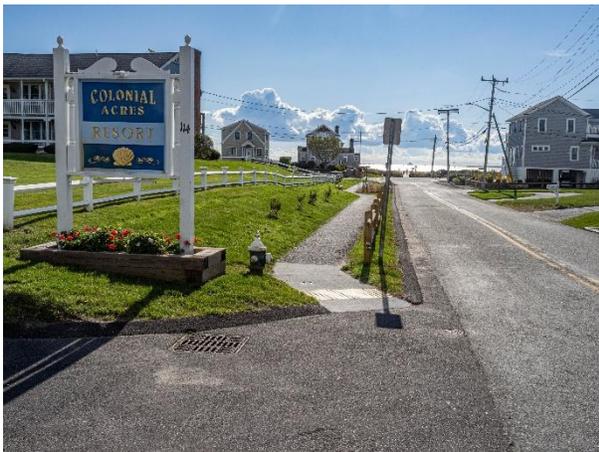
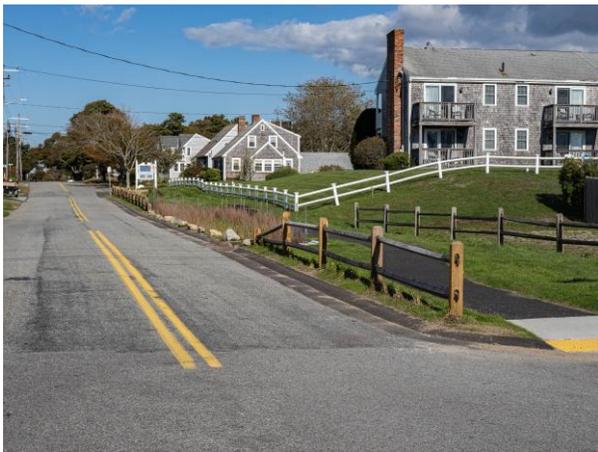
After: The final porous pavement sidewalk, established plantings and grass, the tree trench planted with shrubs connected to the storm drain shown in the foreground (left) and the bioretention planted with grass behind the stone edging to the roadway (right). Credit: Gerry Beetham

area of 0.98 acres, including 39% impervious surface (0.38 acres). In addition, the project removed 1,750 sf of impervious pavement (sidewalk) and replaced it with porous pavement.
