Memorandum

DATE: June 30, 2023

RE: Yarmouth Stormwater Retrofit Assessment – Final Report

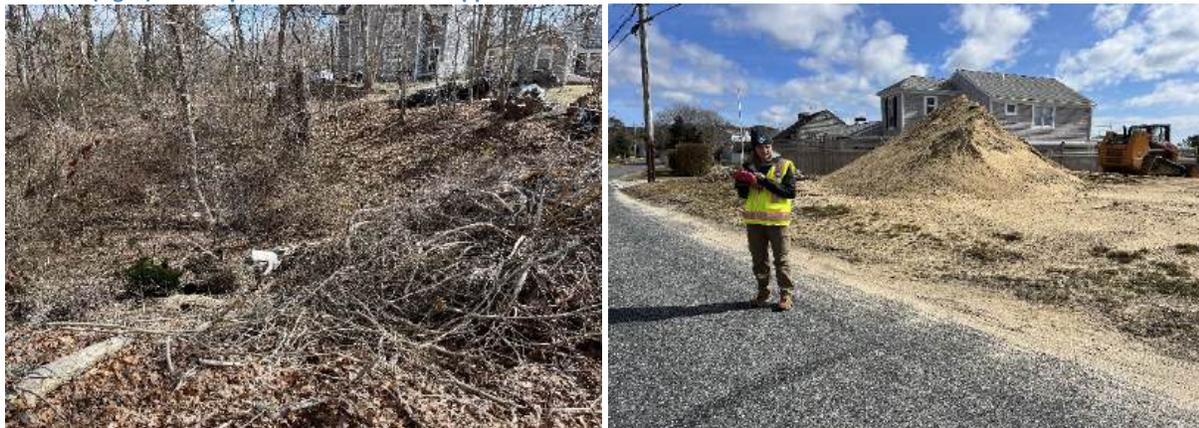
Photo 6. Residential yard waste dumped at the end of Grove Road (left) and construction site with no erosion and sediment controls (right) – examples of source control opportunities.

While on site, Field Teams looked for source control opportunities – ways to prevent pollutant loading at the source before it is picked up by stormwater rather than just removing it downstream in structural practices. Examples of source control include the following: increased street sweeping, reducing fertilizer usage, improving waste management (cleaning up and preventing on-going dumping sites), stabilizing eroding areas and/or construction sites, and hotspot management (increasing preventative maintenance at “hotspot” places such as high-volume parking lots, etc.). These are topics that should also be targeted with any public outreach efforts in the identified areas.

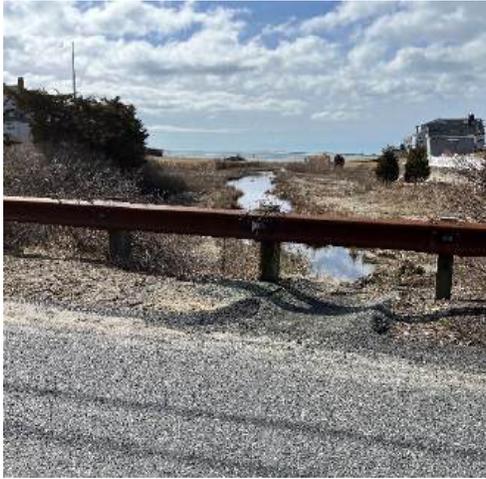
Photo Caption: Standing above the culvert looking toward the ocean showing the paved flume at the low point of the street.

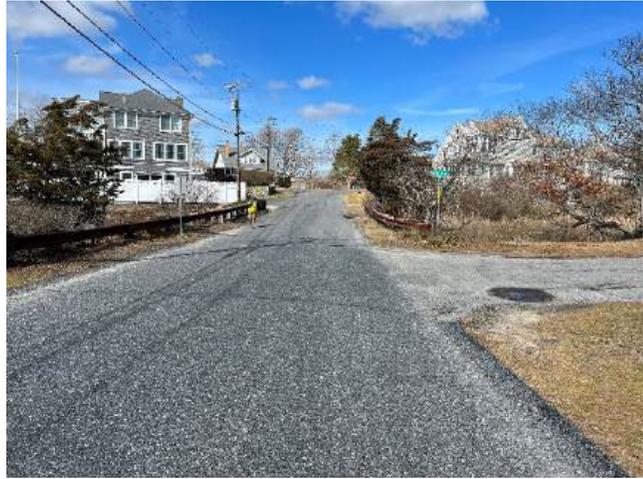
Photo Caption: Park Avenue looking west toward the low point of the road.

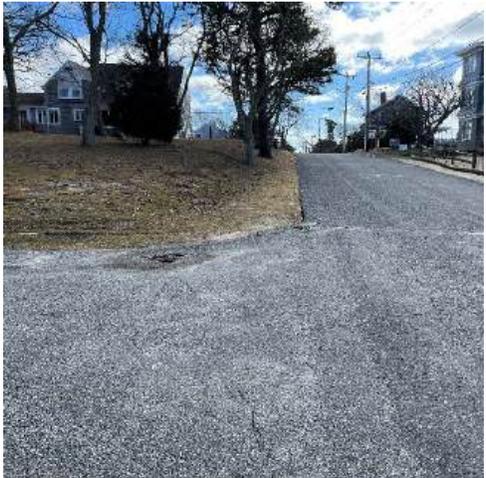
Photo Caption: Eastern Corner of Park Avenue and Park Street where a bioretention is proposed.

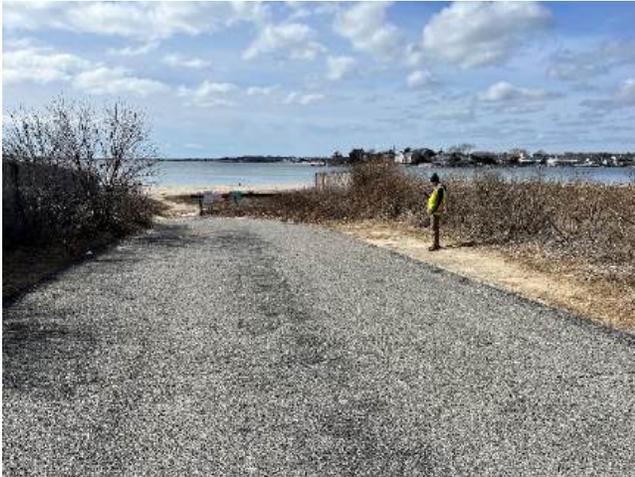
Photo Caption: Grove Street looking toward beach access.

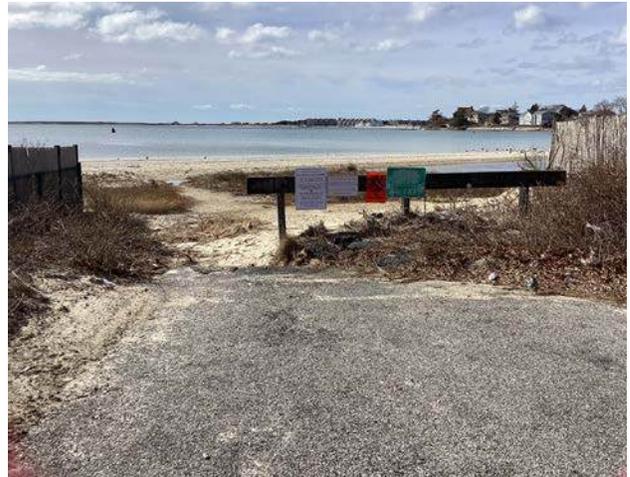
Photo Caption: Beach access at end of Grove Street.

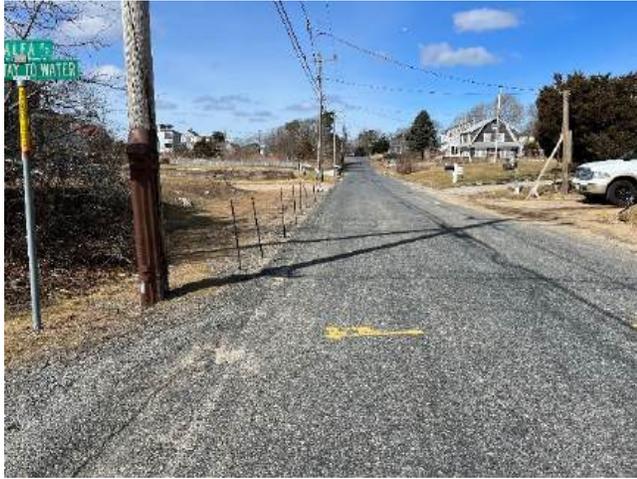
Photo Caption: Corner of Park Ave and Malfa Road looking west – proposed bioretention along southside of road.

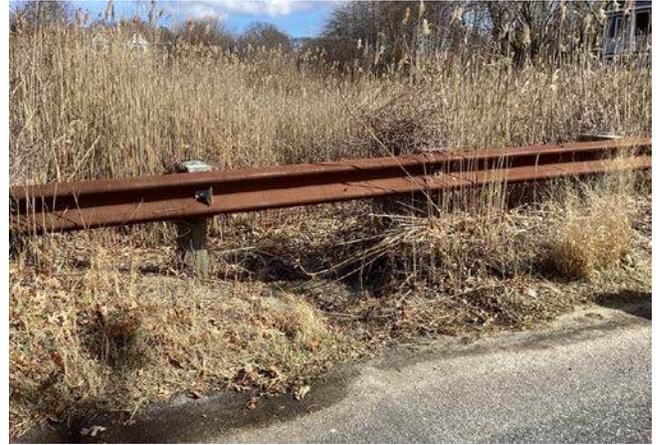
Photo Caption: Standing at low point of Park Avenue looking inland.

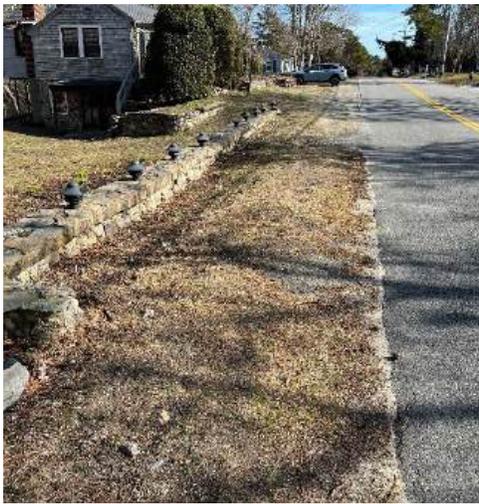
Photo Caption: Catch basin on the west side of Wimbledon Drive furthest north.

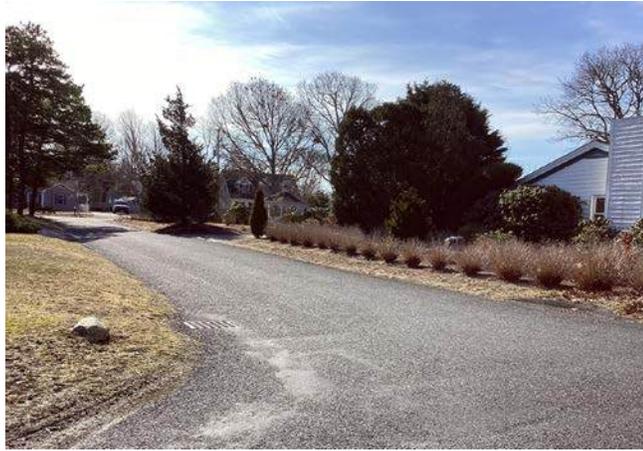
Photo Caption: Two catch basins on Preston Way that connect to Wimbledon outfall.

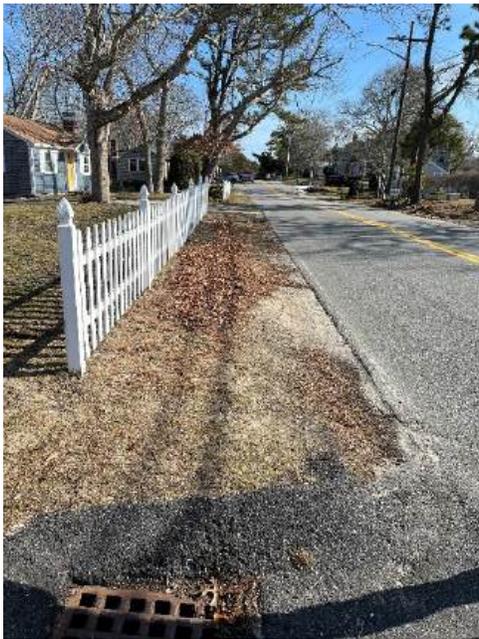
Photo Caption: Catch basin on the west side of Wimbledon Drive closest to outfall.

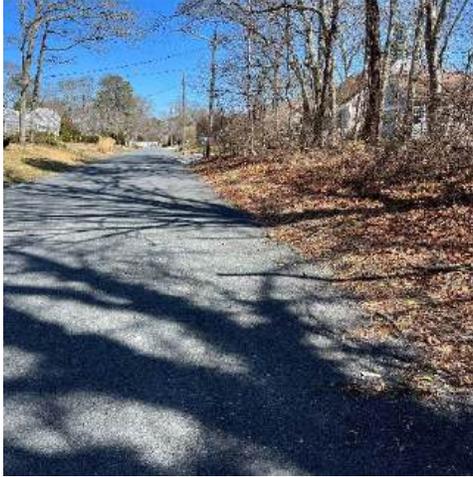
Photo Caption: Tanglewood Drive looking northeast. Town property on right side of photo.

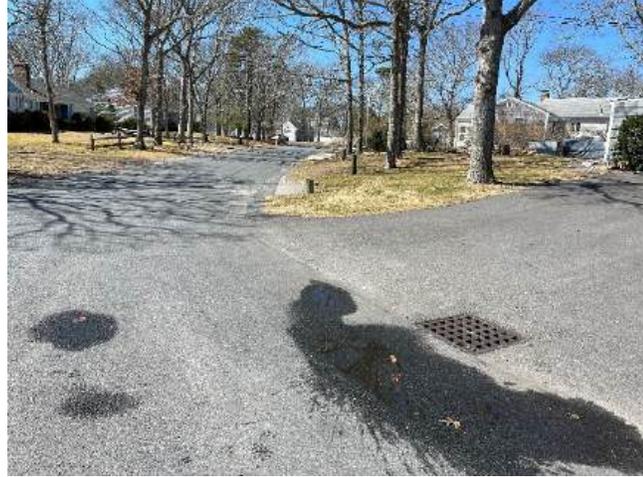
Photo Caption: Catch basin at low point of Tanglewood Drive looking west towards Webster Road.

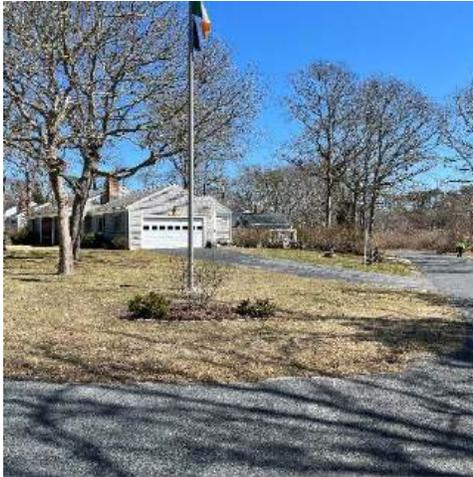
Photo Caption: Southwest corner of Tanglewood Drive where a bioretention is proposed in the ROW in front of the flag pole.

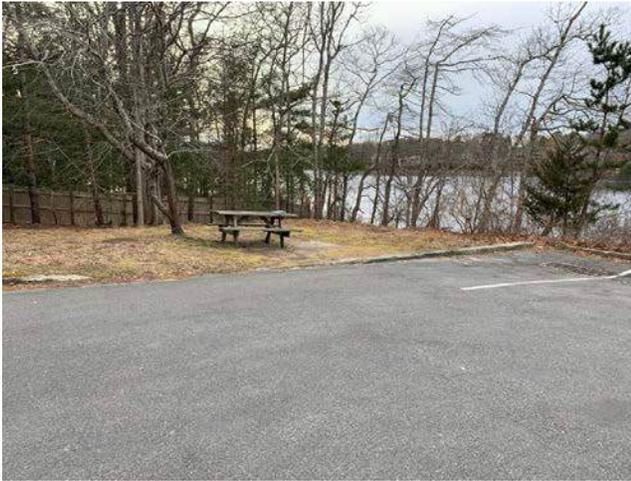
Photo Caption: Area of proposed BMP.

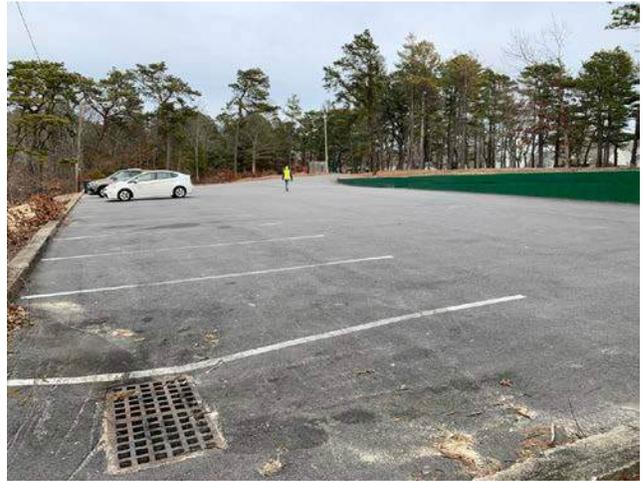
Photo Caption: Low point in parking lot.

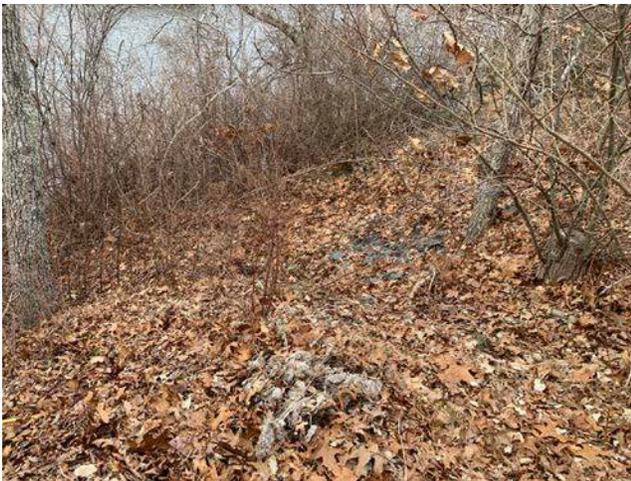
Photo Caption: Outfall at Long Pond.

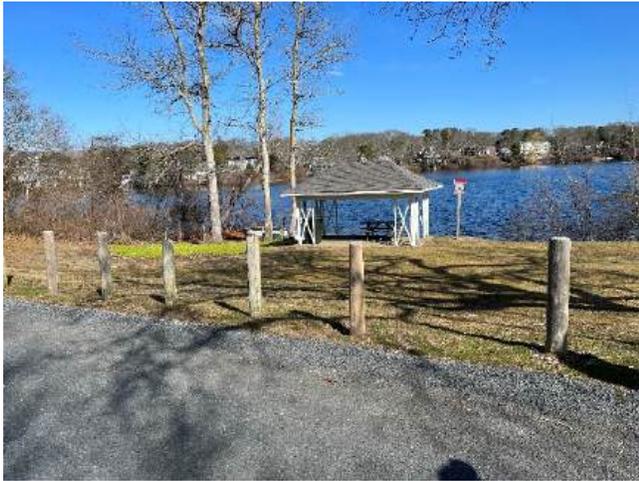
Photo Caption: Area of proposed BMP.

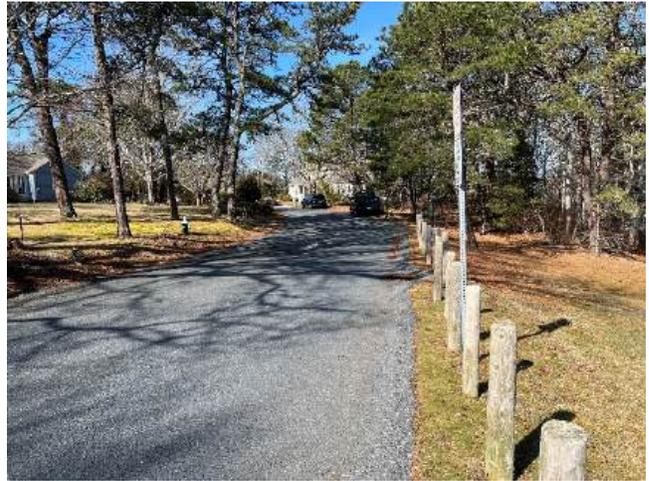
Photo Caption: Looking west on Indian Memorial Drive.

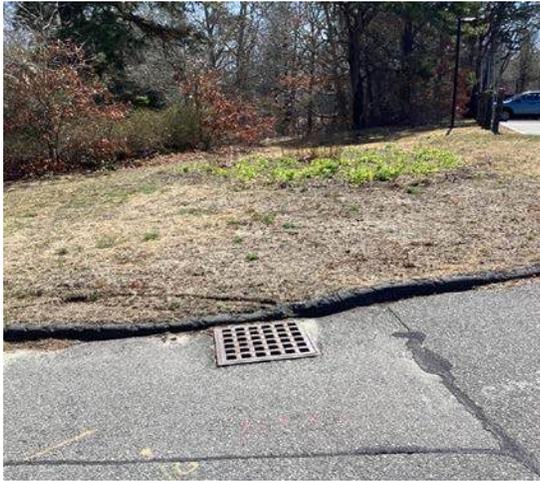
Photo Caption: Area for proposed BMP.

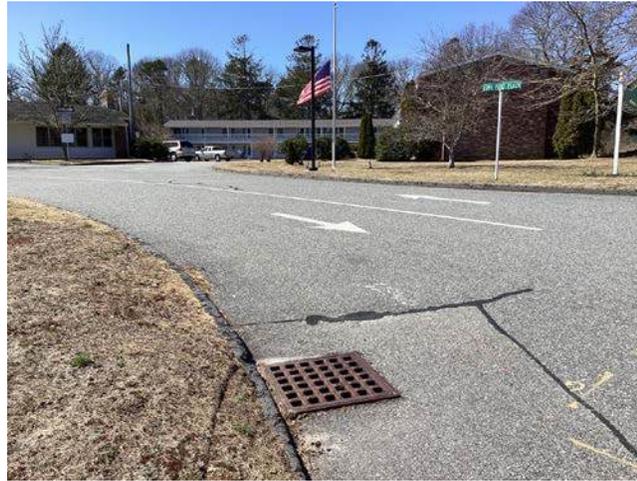
Photo Caption: Catch basin in driveway for Housing Authority property.

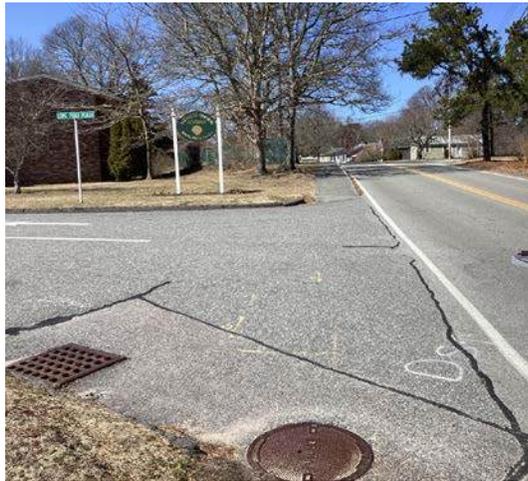
Photo Caption: Looking north on Long Pond Drive.

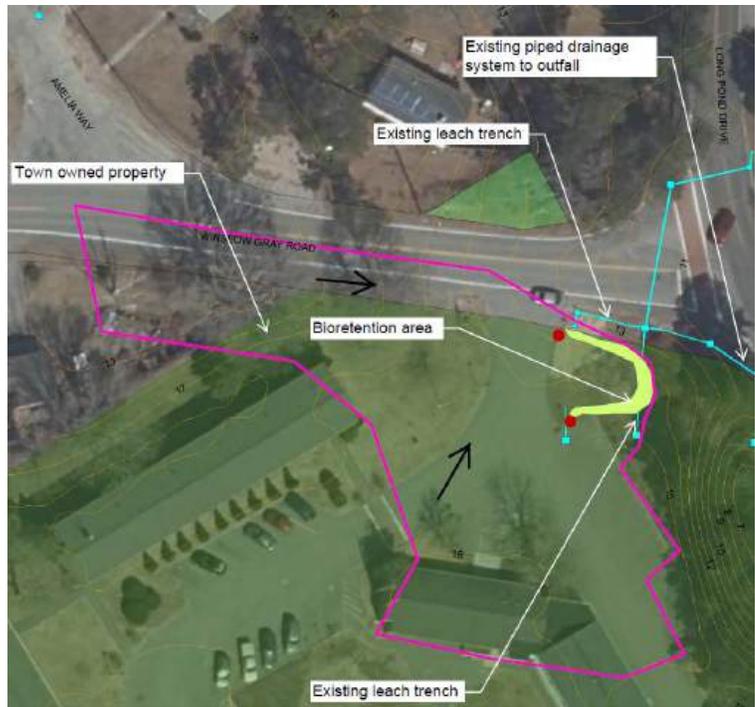
Site Sketch: Drainage area (pink), BMPs (light green), paved flumes (dark red), existing infrastructure (cyan), and drainage flow paths (arrows).

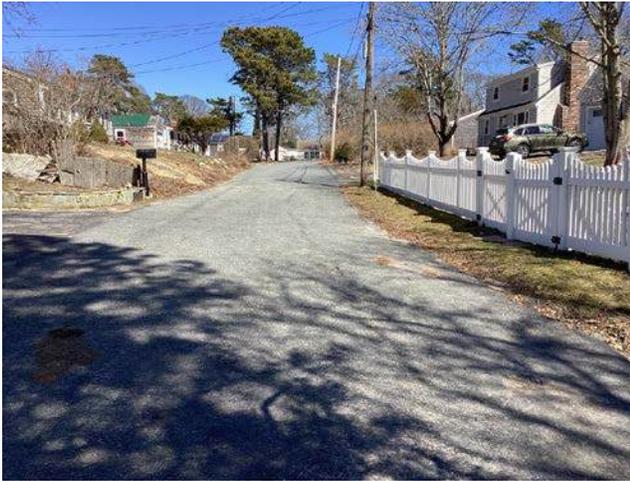
Photo Caption: Looking east up Smith Road.

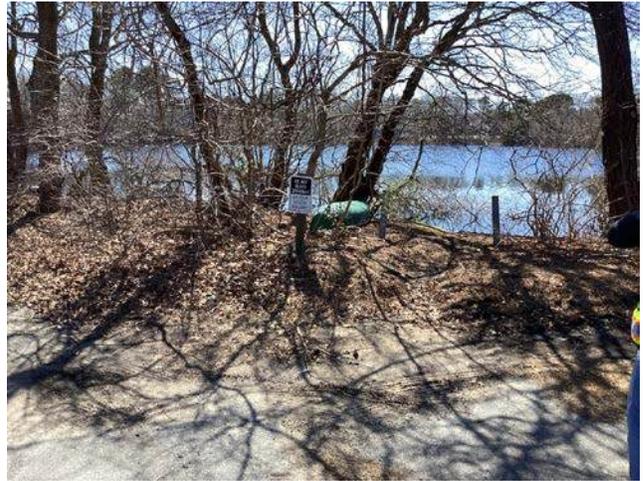
Photo Caption: Looking toward James Pond.

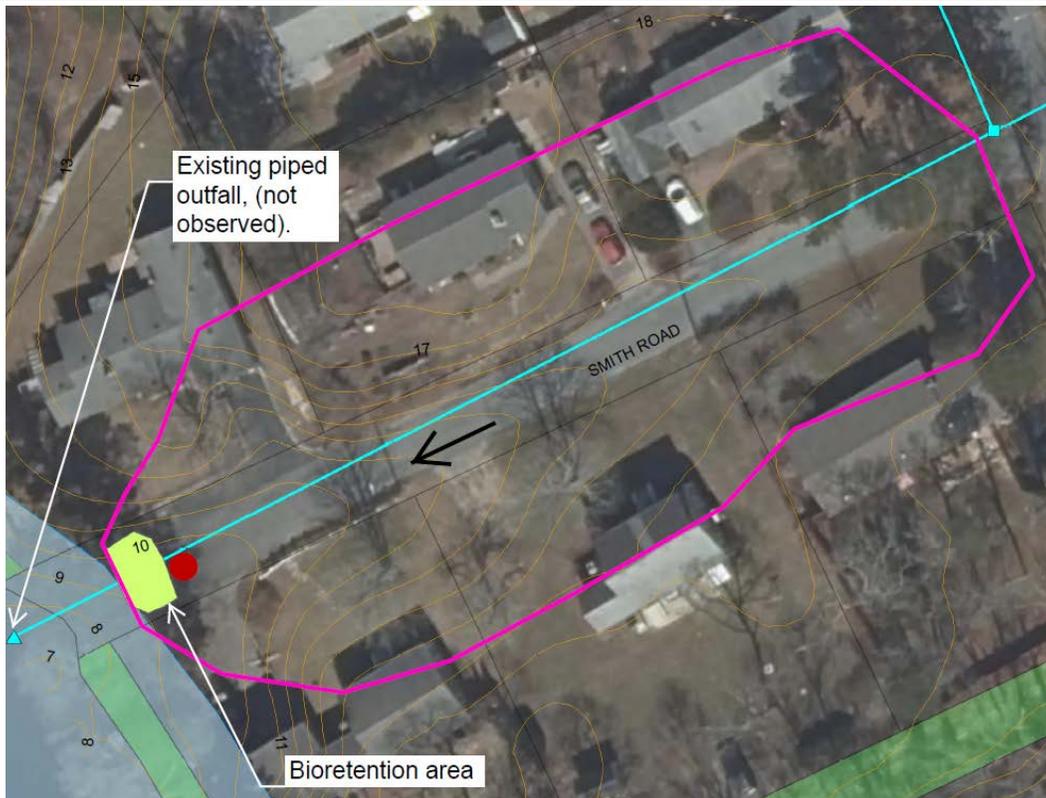
Site Sketch: Drainage area (pink), BMPs (light green), paved flumes (dark red), existing infrastructure (cyan), and drainage flow paths (arrows).

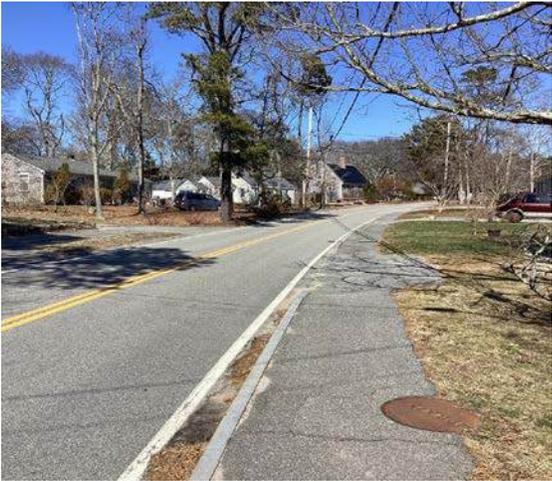
Photo Caption: Looking east on Wood Road.

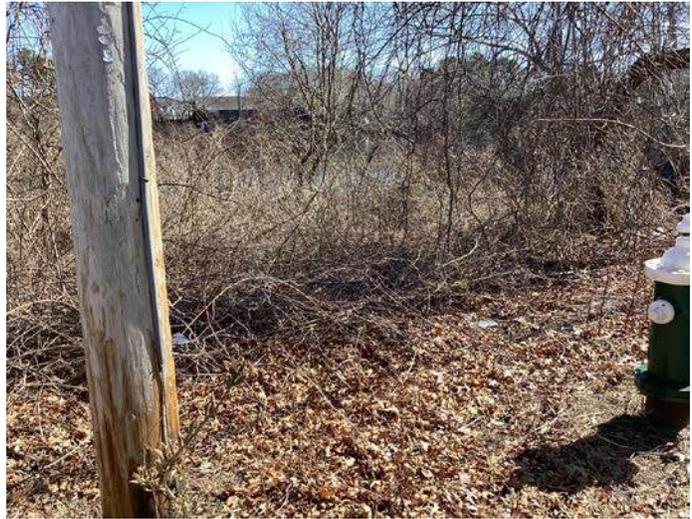
Photo Caption: Area of proposed BMP.

<p>Concept Description: The concept for this site is to replace a portion of the aging leach trenches with a constructed wetland with an overflow to James Pond. A retaining wall or terraced system may be required due to steep slopes.</p>		
GENERAL SITE INFORMATION	RETROFIT DETAILS	
<p>Site Contact: Amanda Lima (Town Engineer) Ownership: Town Existing Site Condition: Fair Land Use: Residential Roadway</p>	<p>Existing or New?: Existing Proposed BMP/Pretreatment: Constructed Wetland / Sediment Forebay Non-Structural Controls: Street Sweeping BMP Maintenance Burden: Low</p>

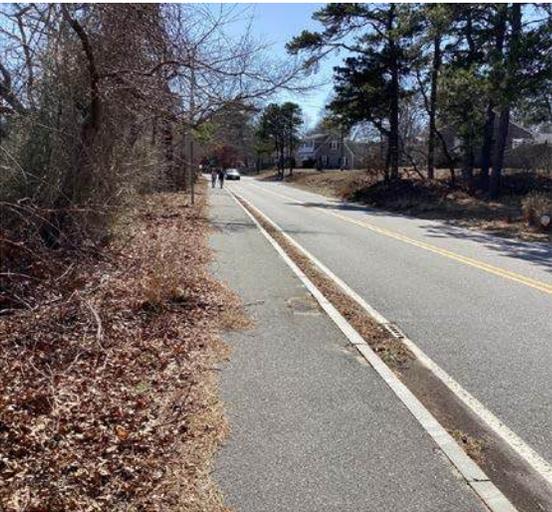
Photo Caption: Looking west on Wood Road.

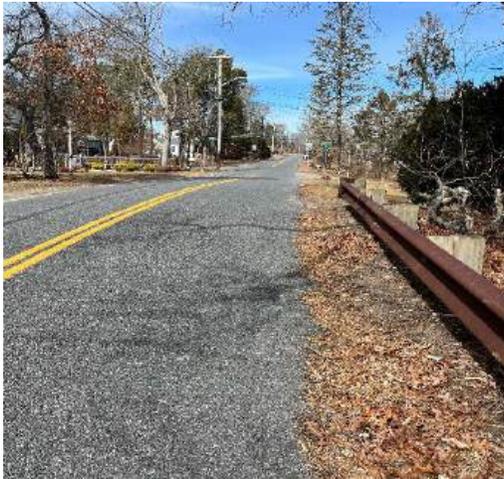
Photo Caption: Baxter Avenue looking north toward Gleason Avenue.

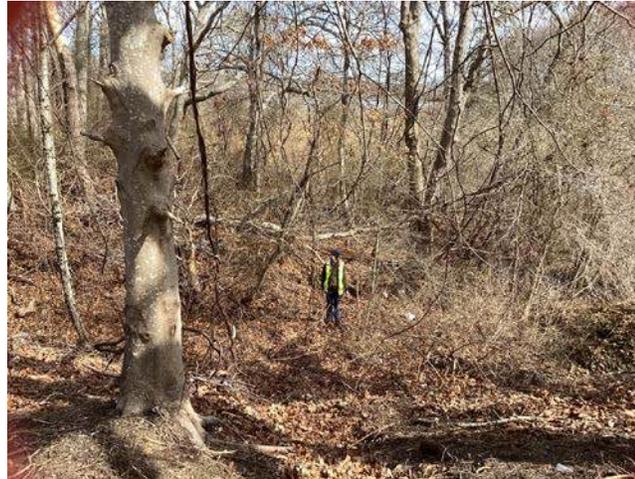
Photo Caption: Town-owned property on Baxter Avenue. Area for BMP.

<p>Concept Description: The concept for this site consists of installing a constructed wetland on the town-owned property. A catch basin is proposed to be installed at the low point of Baxter Avenue and piped to the constructed wetland. Additionally, the four catch basins to the north are proposed to be redirected via pipes and structures to the constructed wetland.</p>

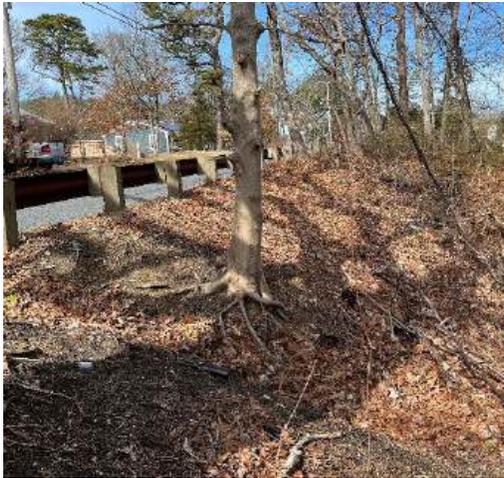
<p>Site Description: At the low point on Baxter Avenue just north of Pamela Court, there is an eroded flow path (no formal drainage infrastructure) down a steep embankment and into a wetland on a town-owned property. Most of this property is wetlands, however, there is some upland space available in the northwestern corner of the parcel. In the drainage area to the north, there are a four catch basins on Cleveland Way and Gleason Avenue that are directed down Gleason Avenue to the wetland. There is a high point separating the catch basins from the Baxter Avenue low point drainage area.</p> <p>Existing BMP on site? None</p>	<p>Site Location: Baxter Avenue</p>

Photo Caption: Eroded flow path on town-owned property from Baxter Avenue.

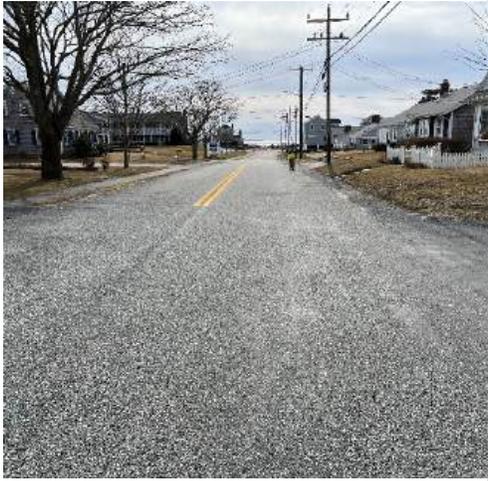
Photo Caption: Standish Way looking toward the beach parking lot.

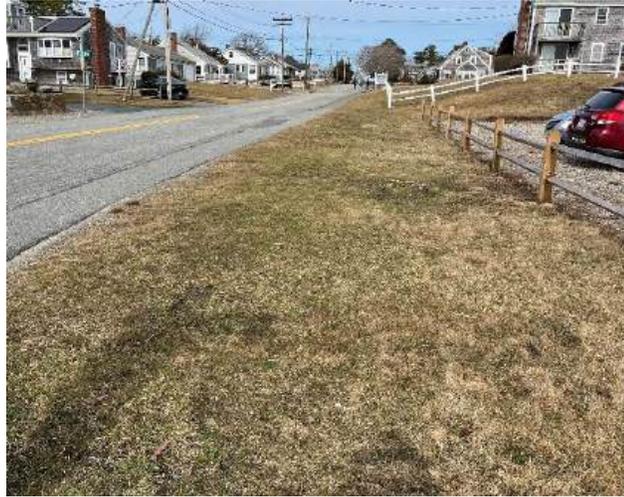
Photo Caption: Corner of Standish Way and Windemere Road. Area for BMP.

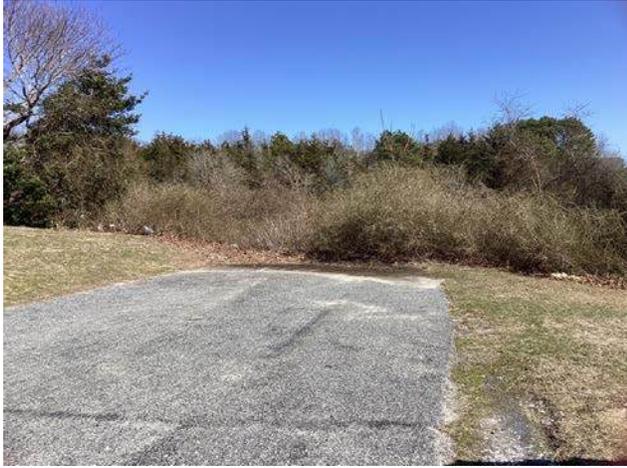
Photo Caption: End of Baker Avenue.

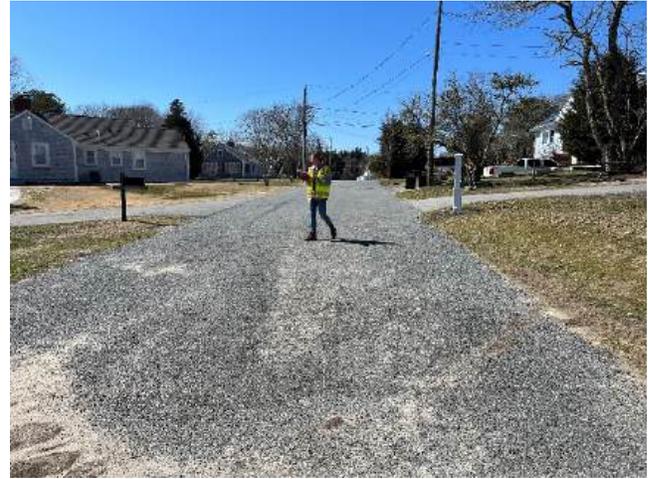
Photo Caption: End of Baker Ave looking toward Camp Street.

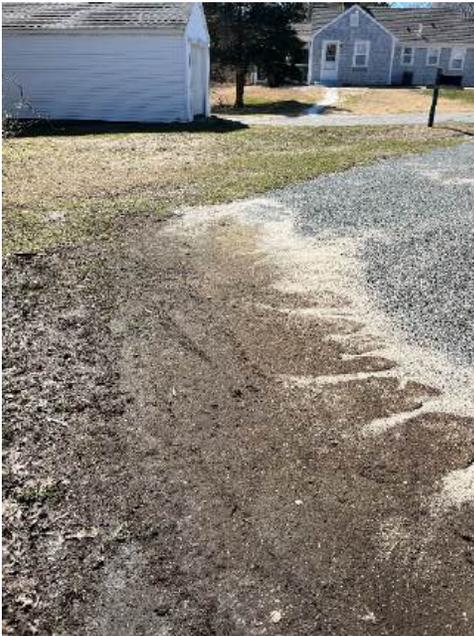
Name: End of Baker Avenue - Bioretention		ID#: MC-5
<p>Site Description: The eastern end of Baker Avenue stops at Mill Pond. The road extends past the last driveway on Baker Avenue. There is some vegetation between Baker Avenue and Mill Pond. There is evidence of sediment accumulation and ponding at the end of Baker Avenue.</p> <p>Existing BMP on site? None</p>	<p>Site Location: End of Baker Avenue</p>

Photo Caption: Sediment accumulation at the end of Baker Avenue.

<p>Concept Description: The concept for this site is to remove the pavement on Baker Avenue up to the last driveway. This area would then be replaced with a bioretention area and a vegetated buffer between the wetland and the road.</p>		
GENERAL SITE INFORMATION	RETROFIT DETAILS	
<p>Site Contact: Amanda Lima (Town Engineer) Ownership: Town Existing Site Condition: Fair Land Use: Residential</p>	<p>Existing or New?: New Proposed BMP/Pretreatment: Bioretention / Sediment Forebay Non-Structural Controls: Pavement Removal, Revegetation, Invasives Management BMP Maintenance Burden: Low</p>

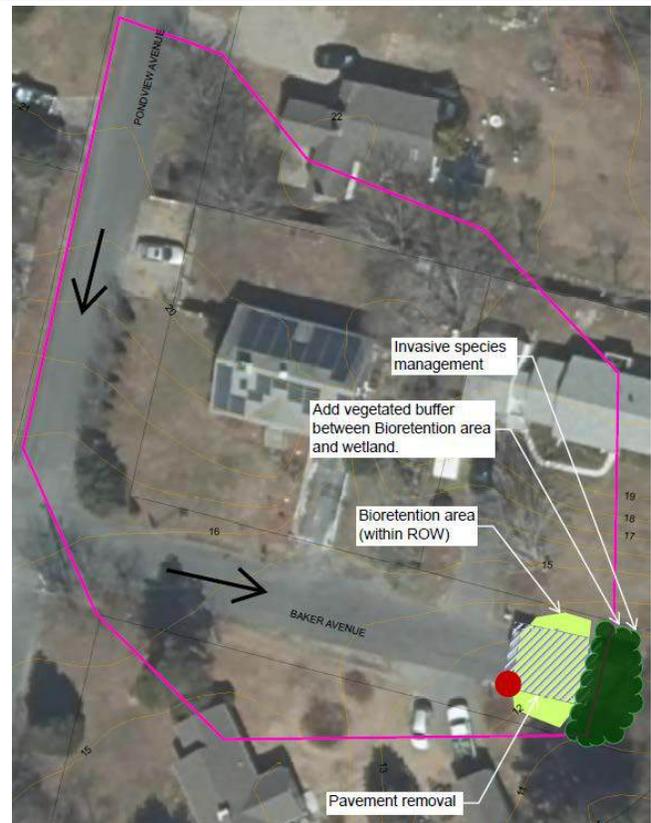
Site Sketch: Drainage area (pink), BMPs (light green), paved flumes (dark red), pavement removal (striped gray), revegetation (dark green), and drainage flow paths (arrows).

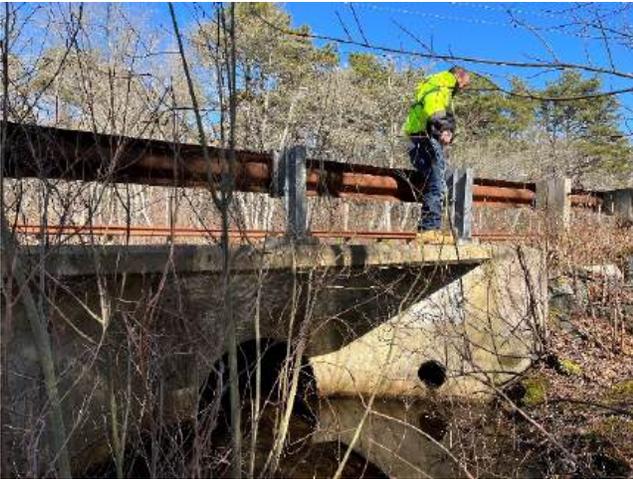
Photo Caption: Culvert crossing under Buck Island Road.

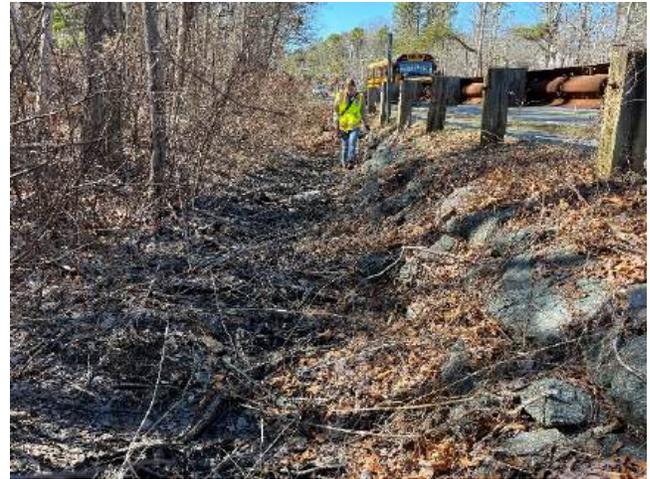
Photo Caption: Standing at culvert crossing looking at existing swale.

<p>Concept Description: The concept for this site is to convert the existing swale into a wet swale with an overflow spillway that outlets into the creek.</p>		
GENERAL SITE INFORMATION		RETROFIT DETAILS
<p>Site Contact: Amanda Lima (Town Engineer) Ownership: Town Existing Site Condition: Good Land Use: Main road</p>	<p>Existing or New?: Existing Proposed BMP/Pretreatment: Wet Swale / Sediment Forebay Non-Structural Controls: Buffer Restoration BMP Maintenance Burden: Low</p>

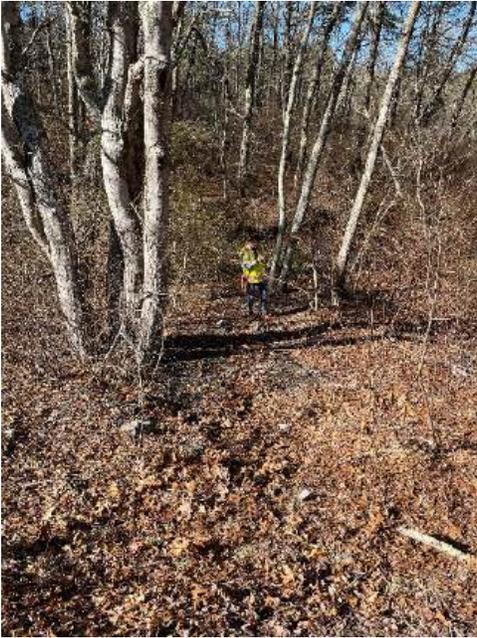
Photo Caption: BMP area upgradient of creek.

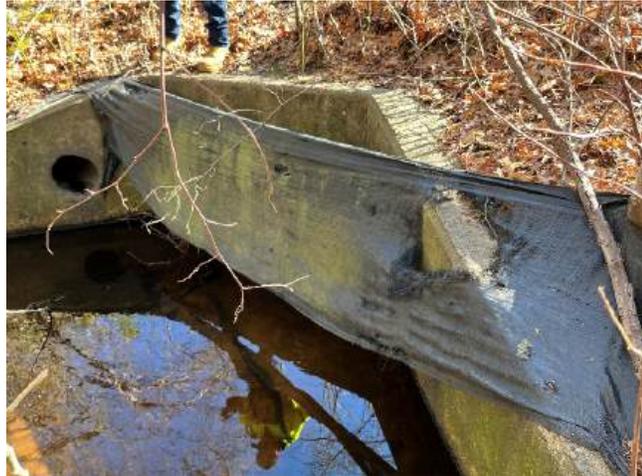
Photo Caption: Northern culvert crossing headwall on Buck Island Road – second outfall from target drainage area visible on left side of photo.

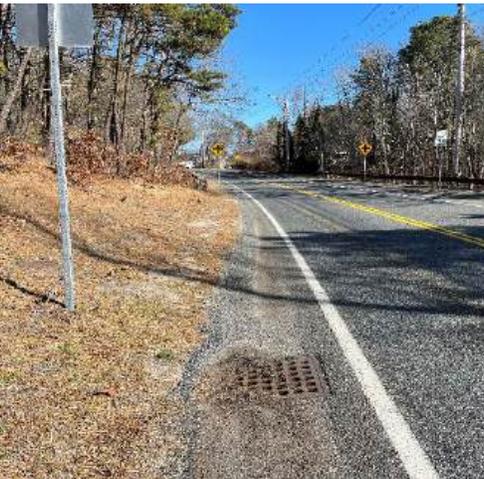
Photo Caption: Catch basin on Buck Island Road.

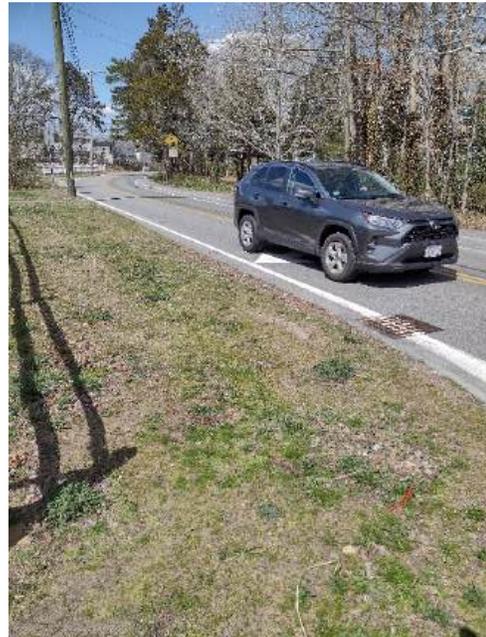
Photo Caption: Catch Basin at 54 Old Main Street (Location 14- Bioretention location).

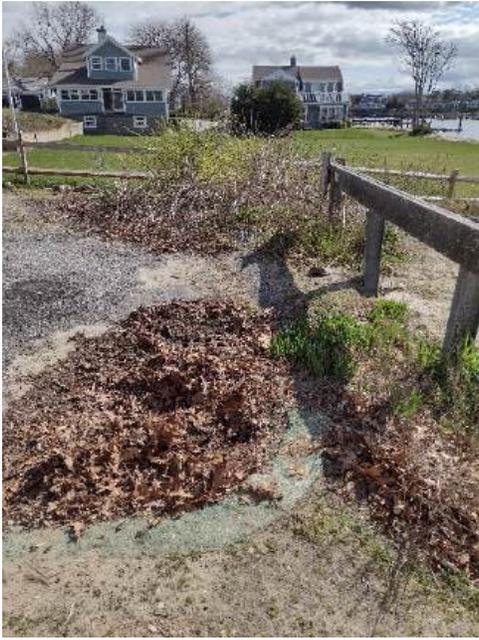
Name: Homer Avenue - Bioretention		ID#: OM-3
<p>Site Description: Homer Avenue is a steep road that ends at a public beach access point on Bass River. The road extends past the last driveway. There is a leaching basin at the end of Homer Avenue that is covered in sediment and leaves with a flattened silt sock around the structure with signs of erosion. There is no vegetation between Baker Avenue and Mill Pond.</p> <p>Existing BMP on site? Leaching basin</p>	<p>Site Location: End of Homer Avenue</p>

Photo Caption: Existing leaching basin clogged with leaf litter and sediment.

<p>Concept Description: The concept for this site is to remove pavement at the end of the road. This area would be replaced with a bioretention area that overflows into the leaching basin and a vegetated buffer between the beach and the road.</p>		
GENERAL SITE INFORMATION		RETROFIT DETAILS
<p>Site Contact: Amanda Lima (Town Engineer) Ownership: Town Existing Site Condition: Poor Land Use: Residential, beach access</p>		<p>Existing or New?: Existing Proposed BMP/Pretreatment: Bioretention / Sediment Forebay Non-Structural Controls: Pavement Removal, Revegetation, Public Education BMP Maintenance Burden: Low</p>

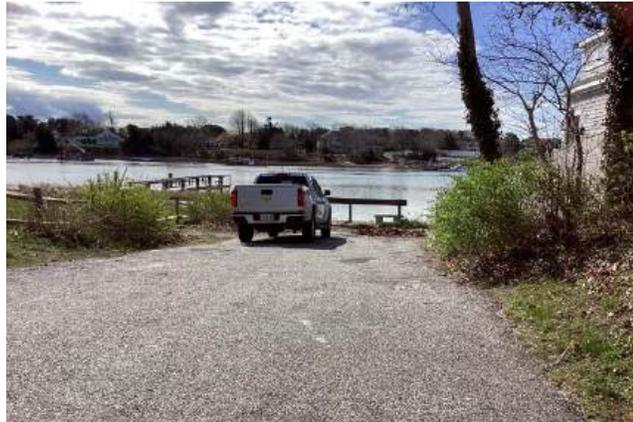
Photo Caption: End of Homer Avenue looking toward Bass River.

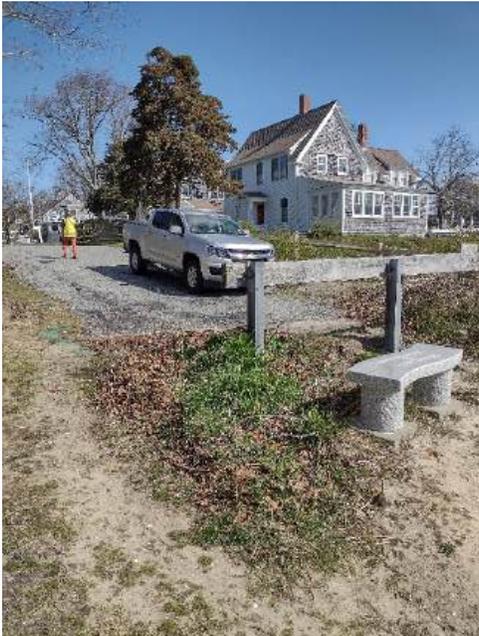
Photo Caption: Beach access at end of Homer Avenue.

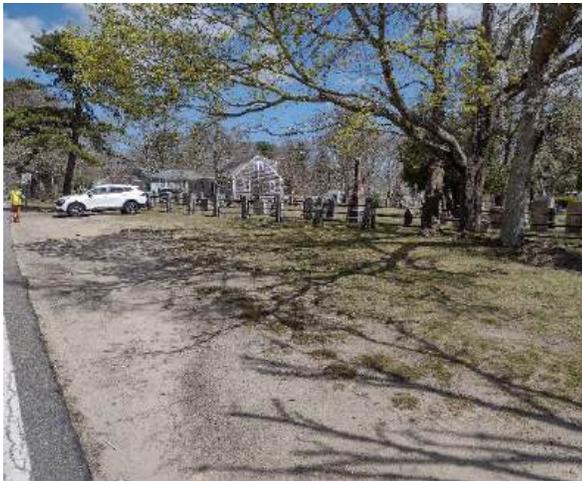
Photo Caption: Cemetery informal parking looking northeast.

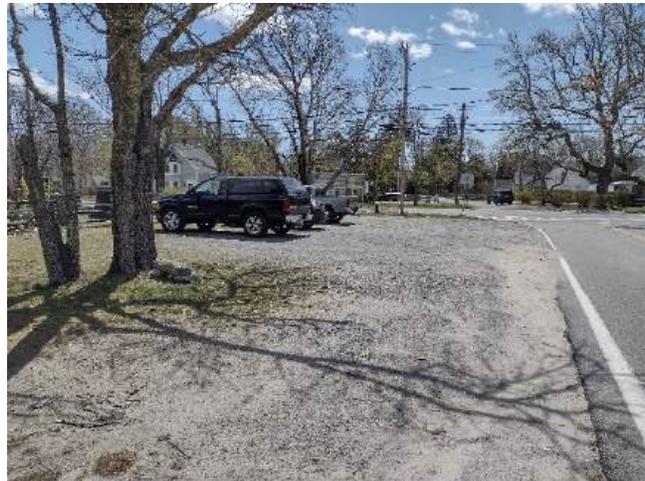
Photo Caption: Gravel parking lot area.

<p>Concept Description: The concept for this site is to replace the gravel parking area with porous pavement or pavers and to add a bioretention area along the parking area. Runoff from Wood Road would be directed to the bioretention area and any overflow would continue to the existing catch basins.</p>		
GENERAL SITE INFORMATION	RETROFIT DETAILS	
<p>Site Contact: Amanda Lima (Town Engineer) Ownership: Town Existing Site Condition: Poor Land Use: Cemetery parking</p>	<p>Existing or New?: New Proposed BMP/Pretreatment: Bioretention / Sediment Forebay and Porous Pavement Non-Structural Controls: Street Sweeping, Stabilization, Public Education BMP Maintenance Burden: Medium</p>

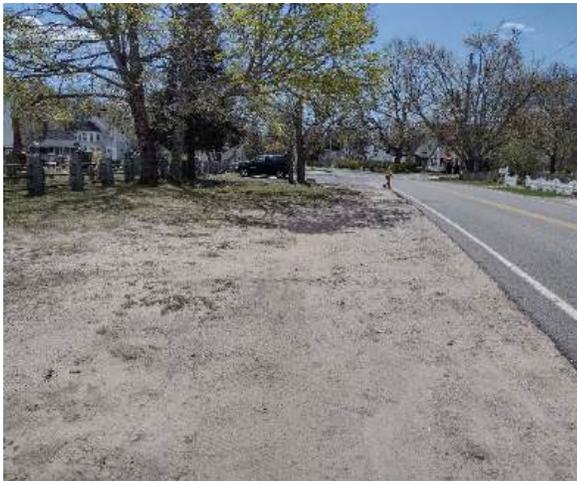
Photo Caption: Cemetery informal parking looking southeast.

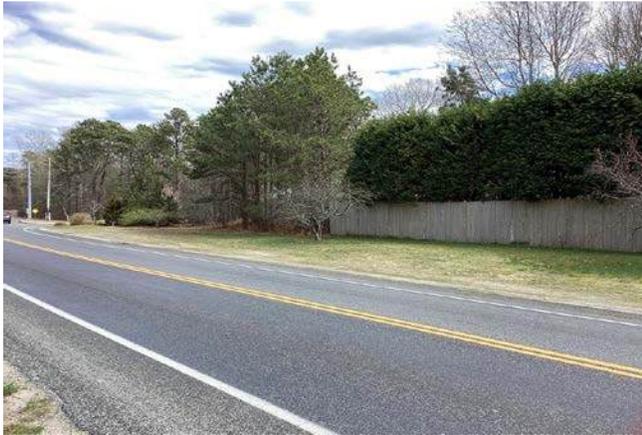
Photo Caption: Town-owned property on Buck Island Road.

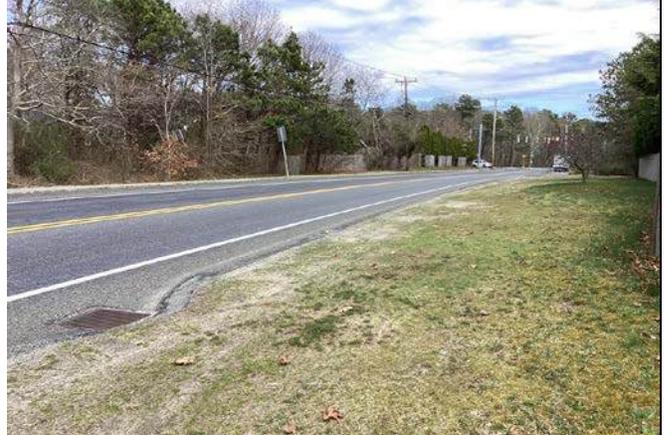
Photo Caption: Catch Basin second closest to West Yarmouth Road intersection on the south side of Buck Island Road.

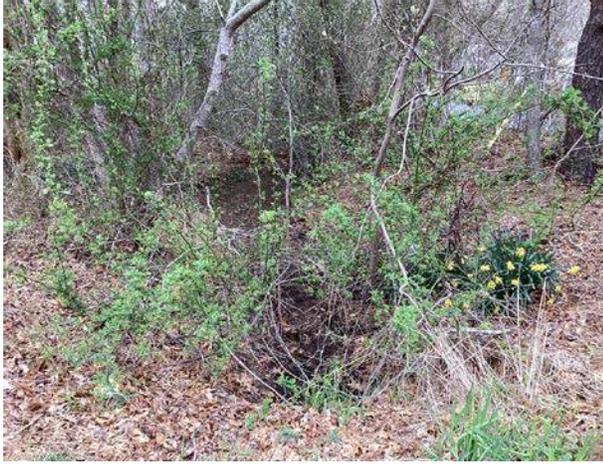
Photo Caption: East outlet/inlet of closed drainage system on Buck Island Road. Looking at existing swale.

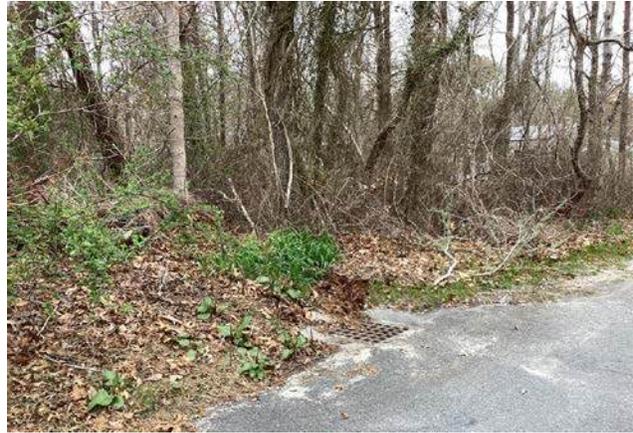
Photo Caption: Catch basin on Lake Road West.

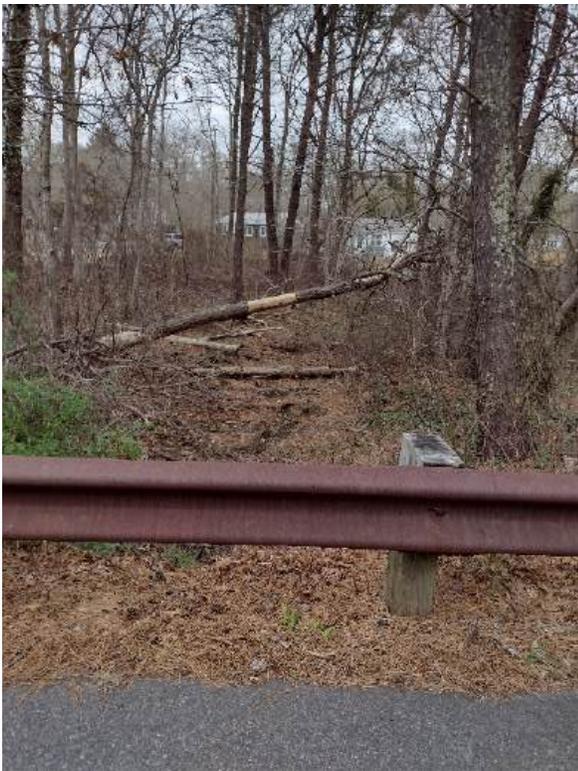
Photo Caption: Standing above west outlet/inlet of closed drainage system on Buck Island Road. Looking at existing swale.

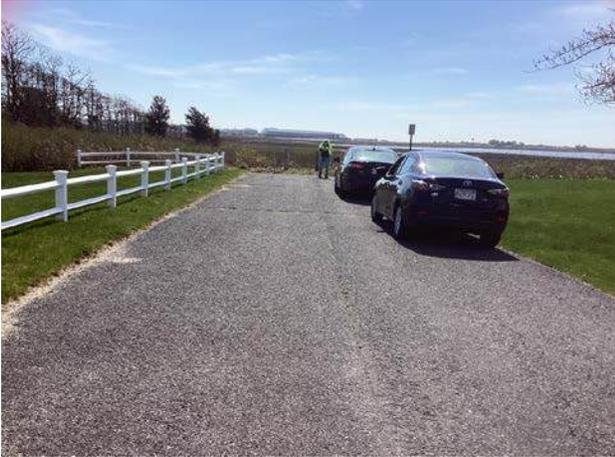
Photo Caption: Looking east, towards marsh.

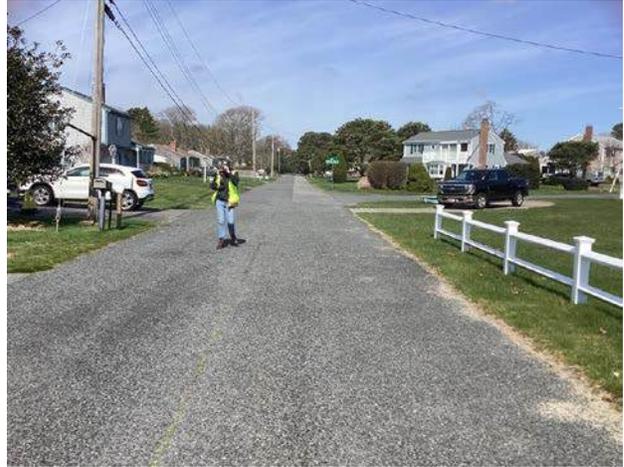
Photo Caption: Looking west up Maushops Path.

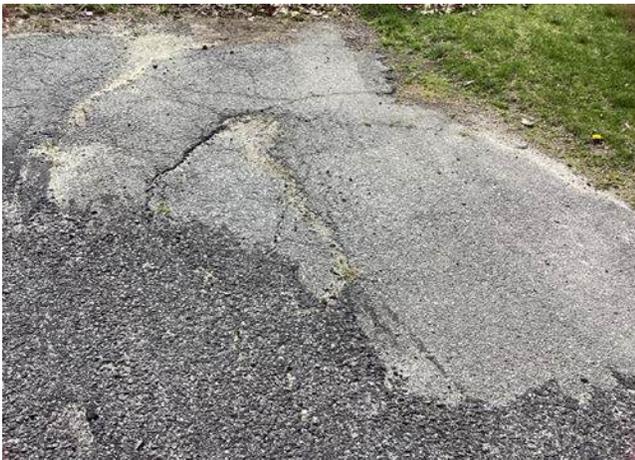
Photo Caption: Layers of chipseal.

<p>Concept Description: The concept at this site is to remove some existing pavement, revegetate to create a larger buffer, and construct a wet swale for runoff. It appears that neighbors have been trimming / clearing the buffer to maintain views; recommend low growing shrubs in buffer. Permeable pavement could still be installed upgradient with this concept.</p>		
GENERAL SITE INFORMATION	RETROFIT DETAILS	
<p>Site Contact: Amanda Lima (Town Engineer) Ownership: Town Existing Site Condition: Fair Land Use: Residential</p>	<p>Existing or New?: New Proposed BMP/Pretreatment: Wet Swale / None Non-Structural Controls: Pavement Removal, Buffer Vegetation BMP Maintenance Burden: Low</p>

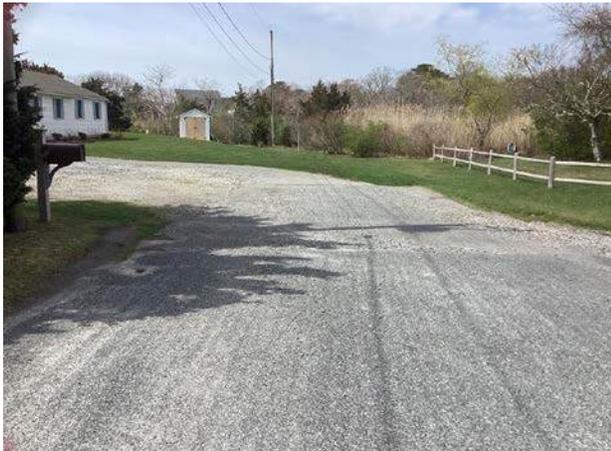
Name: Pawnee Road - Wet Swale		ID#: PR-8
<p>Site Description: The intersection of Pamet Road, Pawnee Road, and Iroquois Boulevard appears to be an area that ponds after rain events and has been chip-sealed over. It is mapped as a proposed area for porous pavement. There are existing catch basins on Iroquois Boulevard, and the one on the eastern side of the roadway has a rust-colored stain along the inlet and in the roadway; it is possible that something has been discharged repeatedly into the catch basin here. No odor was present.</p> <p>Existing BMP on site? None</p>	<p>Site Location: Pawnee Road / Iroquois Blvd Intersection</p>

Photo Caption: Looking west on Pawnee Road.

<p>Concept Description: The concept is to eliminate the existing catch basins and construct a paved flume and wet swale in the ROW. If porous pavement is considered here, should do a larger stretch of road rather than just the intersection which will clog faster from run-on.</p>

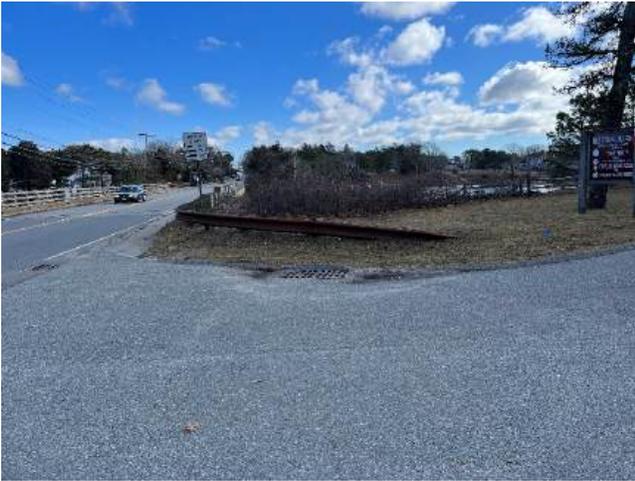
Photo Caption: Area of proposed BMP.

<p>Concept Description: The concept for this site is to install a paved flume to bypass existing catch basins for surface treatment (bioretention). This would be a good opportunity for public education with an additional sign at the entrance.</p>		
GENERAL SITE INFORMATION		RETROFIT DETAILS
<p>Site Contact: Amanda Lima (Town Engineer) Ownership: Town Existing Site Condition: Fair Land Use: Park</p>	<p>Existing or New?: Existing Proposed BMP/Pretreatment: Bioretention / Sediment Forebay Non-Structural Controls: Street Sweeping, Public Education BMP Maintenance Burden: Medium</p>

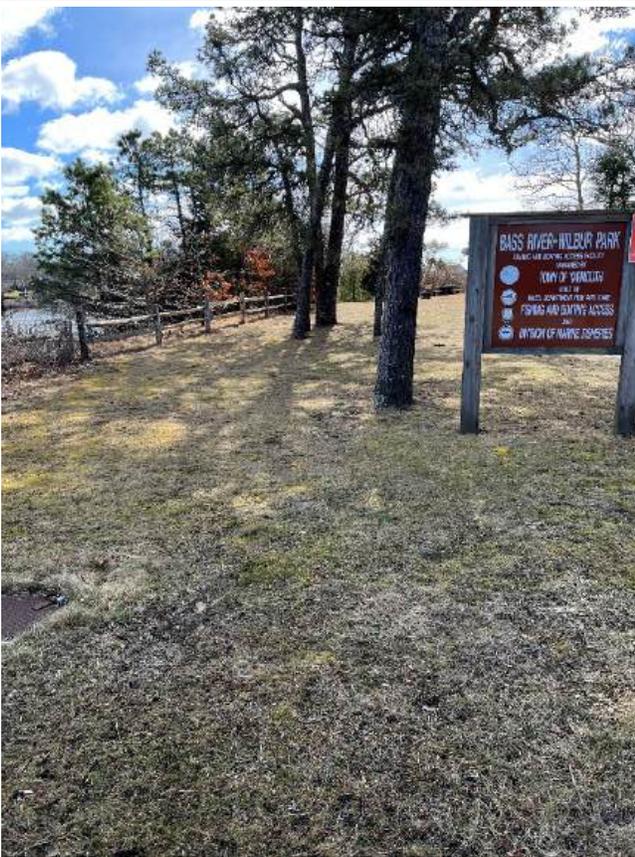
Photo Caption: Area of proposed BMP.
