Memorandum

DATE: June 30, 2023

RE: Yarmouth Stormwater Retrofit Assessment – Final Report

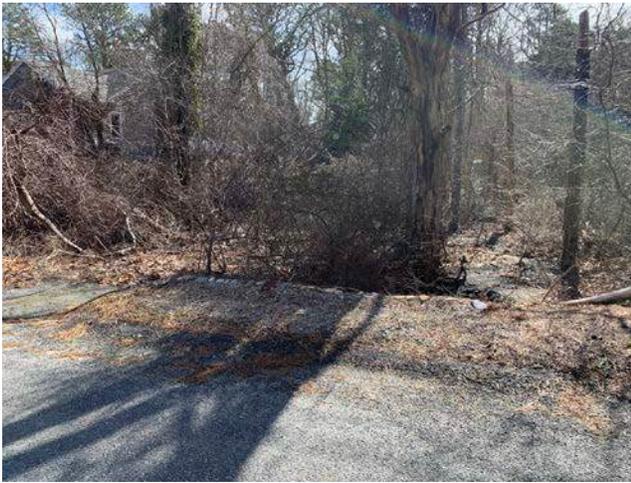
Name: Curve Hill Road 1 - Constructed Wetland		ID#: UBR-4
<p>Site Description: There is a fairly large, closed drainage system along Great Western Road that outfalls to town-owned property. The outlet pipe was not visible (under water); lots of sediment was observed. There is a paved flume for runoff from Curve Hill Road that is also directly discharging to this low point.</p> <p>Existing BMP on site? None</p> <p>Concept Description: The concept for this site is to install a constructed wetland at the outfall pipe. A small sediment forebay will be required for the direct discharge from Curve Hill Road.</p>	<p>Site Location: Between 8 and 18 Curve Hill Road</p>

Photo Caption: Area of existing outfall / proposed BMP

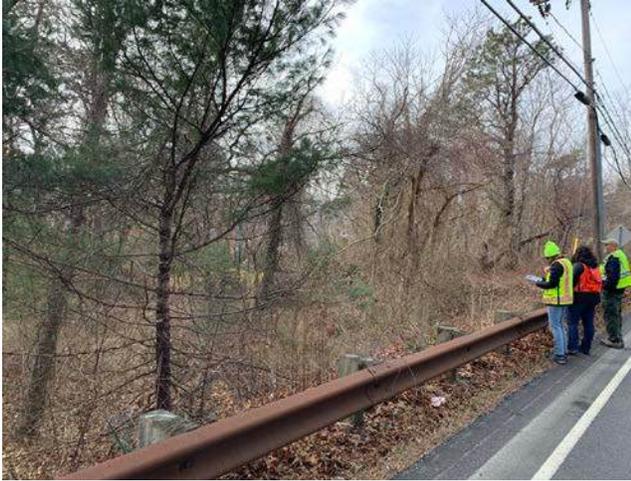
Photo Caption: Area of proposed BMP

<p>Concept Description: The concept for this site is to install a paved flume to bypass existing catch basins at the town-owned parcel. Additionally, it appears that there is enough head to divert runoff from closed drainage system in road to proposed bioretention area. This site will require tree removal.</p>		
GENERAL SITE INFORMATION	RETROFIT DETAILS	
<p>Site Contact: Amanda Lima (Town Engineer) Ownership: Town Existing Site Condition: Fair Land Use: Roadway</p>	<p>Existing or New?: New Proposed BMP/Pretreatment: Bioretention / Sediment Forebay / Deep sump catch basins Non-Structural Controls: Street Sweeping BMP Maintenance Burden: Medium</p>
